Unified Stream Assessment in Seven Watersheds in San Mateo County, California

August 2008

Prepared for the San Mateo Countywide Water Pollution Prevention Program

EOA, Inc. 1410 Jackson St. Oakland, CA 94612

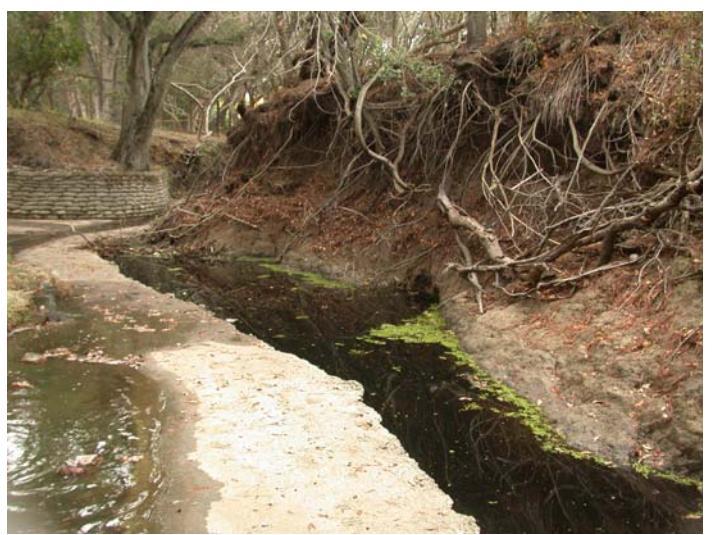
Figure 3. Bank erosion occurring on unprotected banks in Atherton Creek.

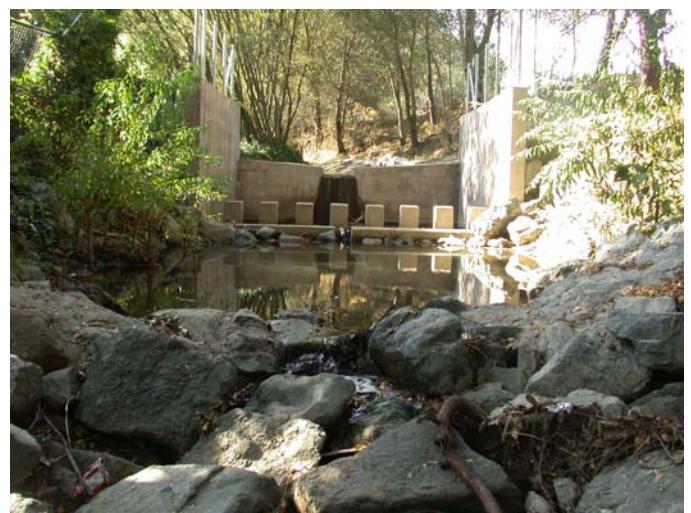
Figure 6. Grade control structure protecting a water supply pipeline in Atherton Creek.

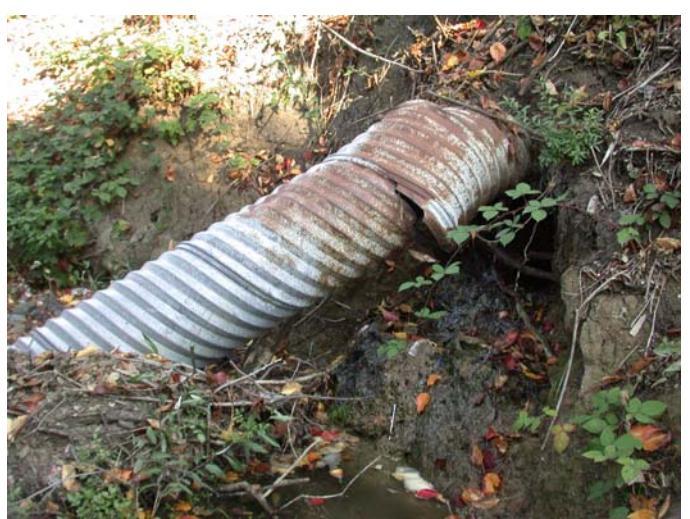
Figure 10. Damaged outfall causing bank erosion in Redwood Creek.

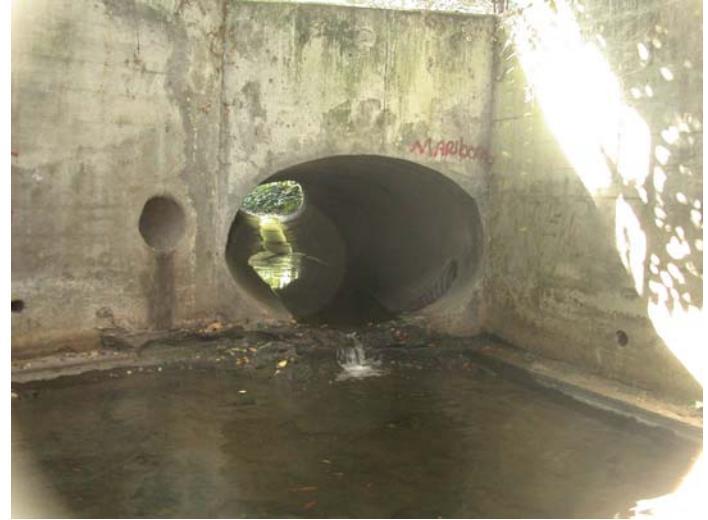
There were 11 road crossings observed in this watershed, four of which were in Reach RW2. Eight of the crossings were modified, seven with culverts and one with concrete blocks. Road crossings in Reaches OA1 and OA2 had 1-2 vertical drops and shallow flow through the culvert, both conditions potentially impeding upstream passage of native fishes. There was a deep pool with large school of fish observed below the culvert in OA1 (Figure 11).

Figure 11. Culvert that may impede upstream fish passage In Arroyo Ojo de Agua.

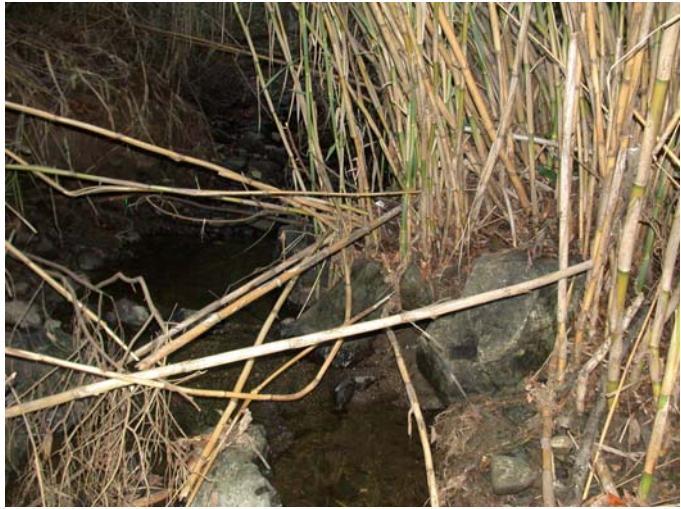
Figure 12. Invasive plant species *Arrundo donax* growing in Arroyo Ojo de Agua.

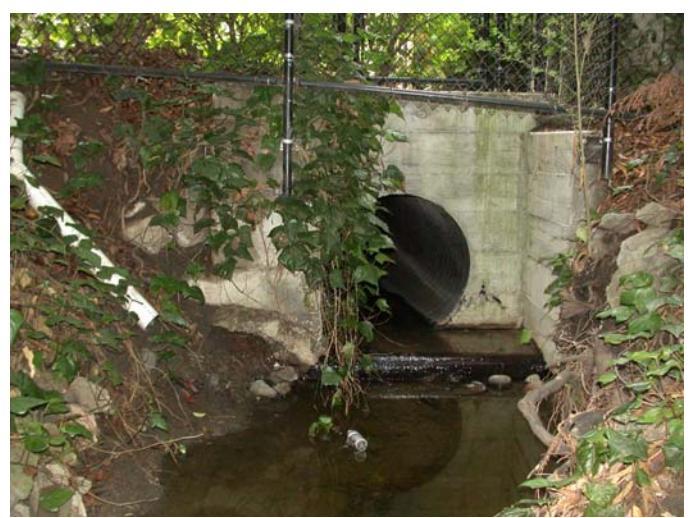
The assessment reaches were highly modified, with about 12,706 feet of armored or culverted channel, equaling about 64% of the total length assessed. Reaches R5 and B1 had the greatest proportion of modified channel, 96% and 94%, respectively. The lowest proportion of modification (36%) occurred in Reach R3. About 40% of the total modified length was culverted sections of creek. Over 500 feet of culvert built under yards of private residences occurred in Reach R4, accounting for over 50% of the total reach length (Figure 16).

Figure 16. One of several culverts built under residences along Ralston creek.

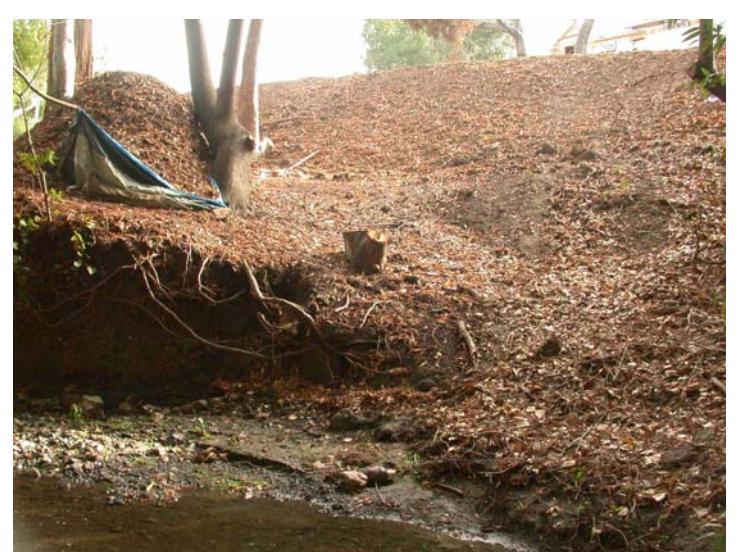
Figure 17. Surface erosion below construction site along Burlingame Creek.

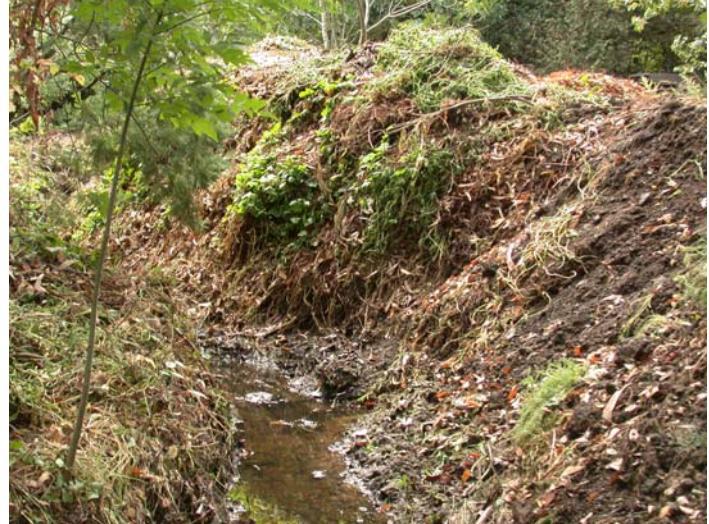
Figure 18. Large pile of yard waste along creek bank in Ralston Creek.

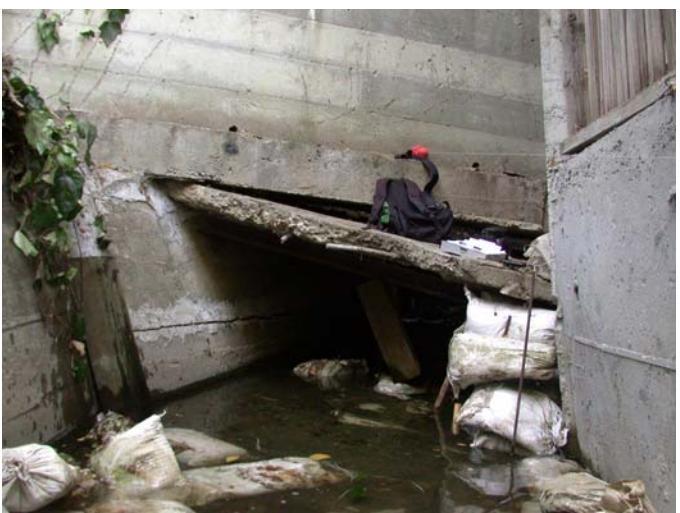
The study reaches in this watershed were highly modified, with about 4,761 feet of armored or culverted channel, equaling about 73% of the total length assessed. The proportion of modified channel ranged from 44% - 99%. Reaches S1 and S5 were almost entirely modified at 99% and 91%, respectively. Reach S2 had the lowest proportion of modification (44%) in the watershed. About 46% of the total modified length was culverted. A culvert in Reach S1 that conveyed the creek under a large utility pipe appeared to be failing (Figure 22).

Figure 22. Potentially failing culvert built under utility pipe and house in Sanchez Creek.

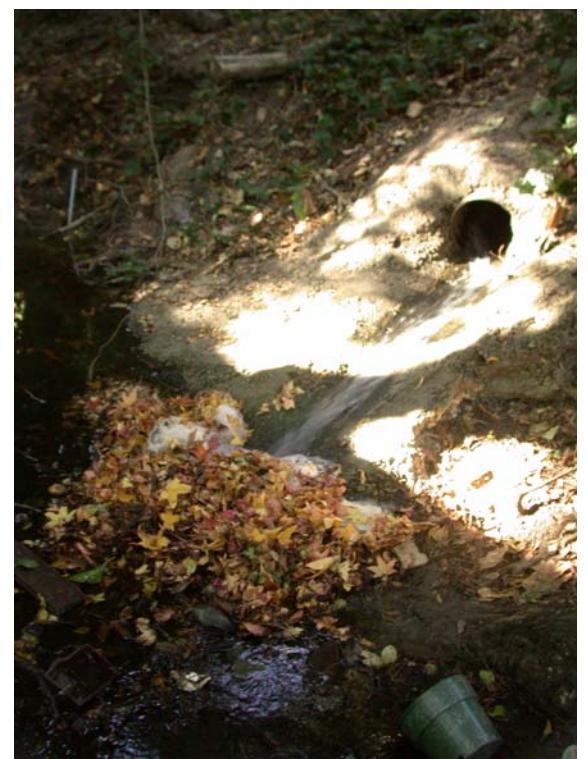
Figure 23. Outfall in Sanchez Creek with discharge containing leaves, suds and trash.

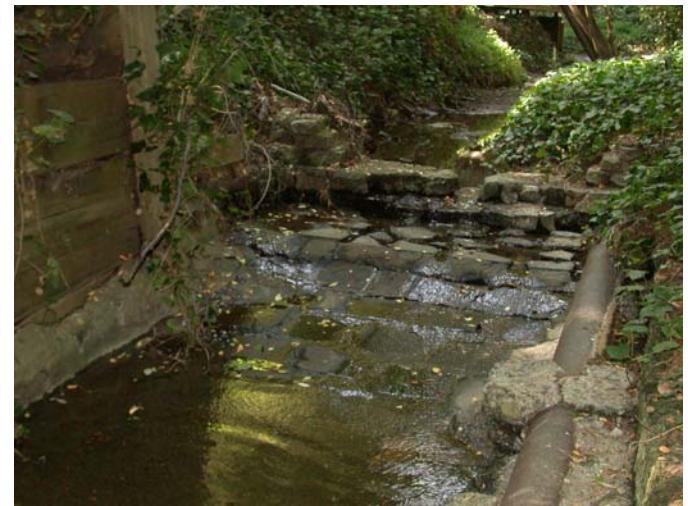
Figure 25. Sewer pipeline in the channel of Easton Creek.

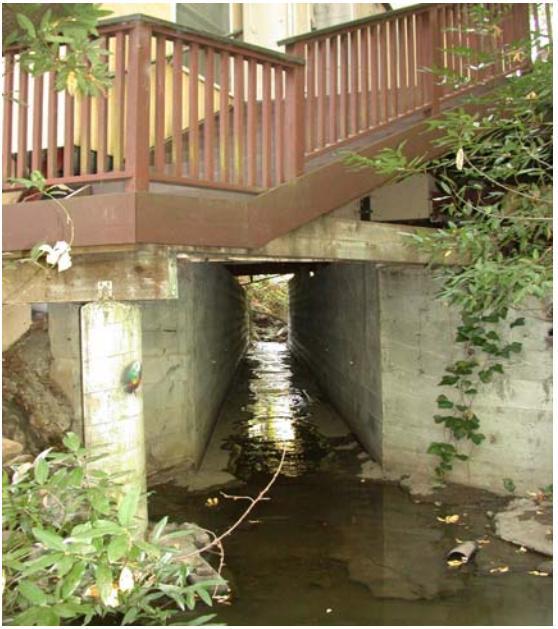
Figure 28. Concrete culvert constructed under a home on Easton Creek.

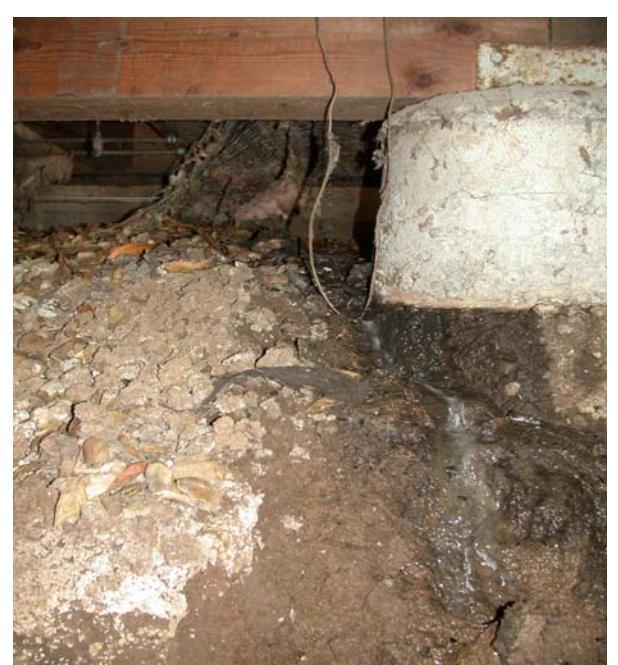
Figure 29. Discharge from leaky pipe under home in Easton Creek.

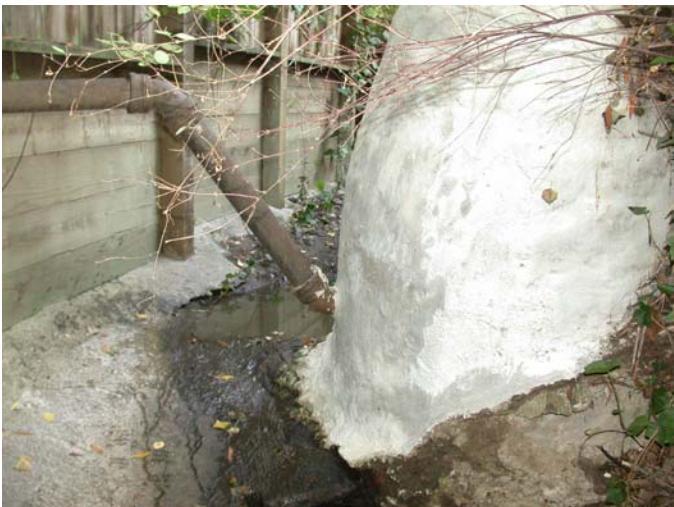
Figure 30. Sewer pipe and access port constructed in the channel of Easton Creek.

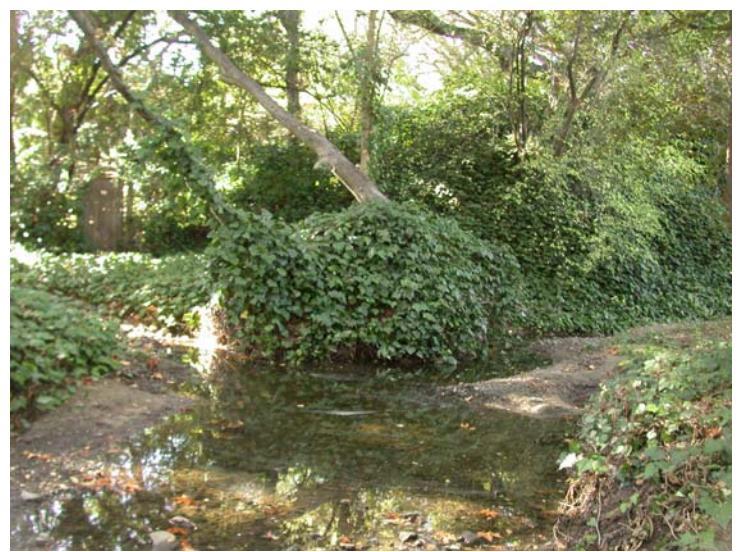
English ivy was the dominant riparian ground cover throughout the watershed (Figure 32). Reaches M1 and M2 had higher reach assessment scores due to better overall flood plain condition (i.e., connectivity and habitat) (Figure 33).

Figure 32. Ivy covered banks at tributary confluence in Mills Creek.

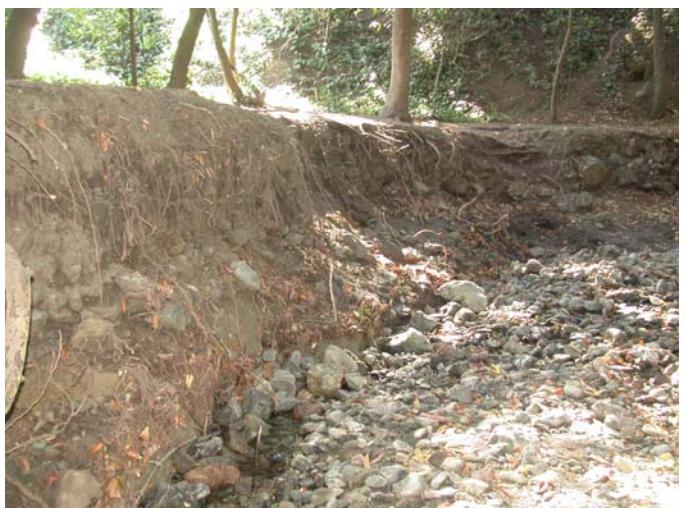
There was about 2,500 feet of erosion observed in this watershed. Reaches M2 and M3 had the greatest proportion of erosion with 49% and 58% of their channels eroded, respectively. Erosion impacts typically consisted of bank scour at failing revetments, downstream culverts and meander bends. The upper portion of Reach M2 within Mills Canyon Park had widespread erosion due to an incised channel with steep banks (Figure 35).

Figure 35. Bank erosion below footpath of park in Mills Creek.

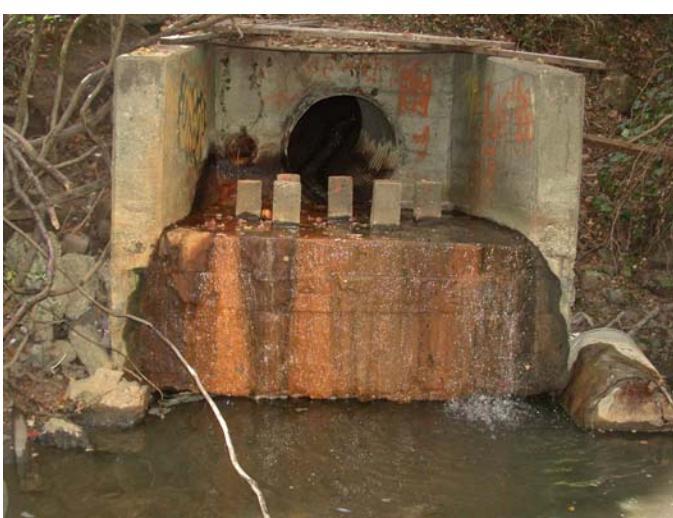
Figure 36. Outfall with turbid discharge and red staining in Mills Creek.

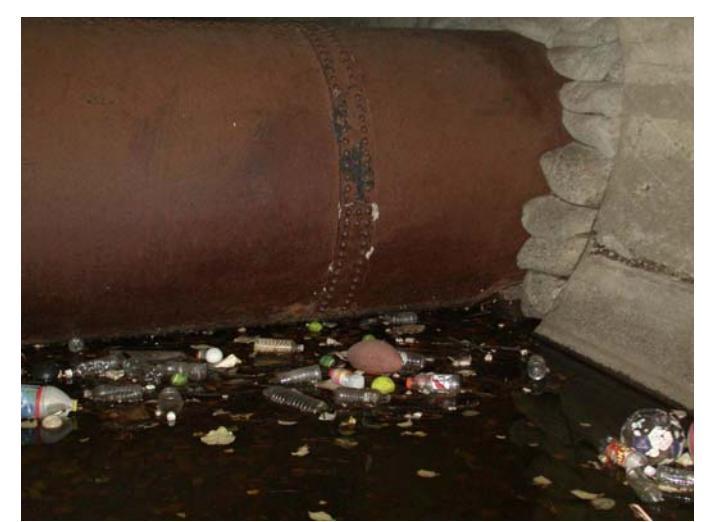
Figure 37. Floating trash trapped by a SFPUC pipeline in Mills Creek.

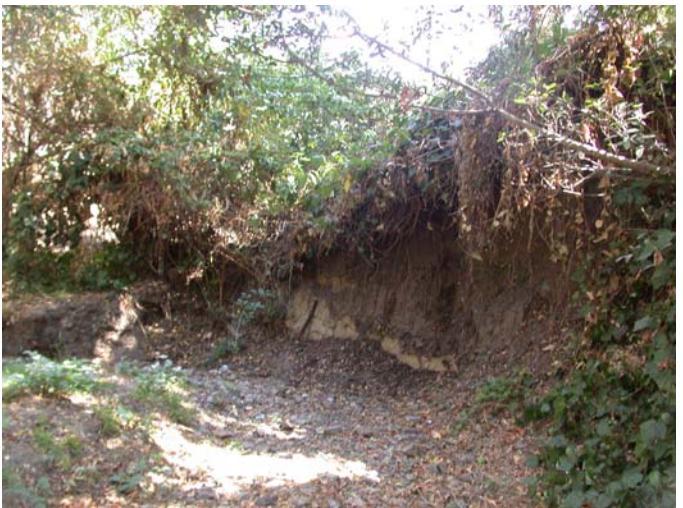
Figure 41. Bank erosion at a meander bend in Millbrae Creek.

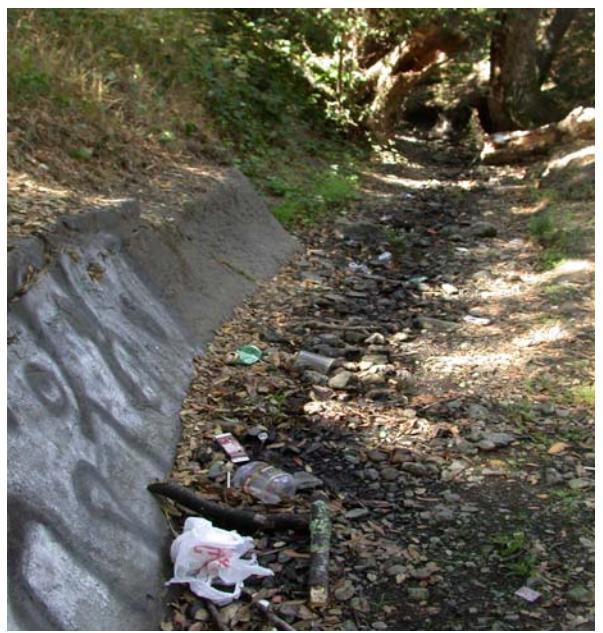
Figure 42. Litter in Millbrae Creek in Reach MB2.
