Unified Stream Assessment in Six Watersheds in San Mateo County, California

August 2007

Prepared for the San Mateo Countywide Water Pollution Prevention Program

EOA, Inc. 1410 Jackson St. Oakland, CA 94612

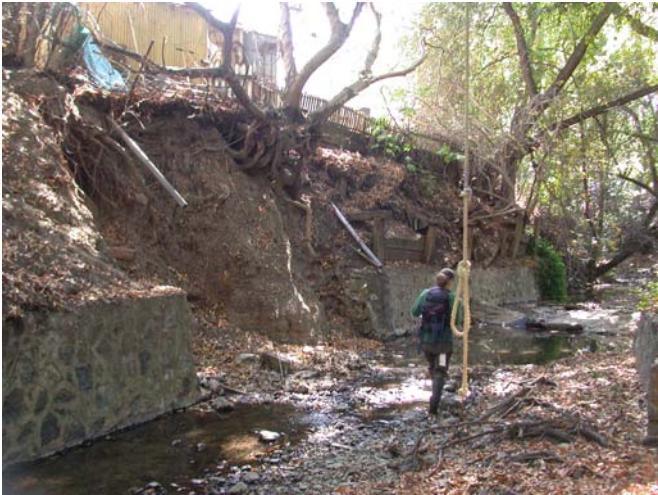
Erosion was mainly manifested as bank failure (Figure 3) (twenty incidences); a minority of the observed cases was bank scour (Figure 4). Reaches C5 and C7 had the highest erosion rates (Table 4). Aggrading sediments were observed in reaches C1, C2 and C6, with evidence of fine sediment and gravel accumulating mid-channel.

Figure 3. An example of bank failure in the Cordilleras Creek watershed. Note the associated outfalls, which do not appear to be municipal storm drains but instead appear to originate from private properties adjacent to the creek. In the foreground is a rope swing used for recreation.

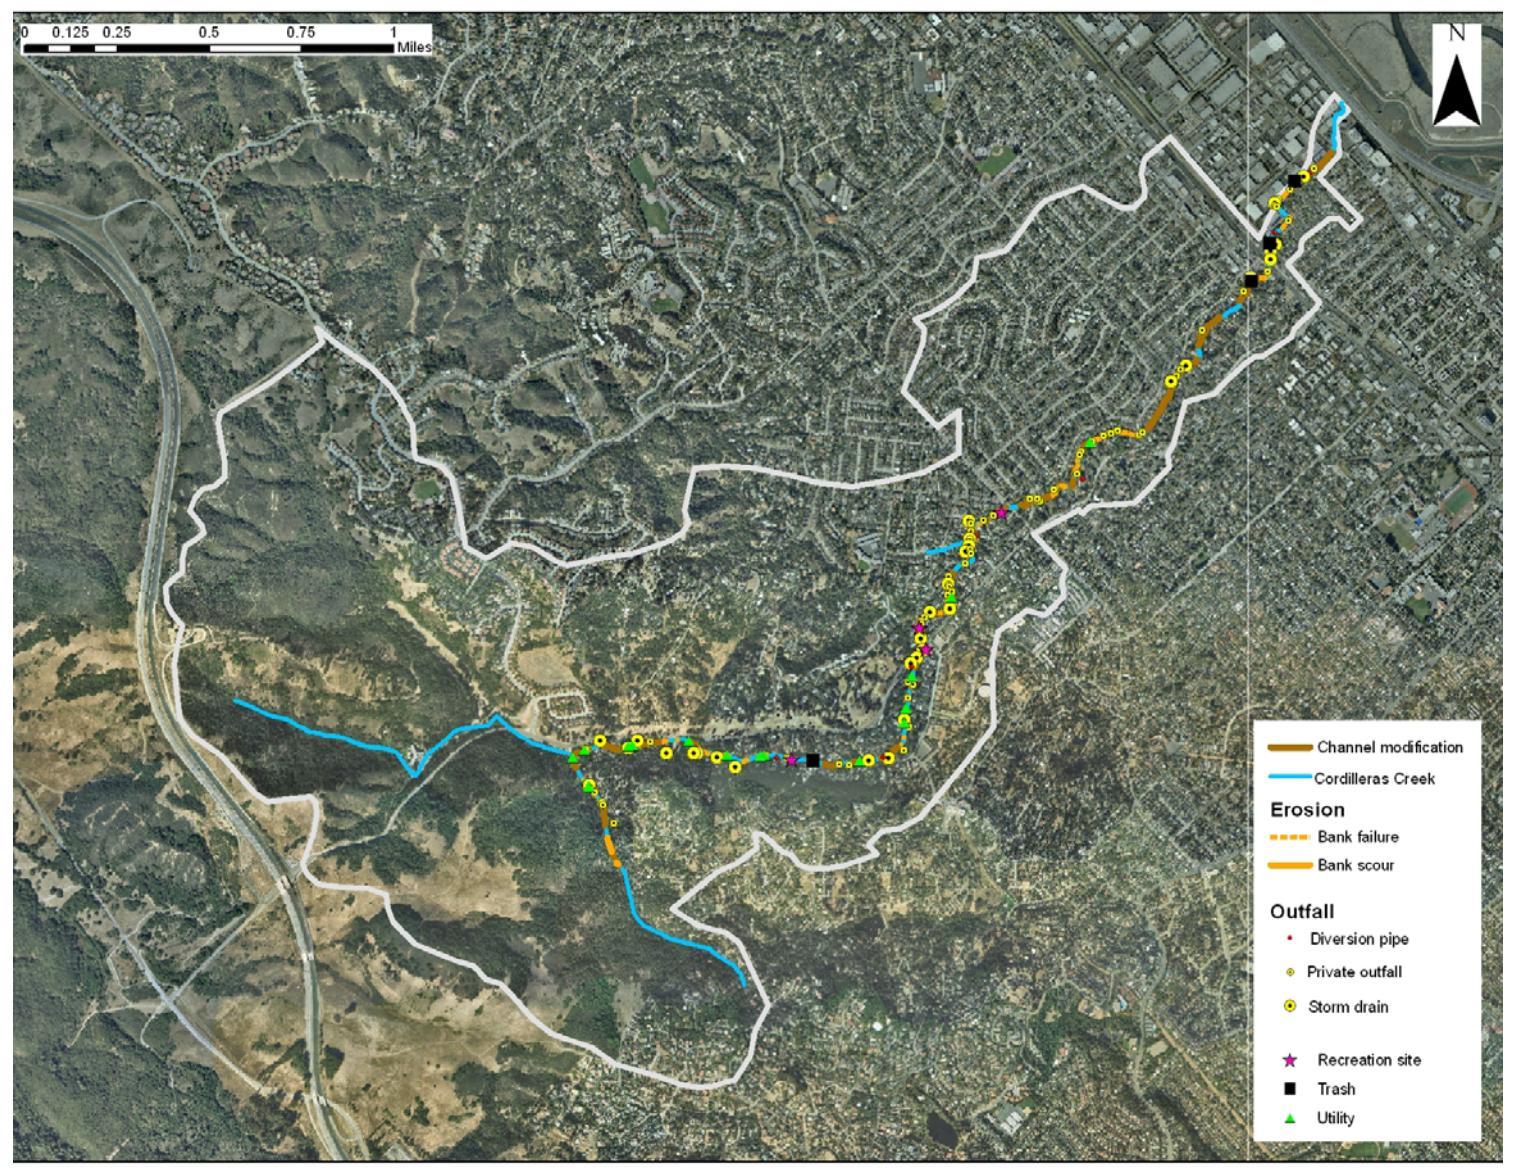
One hundred and nineteen outfalls were documented during the assessment (Figure 4, Table 4). Slightly more than 60% of these were private outfalls. The middle reaches had the highest number of observed outfalls, likely corresponding to the highest housing density. Most of these outfalls had no dry weather flow (83%). However, two storm drains had substantial flow at the time of the assessment. C1 had one storm drain with a substantial flow. Upstream of this outfall the creek was dry. All of the flow in the downstream section of the reach apparently originated from this outfall.

Figure 4. Impact assessments in the Cordilleras Creek watershed. Base image: San Mateo County Department of Public Works.

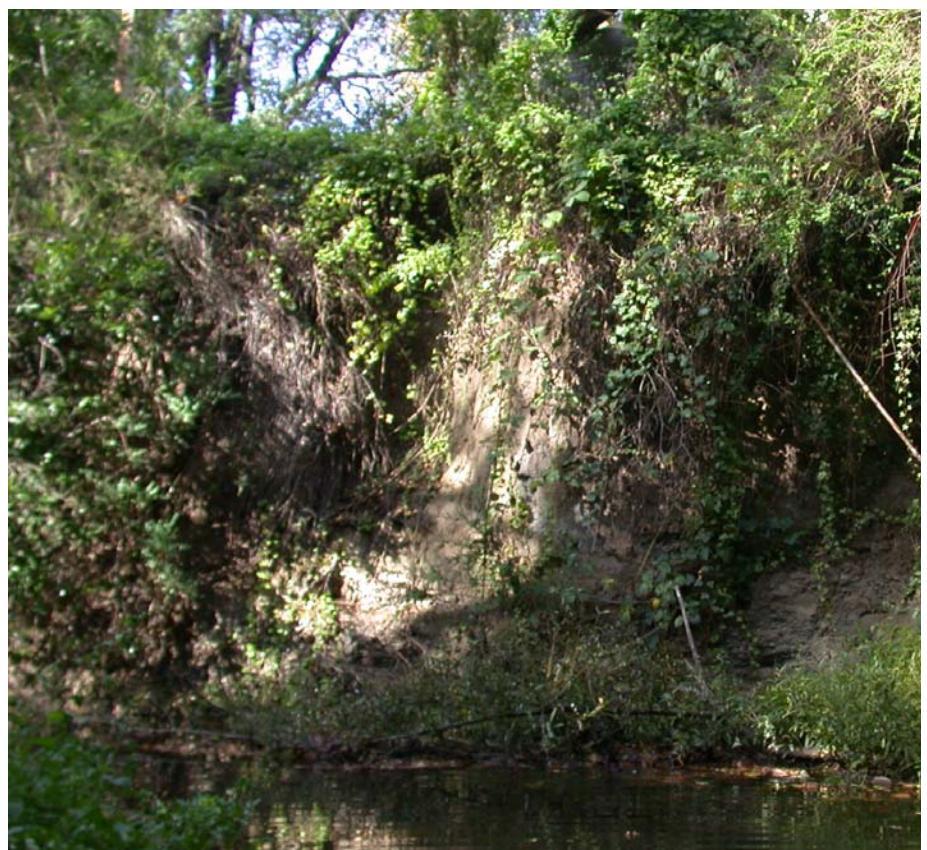
Figure 17. An example of bank failure in the lower San Mateo Creek watershed.

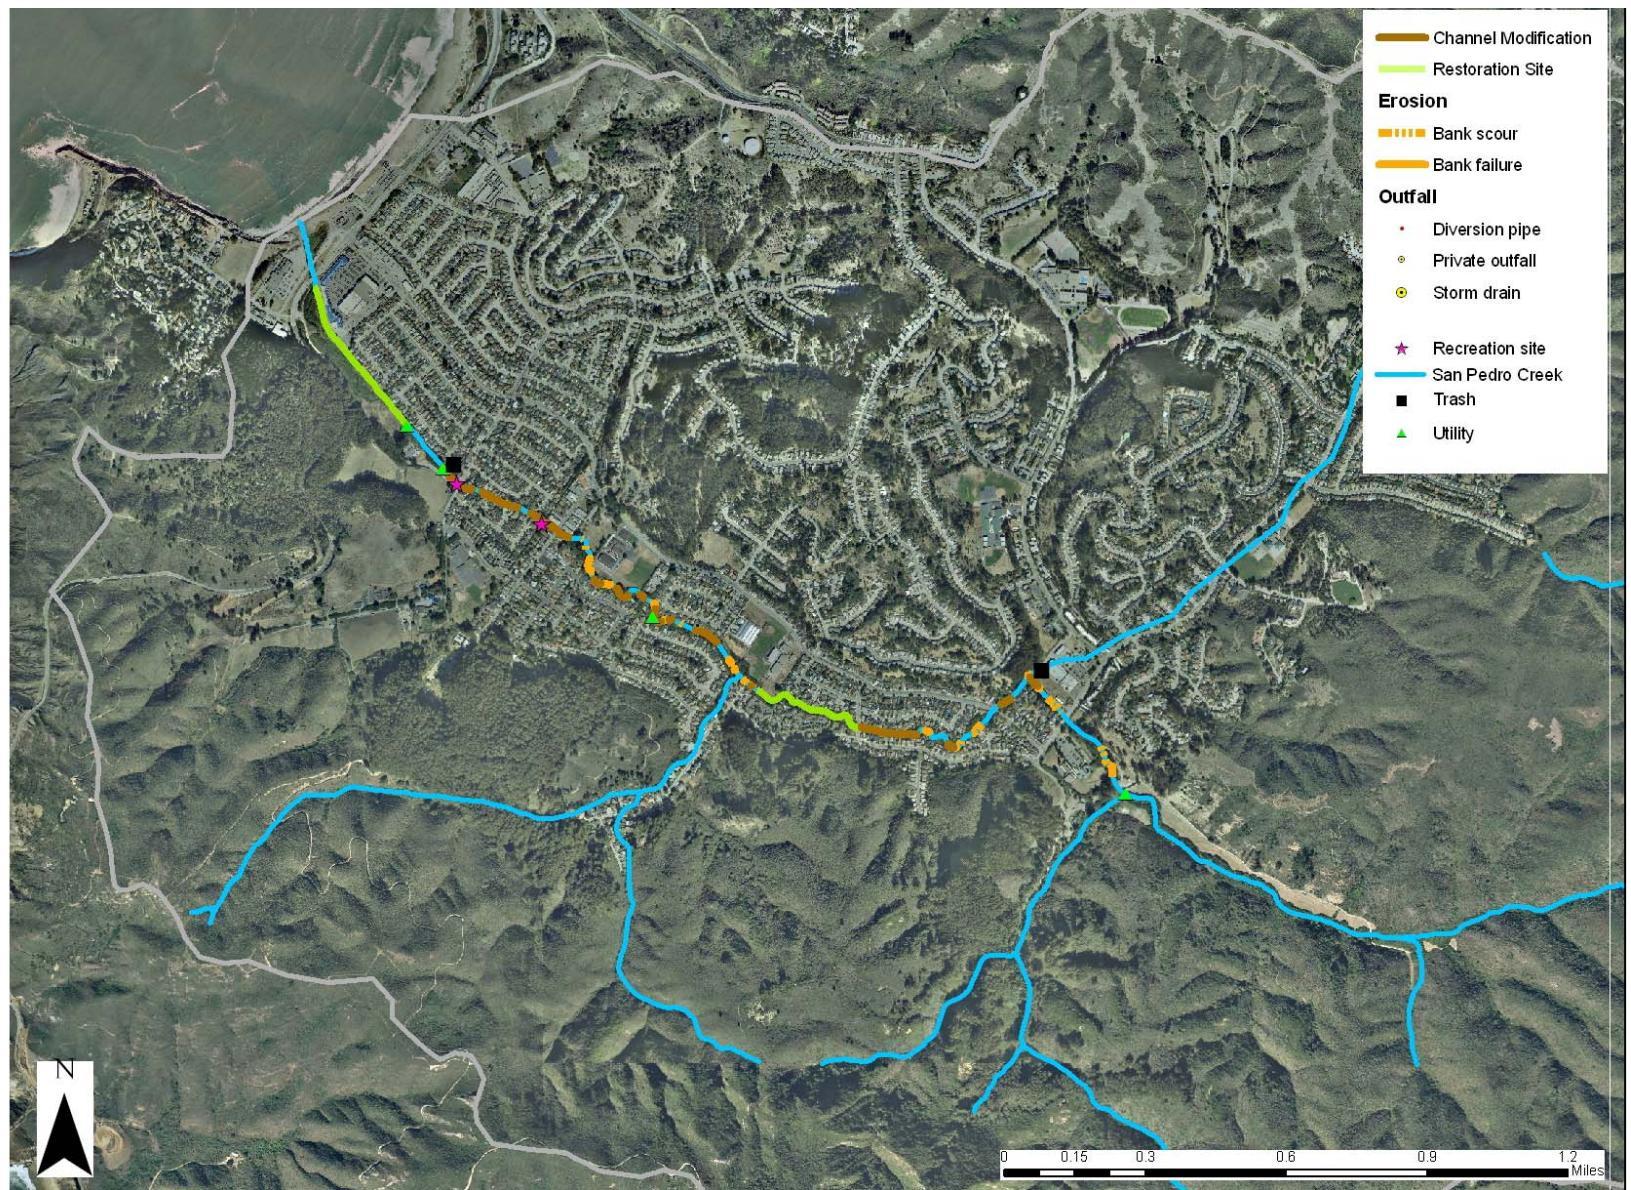
Erosion was greatest in reach SP10 (Table 19, Figure 20). In SP10, one relatively long section (400') of erosion and 2-3 feet of channel incision were observed. Bank scour and bank failure were both equally present in the creek and were often observed at creek meander bends. Slope failure was documented in SP4. Erosion threatened property infrastructure in four reaches (SP4, SP6, SP7 and SP8). In these areas, fences and decks were being undercut by the erosion and the backyards of private properties were often eroding.

Figure 20. Impact assessments in the San Pedro Creek watershed. Base image: San Mateo County Department of Public Works.

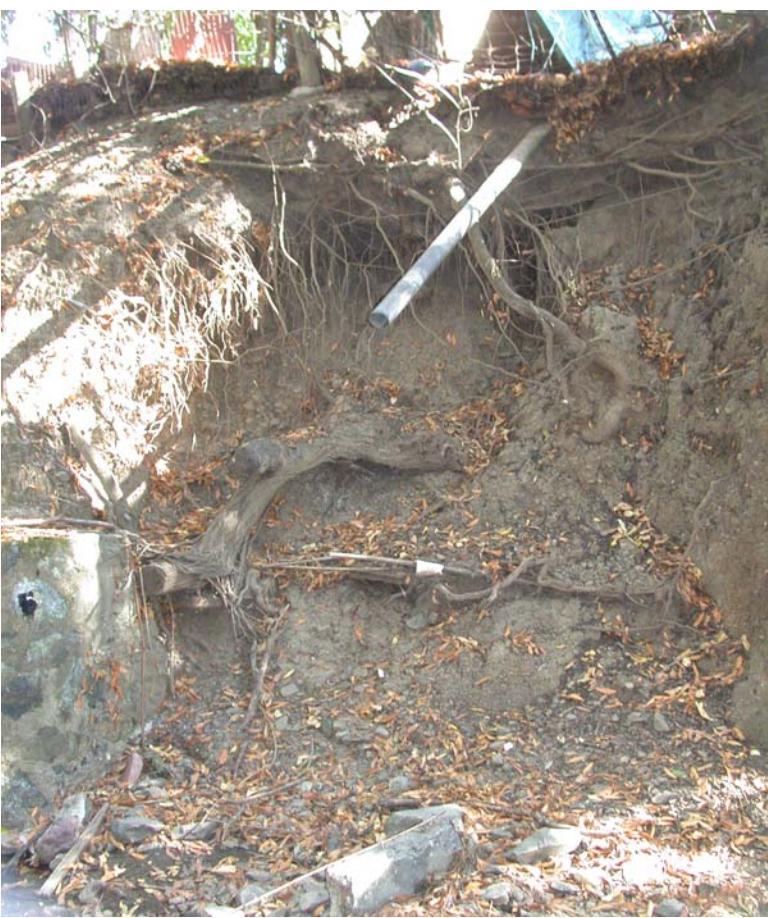
The majority of erosion observed was in the form of bank erosion and bank failure. Unlike channel modifications, there were no particular trends within watersheds with respect to erosion. Many of the creeks had relatively low proportions of their reaches exhibiting current erosion. However, many of these reaches were largely hardened and no longer subject to erosion. The assessments were carried out during the dry season and few dry weather flows were observed. For those outfalls with discharge, few had discoloration, odor, or other indications of illicit discharge. The most important impact associated with outfall pipes was erosion (Figure 22), either immediately downstream from the outfall or head cuts perpendicular to the creek.

Figure 22. Erosion caused or exacerbated by the presence of an outfall. This outfall did not appear to be a municipal storm drain but instead apparently originated from a private property.
