Material Storage Potential Pollution Case Study

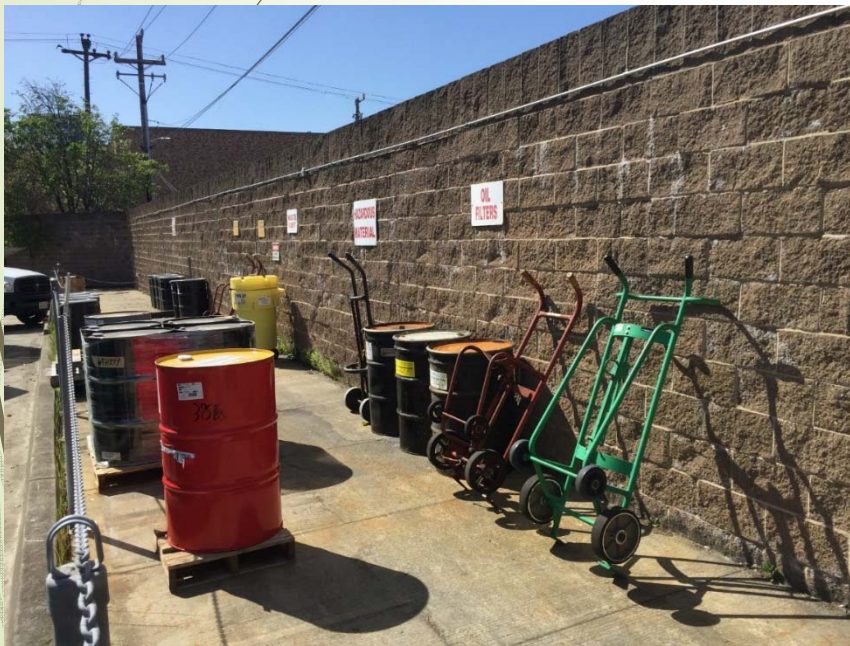
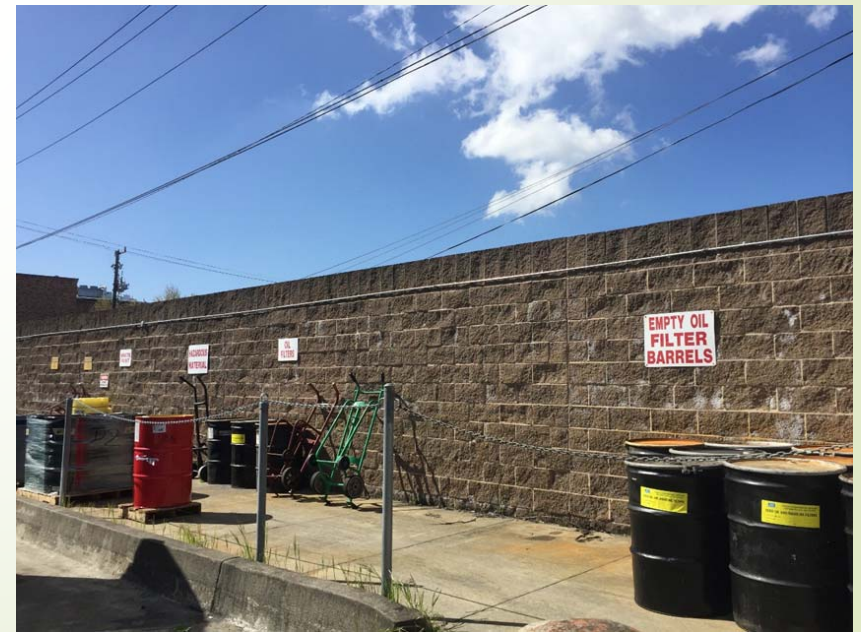
An outside 55 gallon drums storage area contains:

- 1 solvent drum on a pallet (red drum)
- 3 used oil filters drums against the wall under sign – “used oil filters” (by drum dollies)
- 4 petroleum material drums of on a pallet in shrink wrap
- 4 hazardous waste drums
- 1 spill kit
- 2 drums with used paint up against a wall
- 3 empty drums for hazardous waste against wall
- 10 empty drums (not all seen in photo) for used oil filters up against a wall

The containment area has walls on three sides

- Cover drum storage area or Provide enclosures with labels to store drums
- Place drums on spill pallets
- Move drums back from the edge of the containment
- Ensure drums are labeled properly
- Correspond drums with area signs

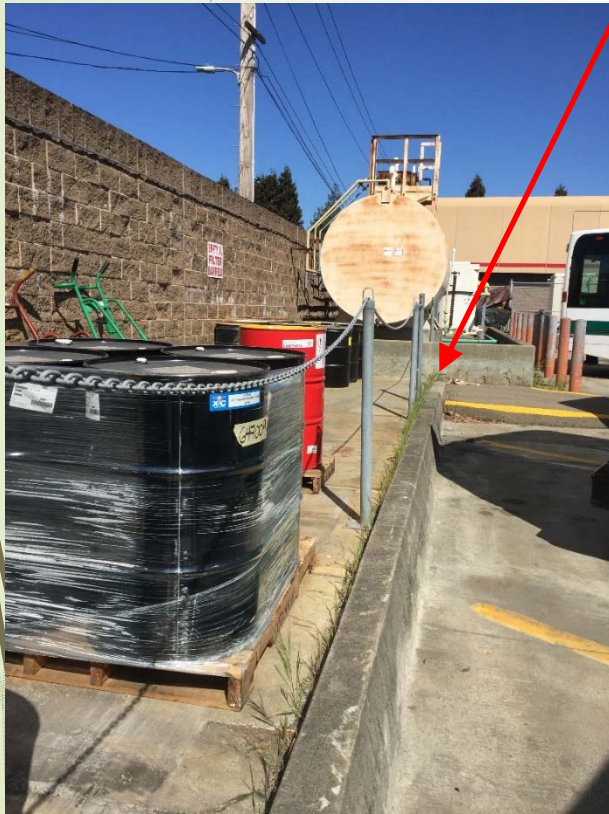
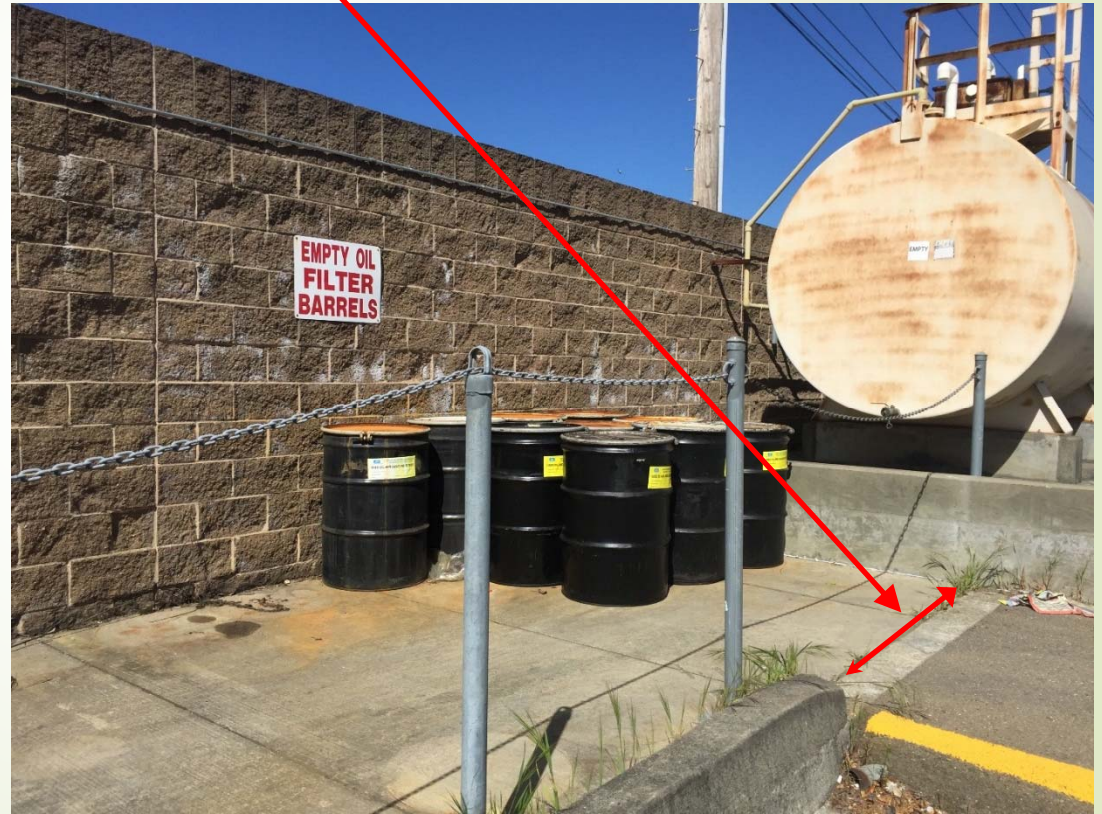
The fourth side has a 6 inch berm running the length of the containment area with a 4 foot break at one end adjacent to a ramp for forklift access.

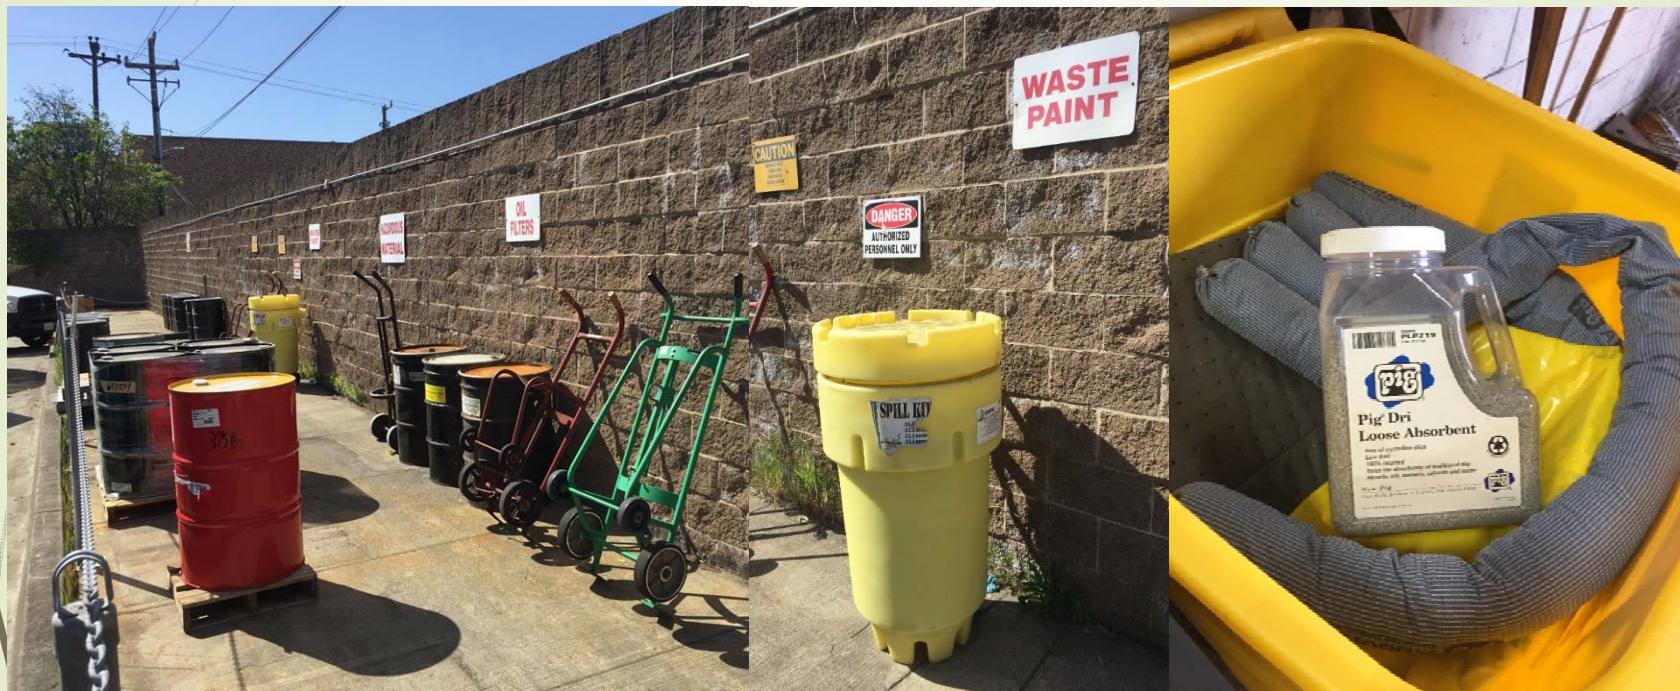
The containment area slants away from the side with the forklift ramp. The spill kit located in the containment area has absorbent material, pads, socks, and instructions.

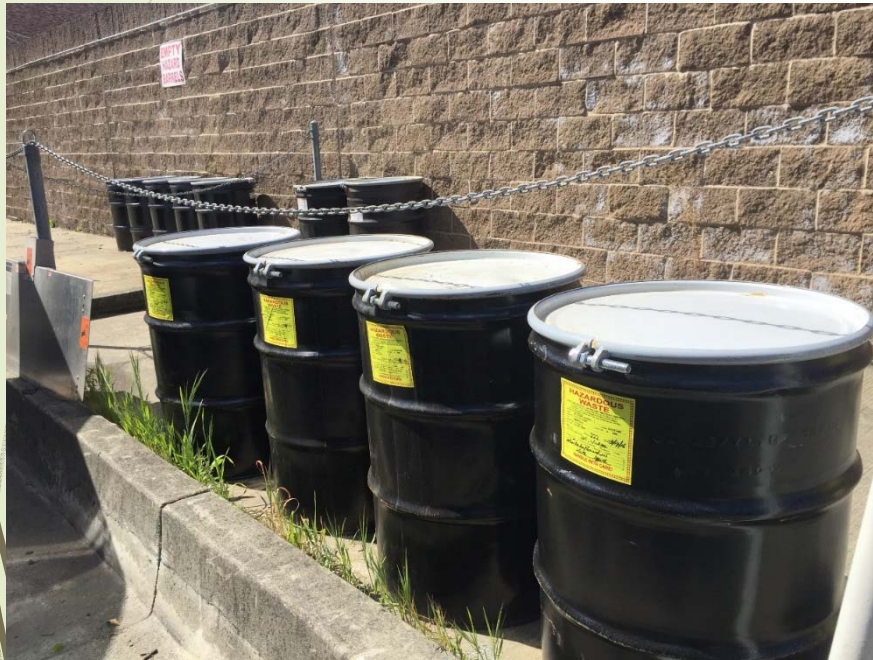
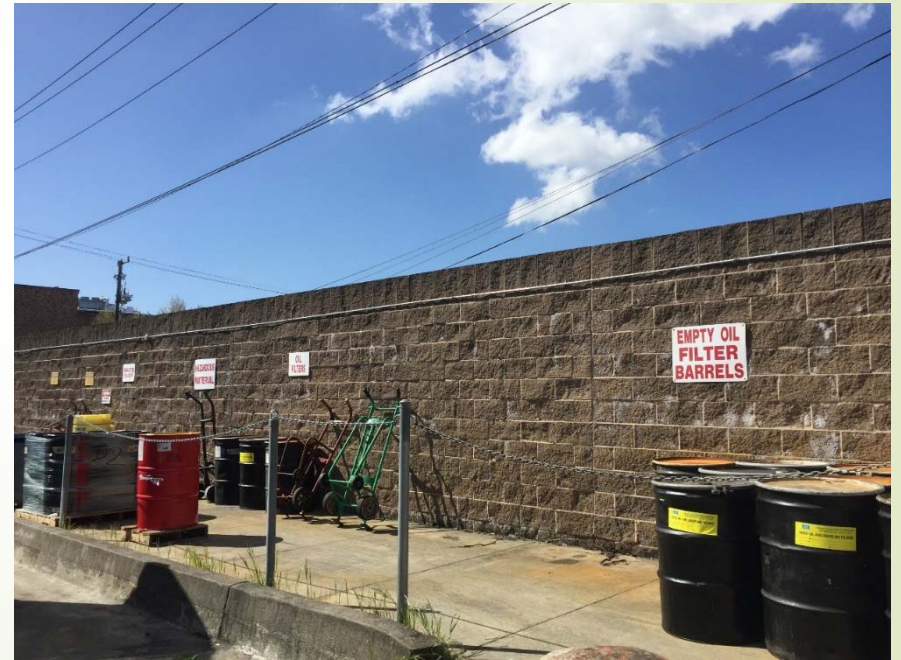
Drums with hazardous waste labels are downslope beyond the spill kit. The section in front of forklift ramp is designated for empty drums.

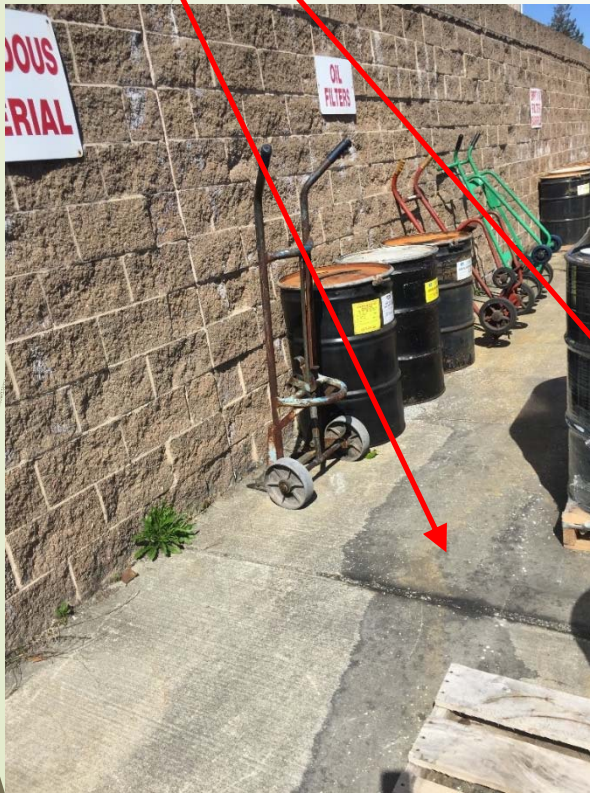
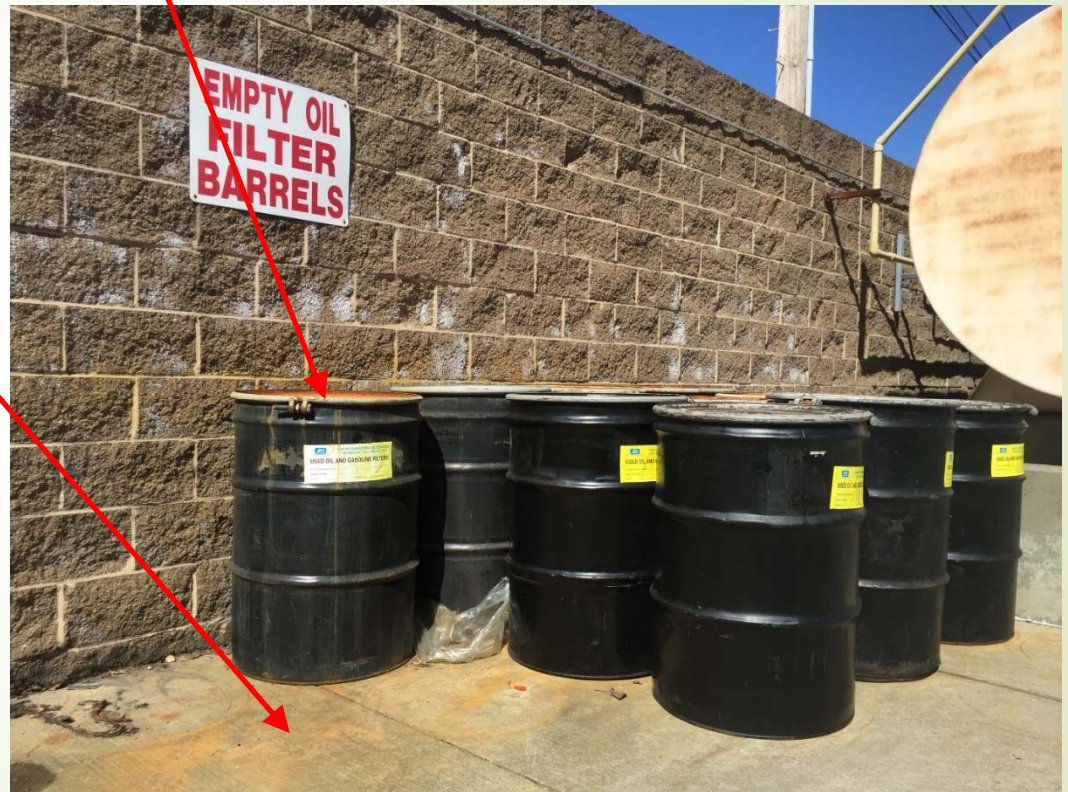
Stains present in containment area including around empty filter barrels with rusted lid rings
