Assessment of Sediment Management Practices in Six High Priority Watersheds in San Mateo County

**San Mateo Countywide
Stormwater Pollution
Prevention Program**

August 2004

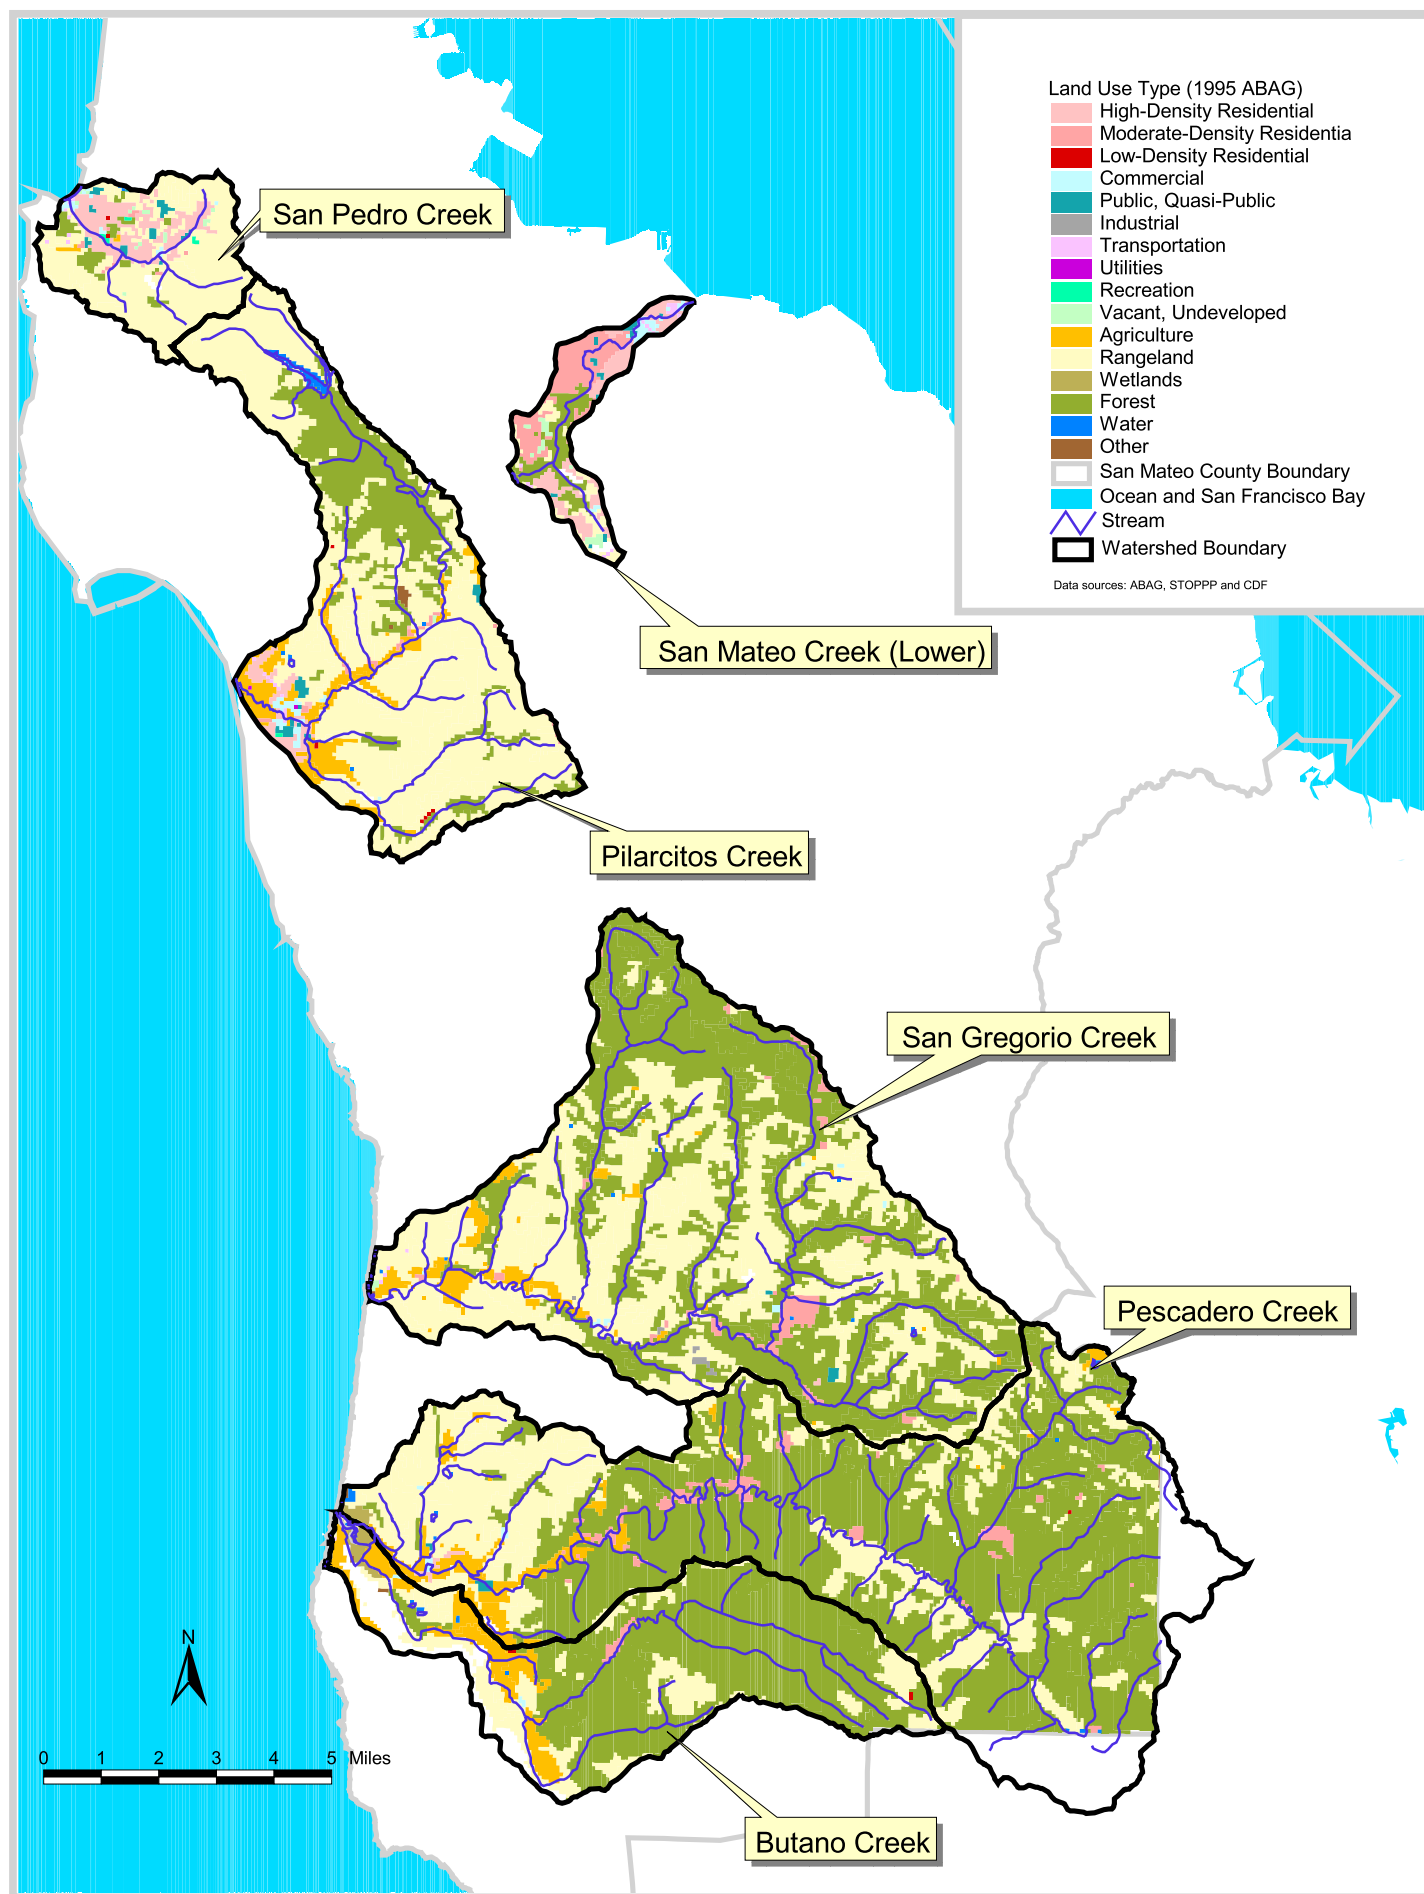
Figure 1. Land use type for six high priority watersheds in San Mateo County.

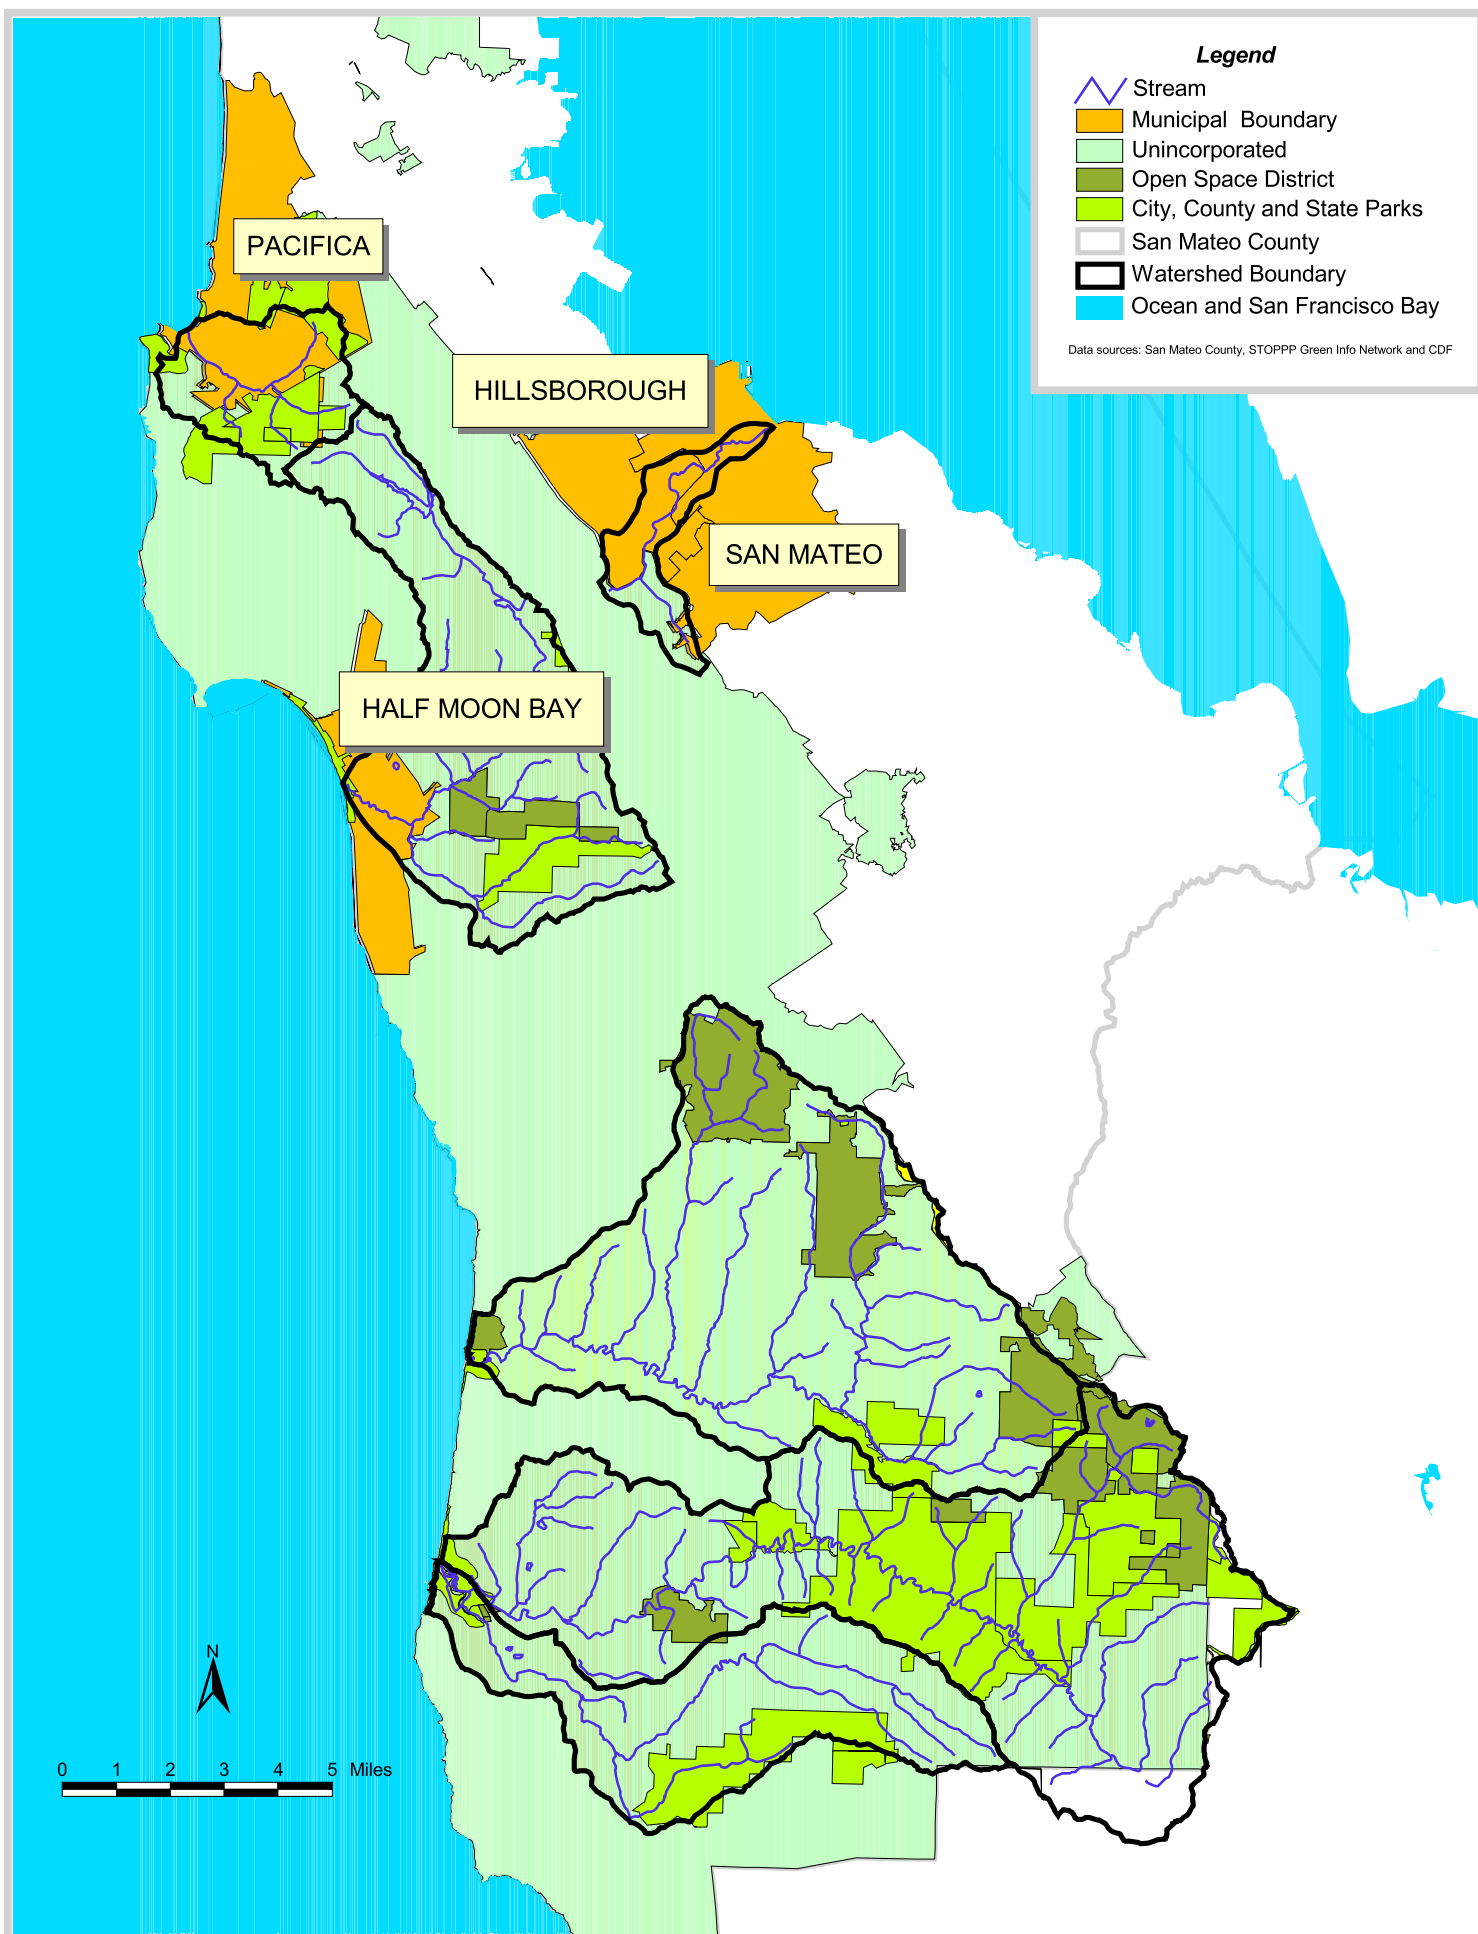
Figure 2. Jurisdictional and protected land boundaries in the six high priority watersheds in San Mateo County.

Several agencies manage land use and development within the six high priority watersheds (Table 2 and Figure 2). The Pescadero, Butano and San Gregorio Creek watersheds are entirely within the unincorporated area of San Mateo County. The town of Pescadero is a small urban area at the mouth of Pescadero and Butano Creeks. Other public lands in these watersheds include Pescadero Creek County Park, which is operated by the County of San Mateo and Pescadero and San Gregorio State Beaches,
