The Unified Stream Assessment: Potential Uses for Stormwater Programs

San Francisco Bay Area Examples

May 2008

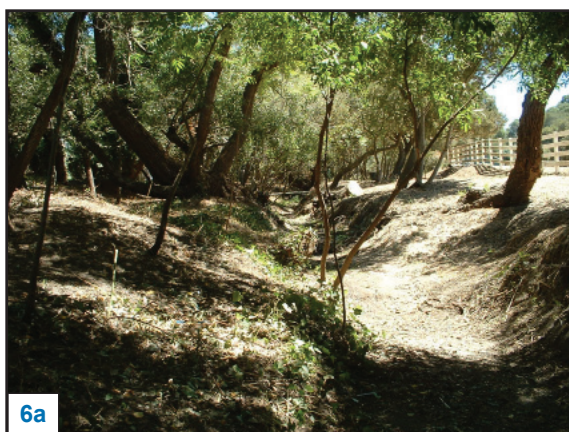
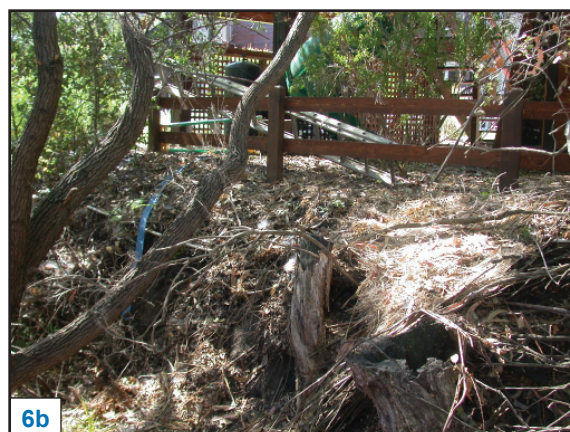
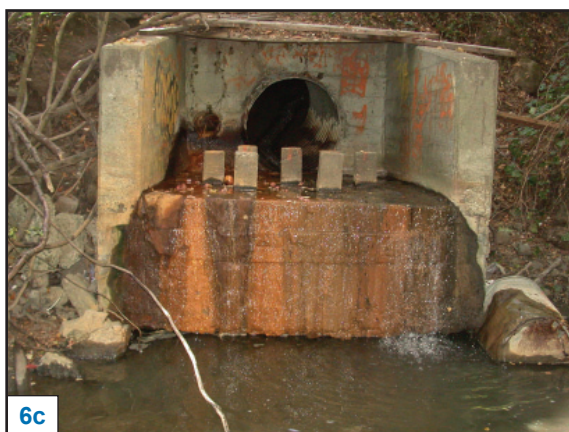
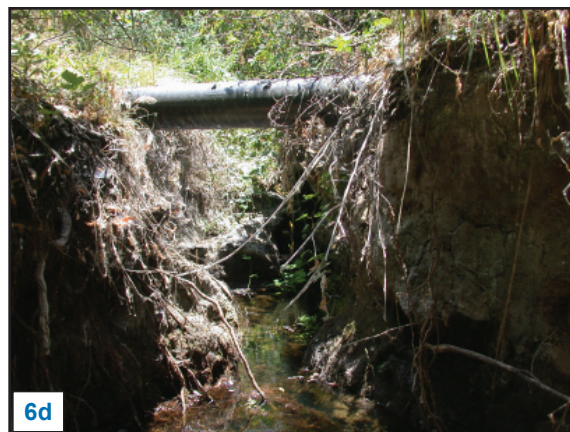
Figure 6. Illegal connections and illicit discharges: a) horse paddock encroaching on riparian corridor; b) pool backwash pipe entering creek; c) outfall with stains and residues; d) incision caused by historic burst water pipe.

Using the outfall and utility assessment forms, field crews collect basic information on the location, condition, and discharge characteristics of outfalls. The presence of sudsy water, oily sheens, and strong “rotten egg” odors in outfall discharge or from pipes that cross the riparian corridor and are leaking, may indicate illegal connections and/or leaks from sewer lines or other sources of nutrient enrichment such as fertilizers or animal waste (Figure 6a).

Additionally, the presence of a high volume of flow, chlorinated odors, and backwash pipes in the riparian corridor may indicate illicit discharges from swimming pools (Figure 6b) or fountains⁵. The presence of stained residues on outfall outlets or discolored discharges⁶ (Figure 6c) may also indicate illicit discharges or areas up-pipe where further investigation is warranted. Surveys may also identify sites where historic events, such as a burst water line (Figure 6d), caused massive erosion and introduced sediment to the creek. Such information may provide insight into historic trends in biological or physical monitoring data and can indicate potential sites for rehabilitation (see below). In addition to noting discharge characteristics, tabulating the location and density of non-municipal outfalls in creek reaches may help to prioritize where to investigate in the event that pollutants are detected in a creek.

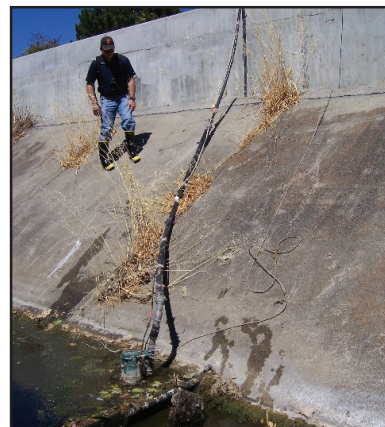
Figure 7. Water diversion pipe and pump.

Sites where water is diverted are typically easy to document during a USA survey (Figure 7). However, their localized and cumulative impacts are more difficult to estimate. While water diverting is not regulated through NPDES permits, this activity can greatly impact flow volume and habitat conditions, and therefore, may be a useful impact to document and refer to the appropriate agency.

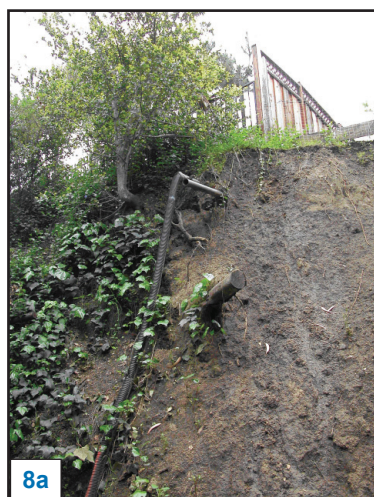
8a

Figure 8. Infrastructure requiring repair: 8a) Hanging outfall; 8b) Outfall threatened by erosion; 8c) Erosion and aggradation burying an outfall; 8d) Failed saccrete threatens private property; 8e) Erosion threatens private property.

The impact assessment forms include data fields to document damage and/or threats to infrastructure in the creek corridor. Typical examples of infrastructure requiring such attention include outfalls that are threatened from downcutting and widening of streambanks (Figure 8a), those with eroded footings (Figure 8b), and outfalls that are corroding, cracking, breaking and/or not functioning appropriately (Figure 8c). Other in-channel structures such as bridges, revetments, and grade controls may also exhibit signs of failing due to undercutting, thereby threatening property (Figure 8d), and causing erosion (Figure 8e).

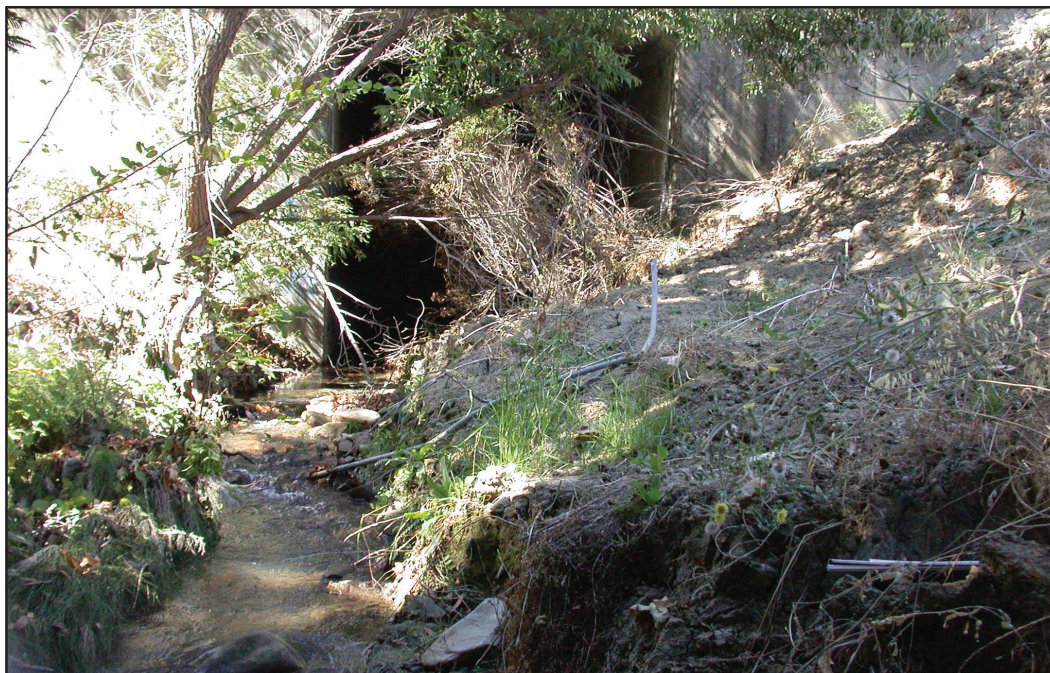
Figure 10. Landslide debris entering creek below a vineyard, blocking a large part of a road culvert and introducing high volumes of sediment to the stream.

Destabilized streambanks contribute sediment loads to creeks and degrade water quality and habitat. Streambank stabilization may be achieved by a range of methods, preferably involving bioengineering techniques to reestablish bank vegetation, and where necessary, altering the geomorphology of streambanks to re-establish a functional floodplain. Streambanks may destabilize for a number of reasons, many of which may be addressed by localized rehabilitation efforts (Figures 10 – 13).

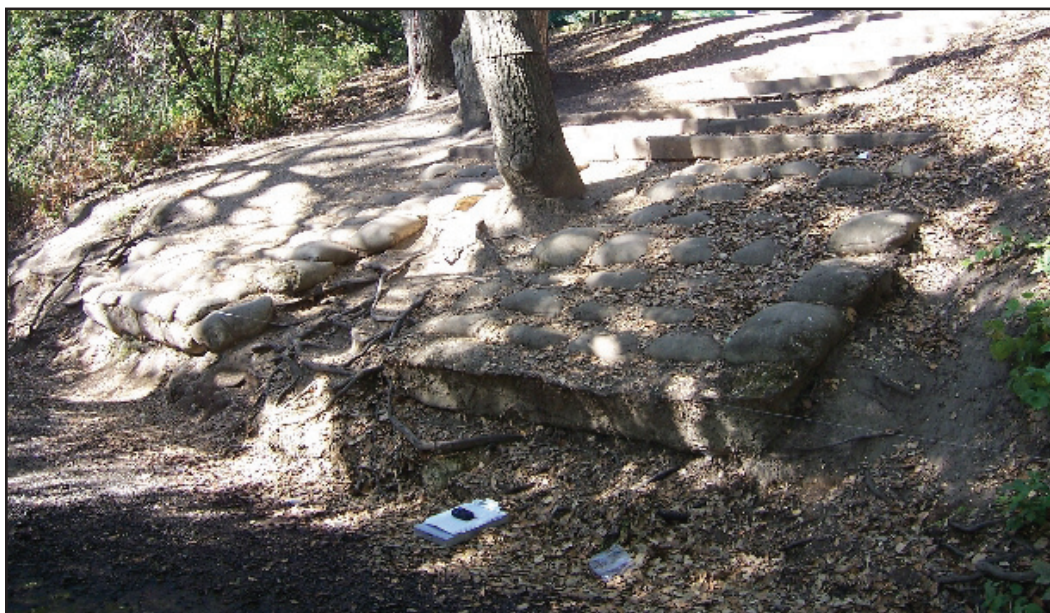
Figure 11. Recreational access contributing to elimination of streambank vegetation, and subsequent erosion and streambank instability.

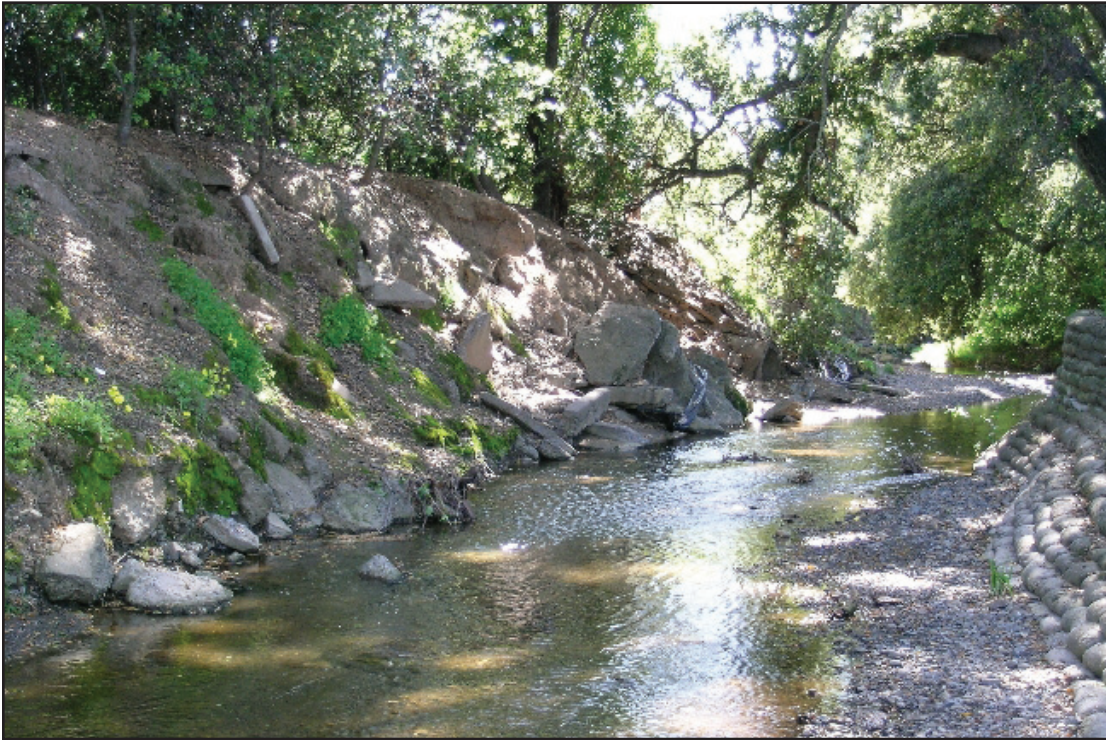
Figure 12. Failing streambank revetment and subsequent erosion.

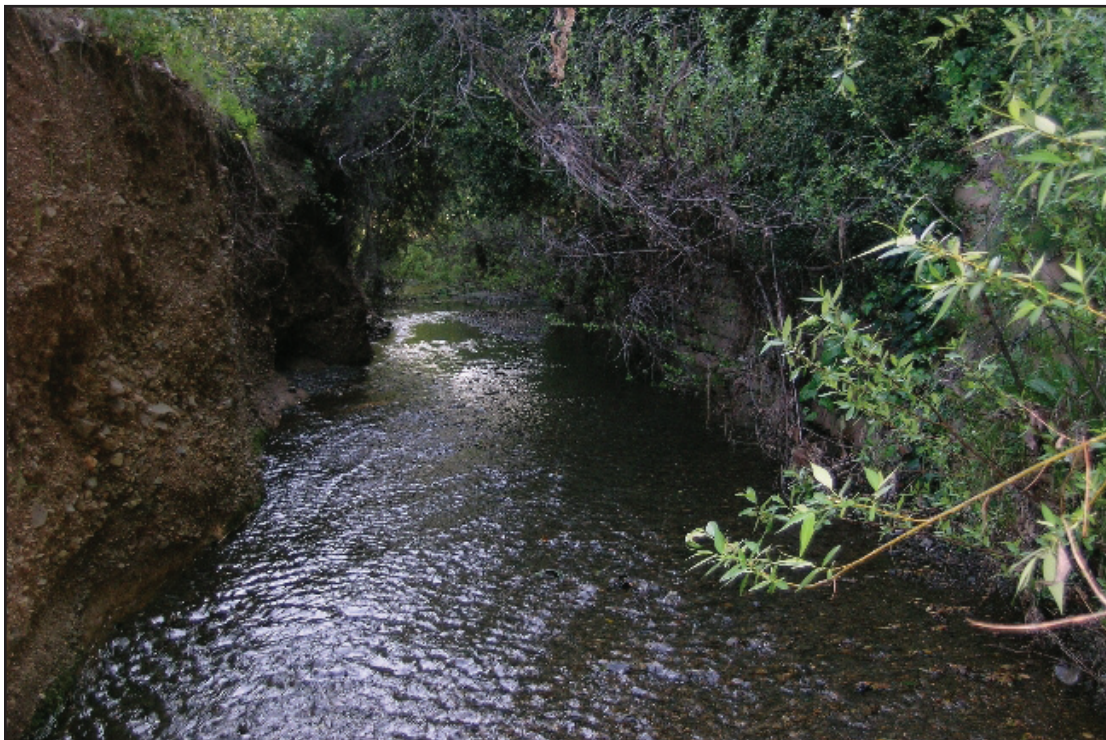
Figure 13. Bank scour resulting from hydromodification and channel engineering - the channel appears to have been straightened, and hardened on the opposite bank, thereby restricting flow and increasing its velocity, resulting in scour of the opposite bank.

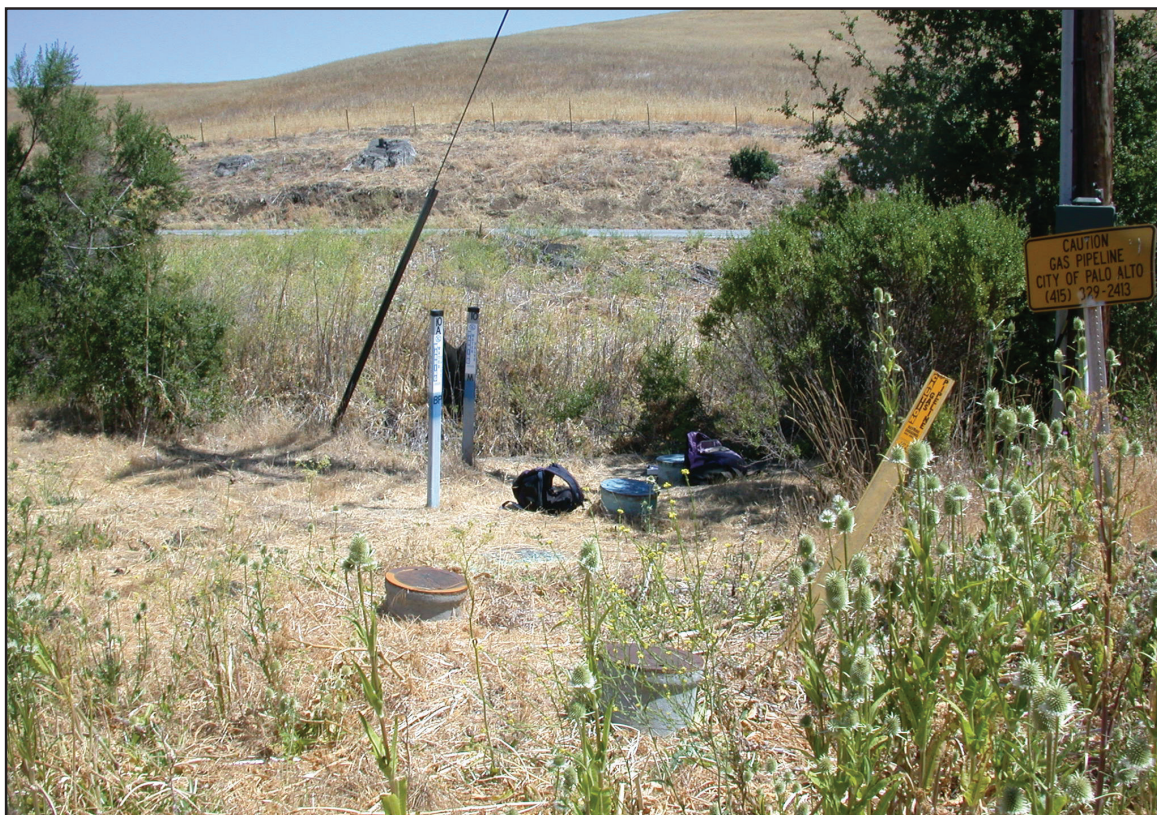
Figure 14. Streambank revegetation opportunity.

Clearing of vegetation in the riparian corridor due for example to placement of utilities and roads (Figure 14) presents opportunities for revegetation to increase stream shading and streambank stabilization. In some cases, riparian plantings may be inappropriate because they do not provide enough root strength to stabilize streambanks (Figure 15) and include non-native ornamental plants that threaten the biological integrity of the riparian community (Figure 16).

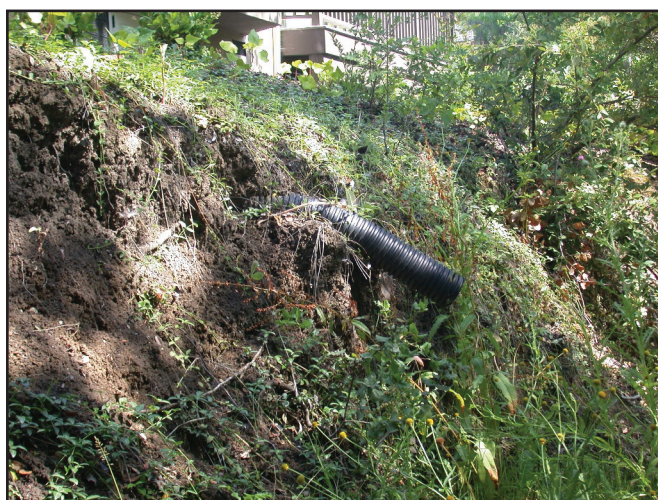
Figure 15. Streambank erosion caused by inappropriate landscape pipe placement and plantings.

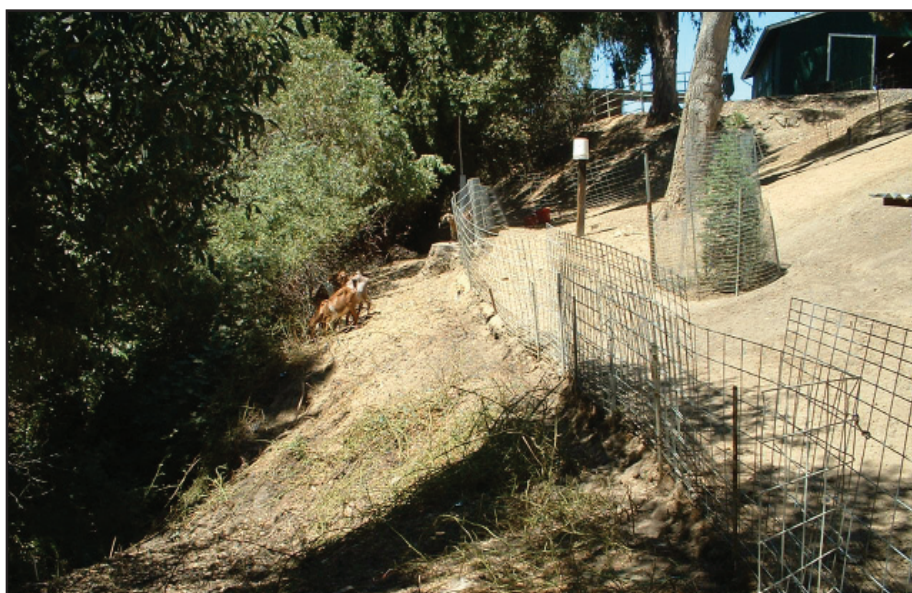
Figure 17. Goats with access to riparian corridor.

Hobby farms, where domesticated animals are allowed access to the creek (Figure 17), or are maintained in enclosures that encroach upon the riparian corridor and have potential to influence water quality through runoff in addition to the physical encroachment are more common in the less densely urbanized areas of watersheds than in the densely developed areas. Such impacts may be addressed by advocating exclusionary fencing and development of alternative water sources, or modifying the location and drainage of enclosure facilities to ensure that runoff does not drain directly into the creek. Barriers to fish passage are commonly created by road culverts (Figure 18), grade control structures, and dams (Table 4). Decisions about whether and how to remove or remediate such barriers largely depends on the species of concern⁸. In some cases, complete removal may be the best option, however, remediation options may include creation of low flow channels or notches, or modification of existing grade control by creating either a series of jump pools along it, or one below an existing grade control structure and a landing pool above it.

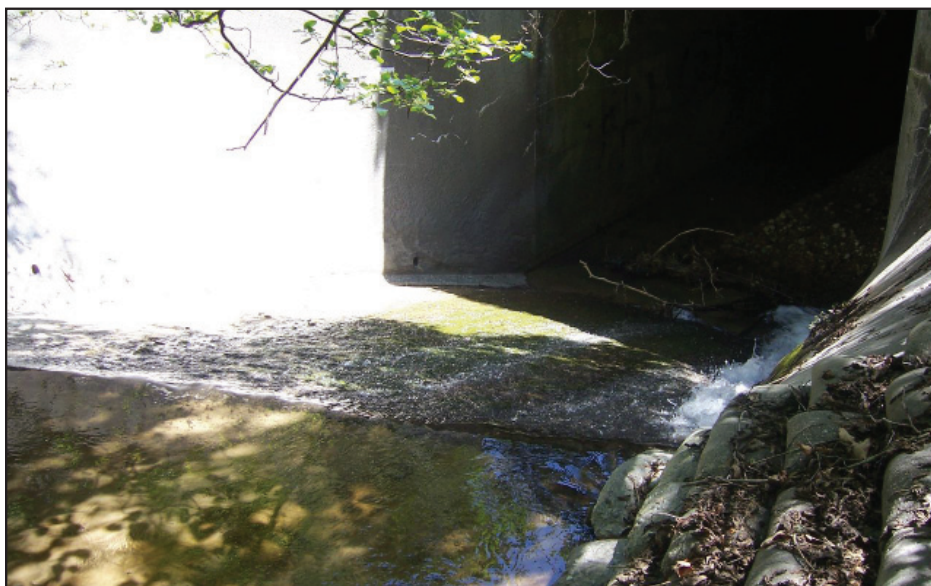
Figure 18. Highway culvert potentially acting as a barrier to fish passage.
