BMP EFFECTIVENESS INVESTIGATION AT BRANSTEN ROAD, CITY OF SAN CARLOS

*Prepared in support of provision C.8.d.ii of
NPDES Permit # CAS612008*

San Mateo Countywide Water Pollution Prevention Program

March 31, 2016

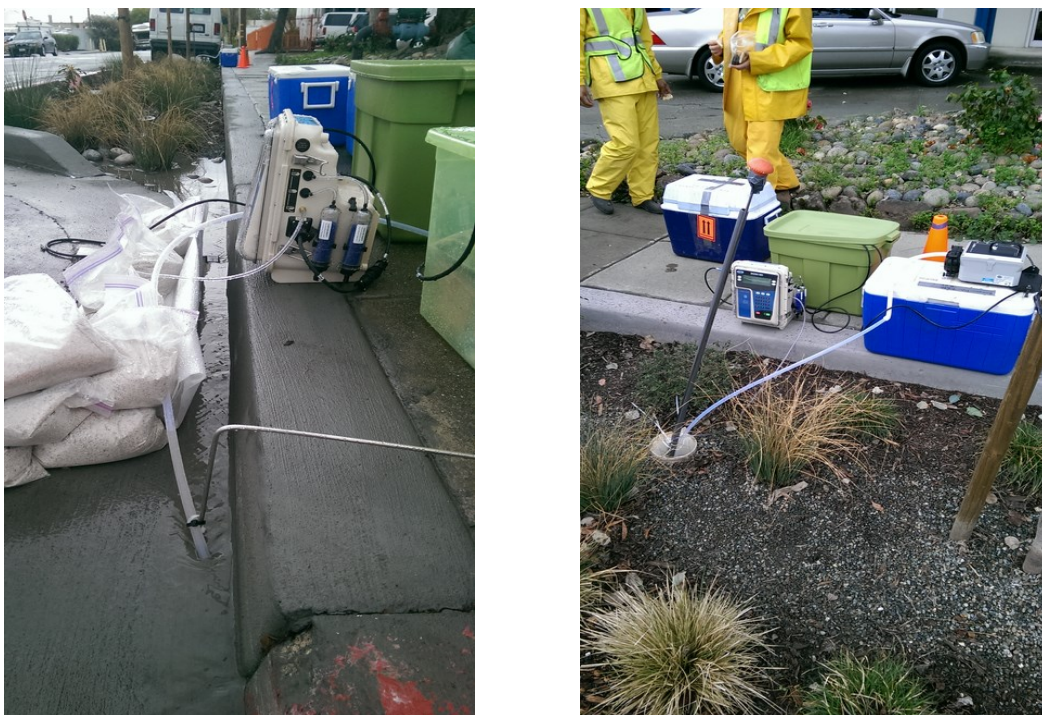
The influent sample was collected along the curb/gutter conveyance about ten feet upstream of the cell. The sample intake tubing was secured to the curb and gutter with a stainless steel rod so that the intake point was positioned in the centroid of flow (Figure 2). The effluent sample was collected from a vertical riser that provided access to the underdrain. The monitoring protocols were altered following the first sampling event to address flooding that caused the bypass flow to mingle with treated flow within the effluent stream being monitored. To avert future flooding during storm events, monitoring personnel temporarily attached a 12” PVC extension to the existing riser for each monitoring event, and removed riser at the end of each event (Figure 2).

Figure 2. Influent (left) and effluent (right) sampling locations at site PUL-7 on Bransten Road, City of San Carlos.
