Assessment of Creek Conditions in San Mateo County Watersheds

SMCWPPP CII Workshop

June 28, 2022

Creek Status Monitoring

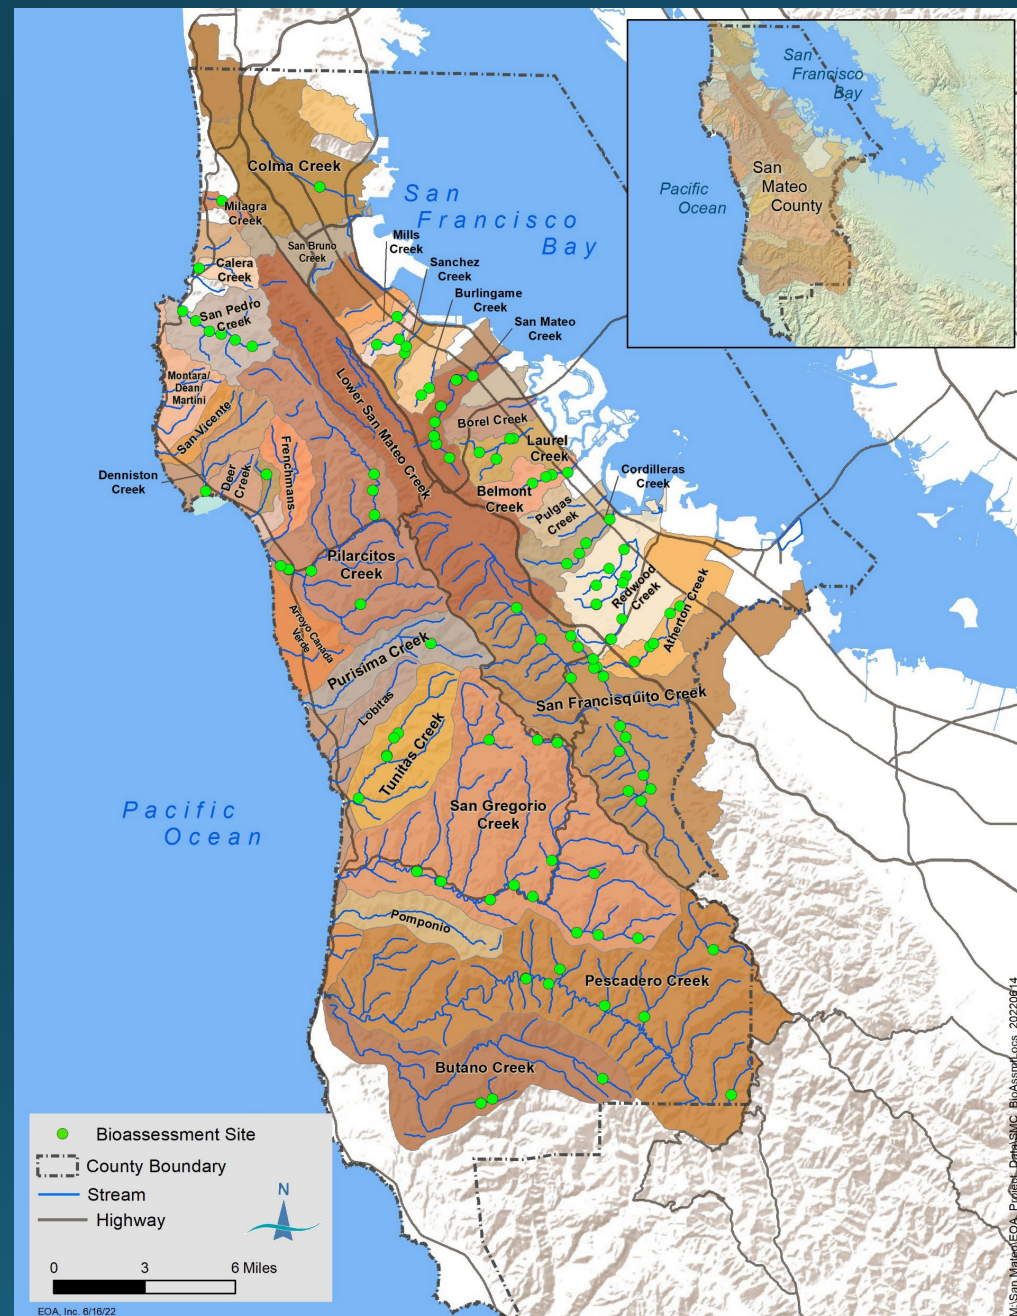
SMCWPPP Bioassessment sites sampled between 2012 and 2021

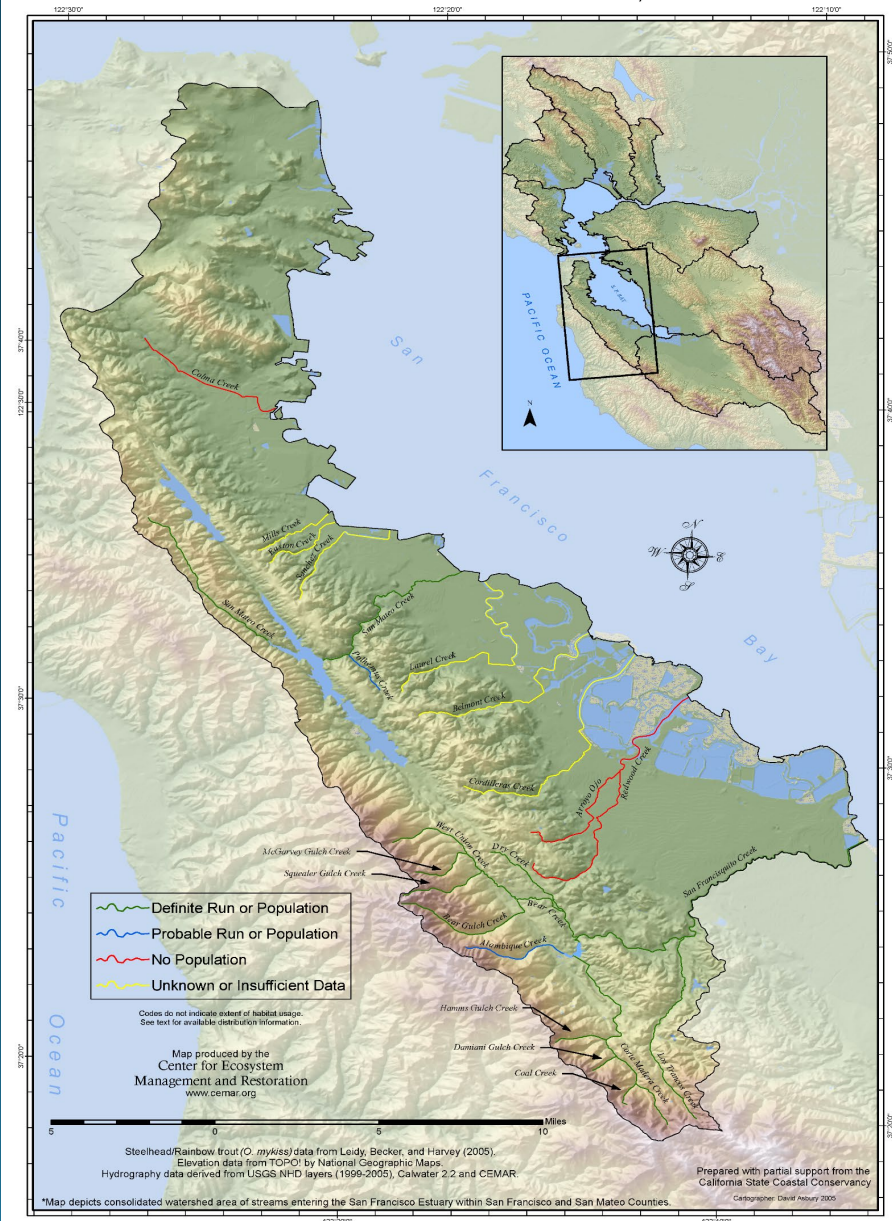
Current status of *Oncorhynchus mykiss* in streams of San Francisco and San Mateo Counties, California*

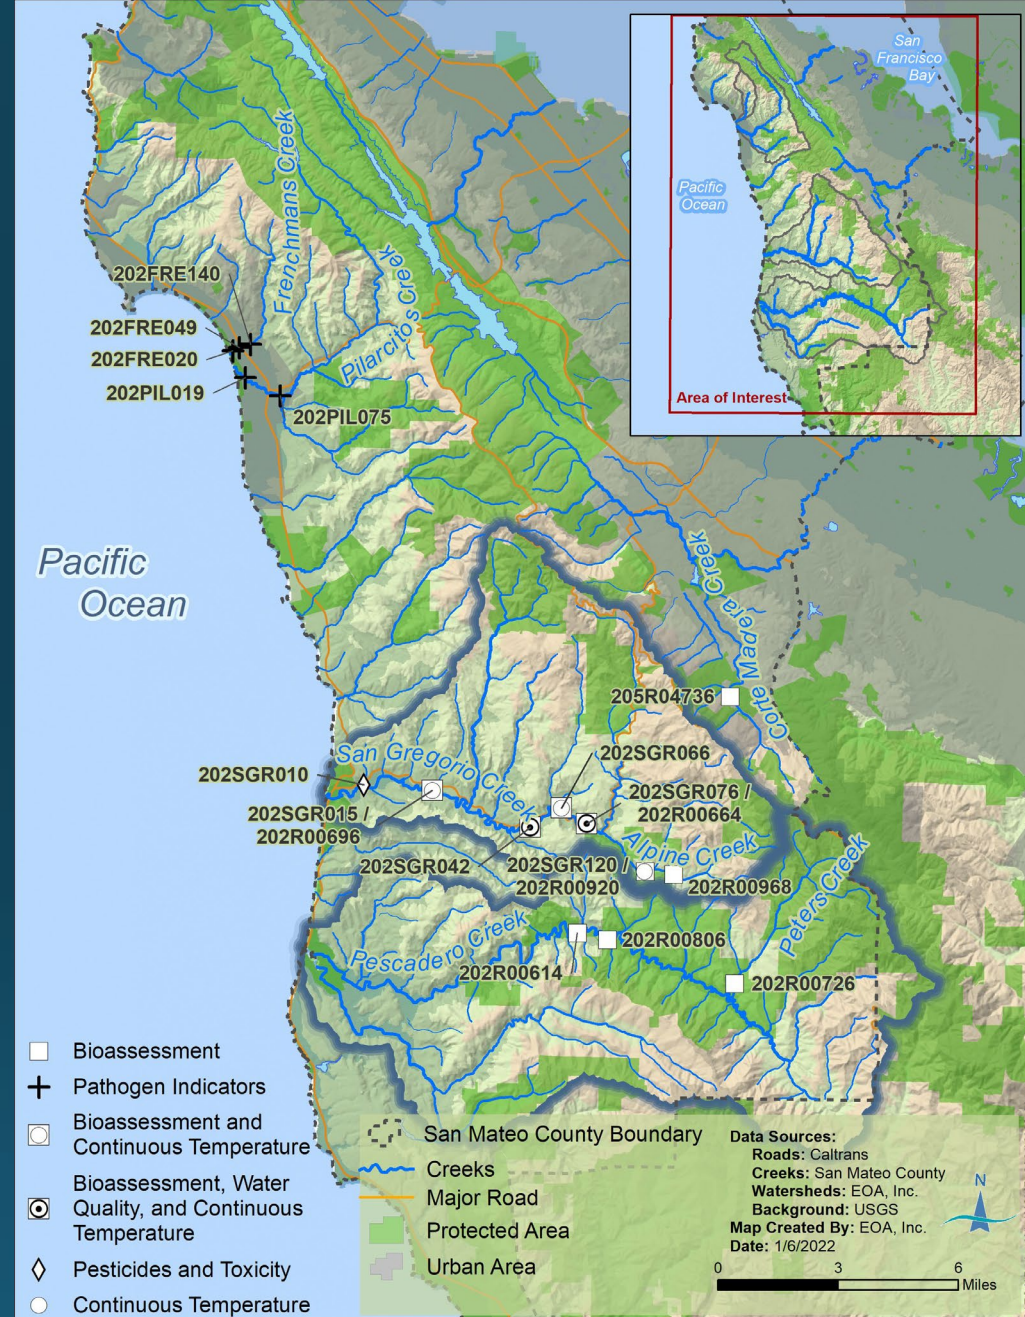
Creek Status Monitoring Sites in 2021

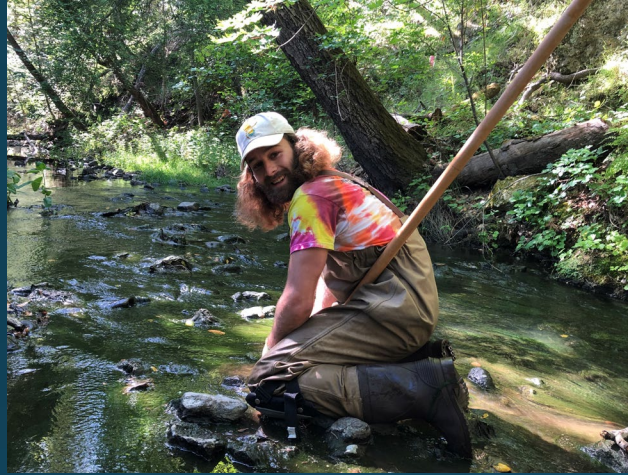
- BMI collected using D-net

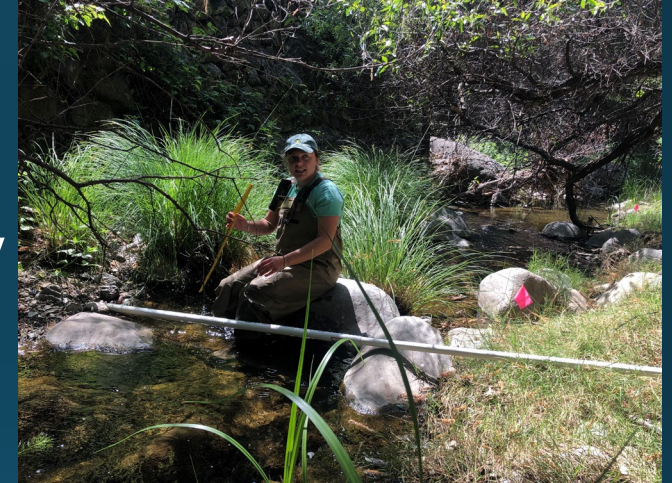
- Habitat measurements include pebble counts, canopy cover

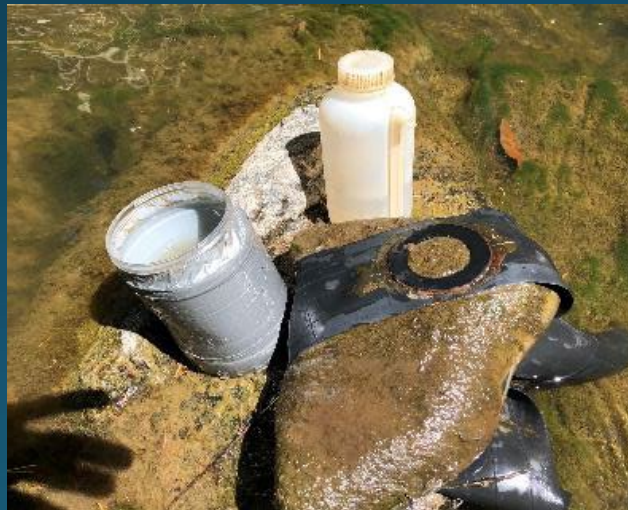
- Benthic algae collected using variety of methods depending on size of substrate

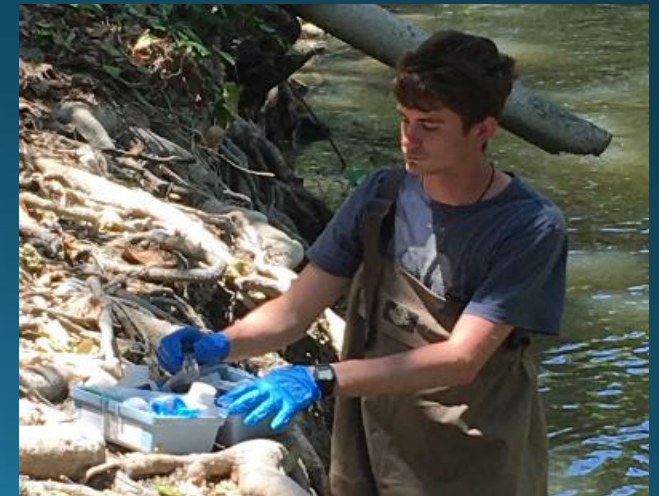
- Water tested for nutrients, chlorine, pH, dissolved oxygen

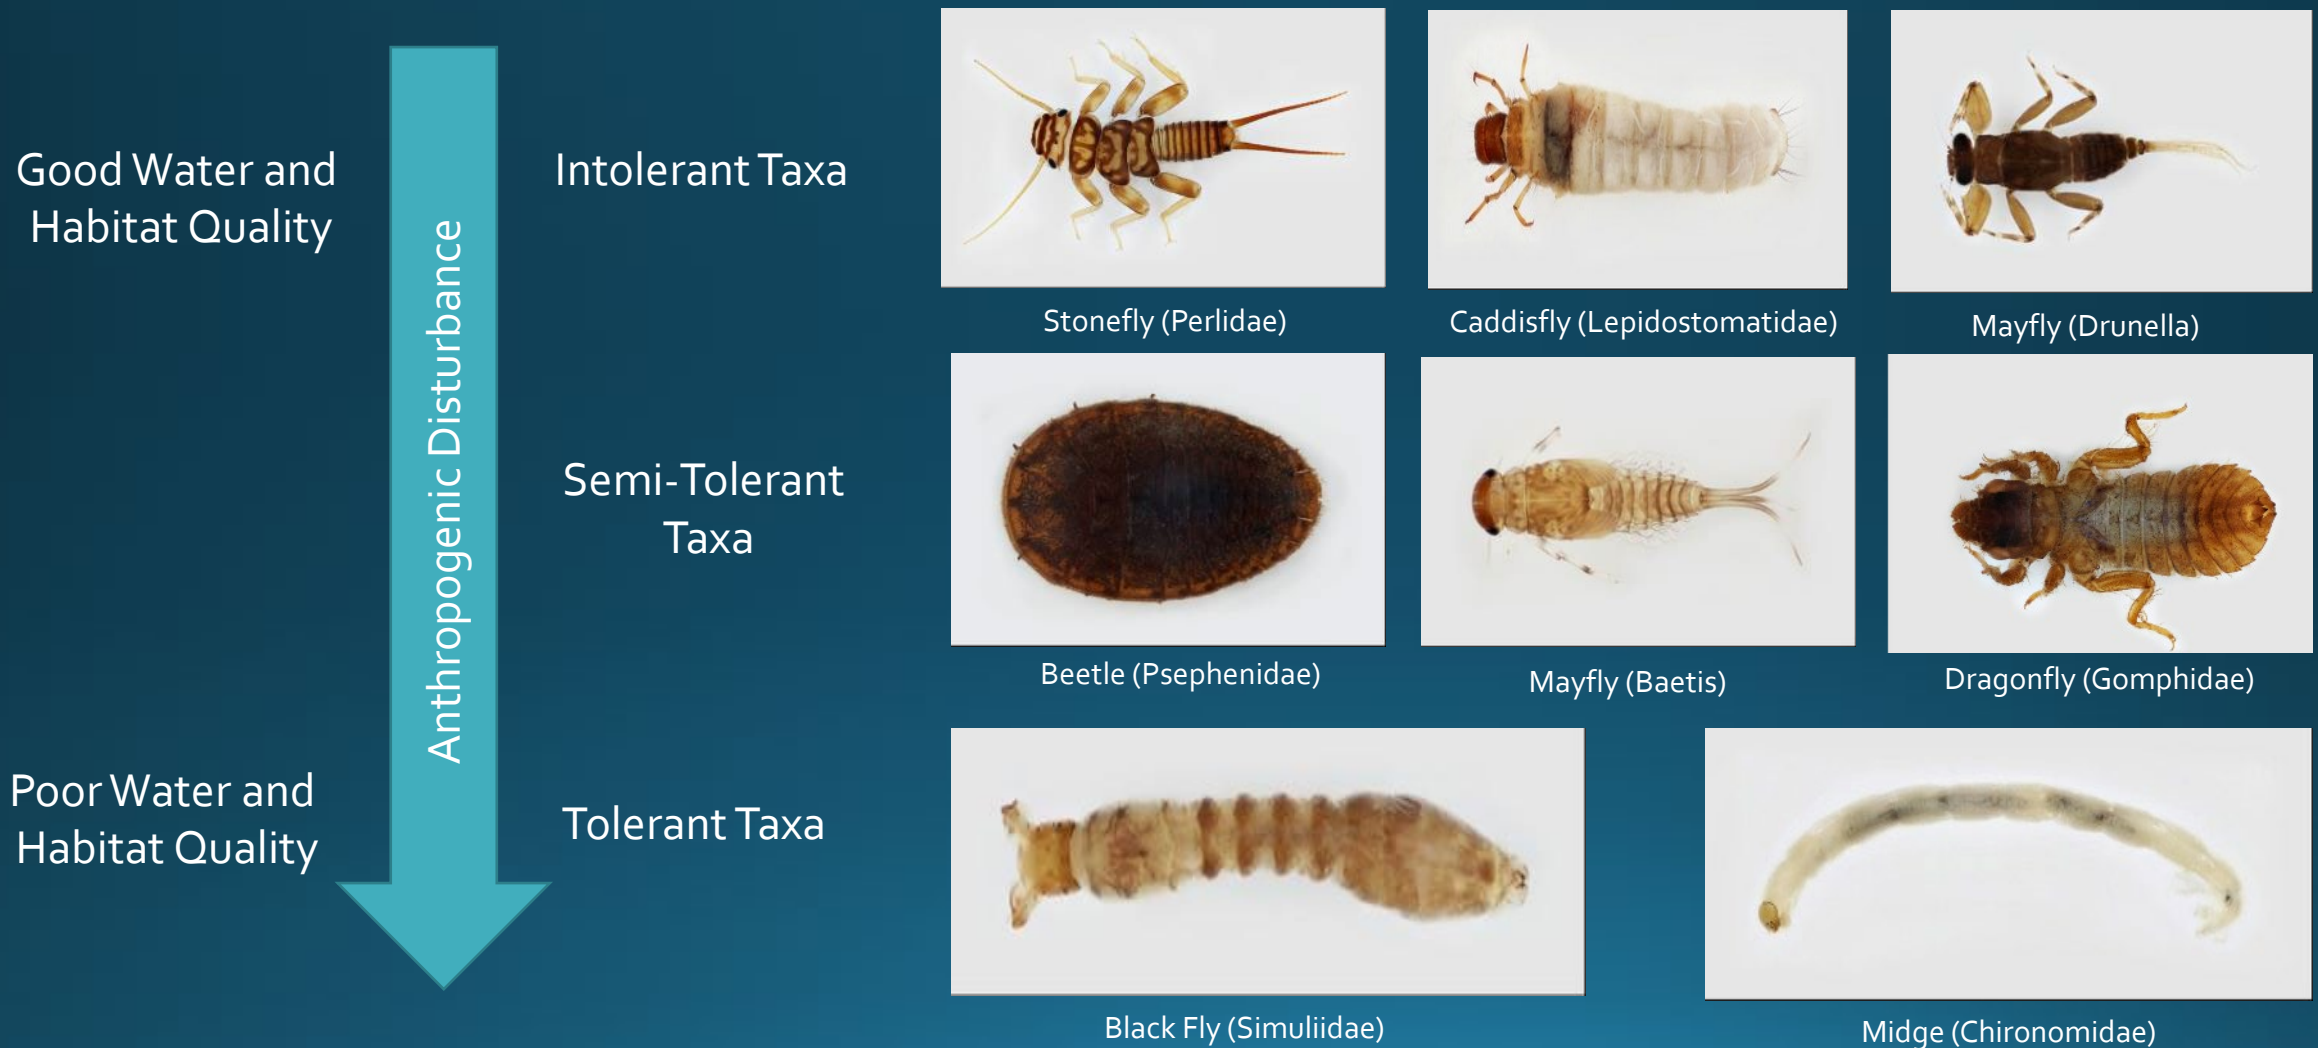
Benthic Macro-invertebrate Response to Disturbance

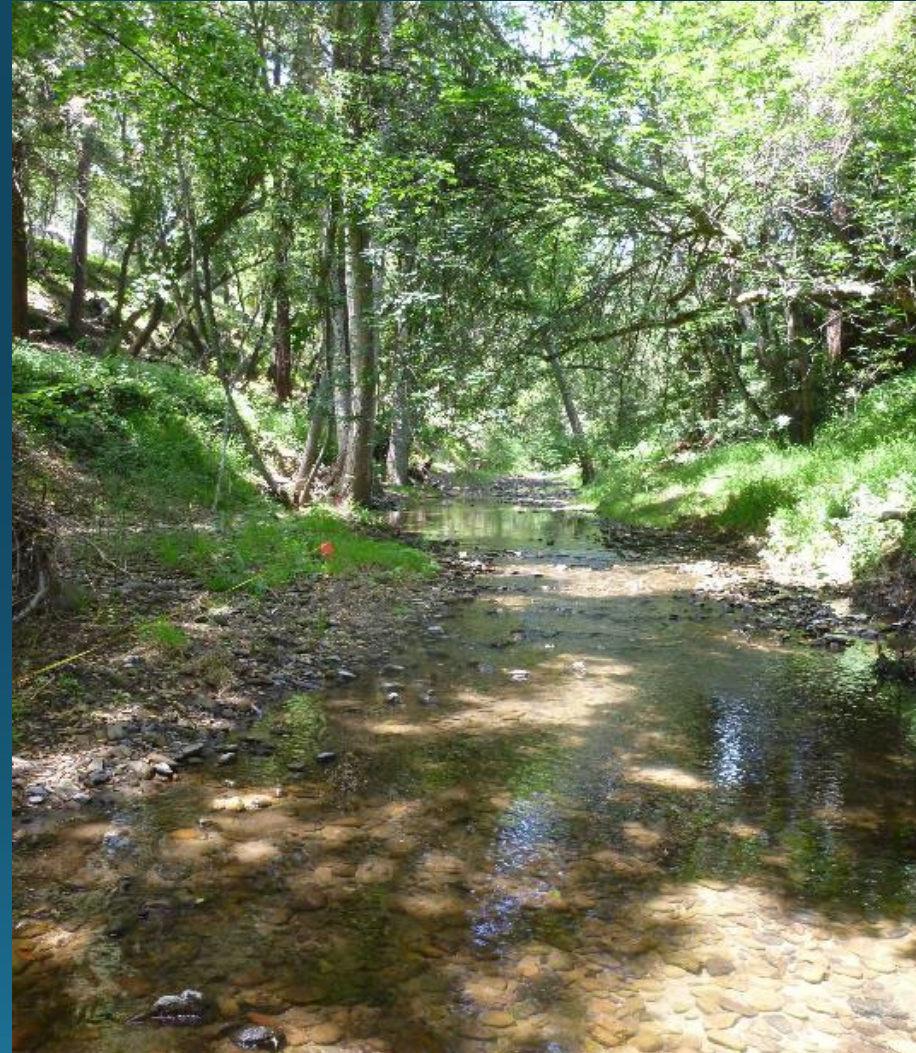
- Streambed substrate
- Channel morphology
- Habitat complexity
- Riparian vegetation cover
- Human disturbance

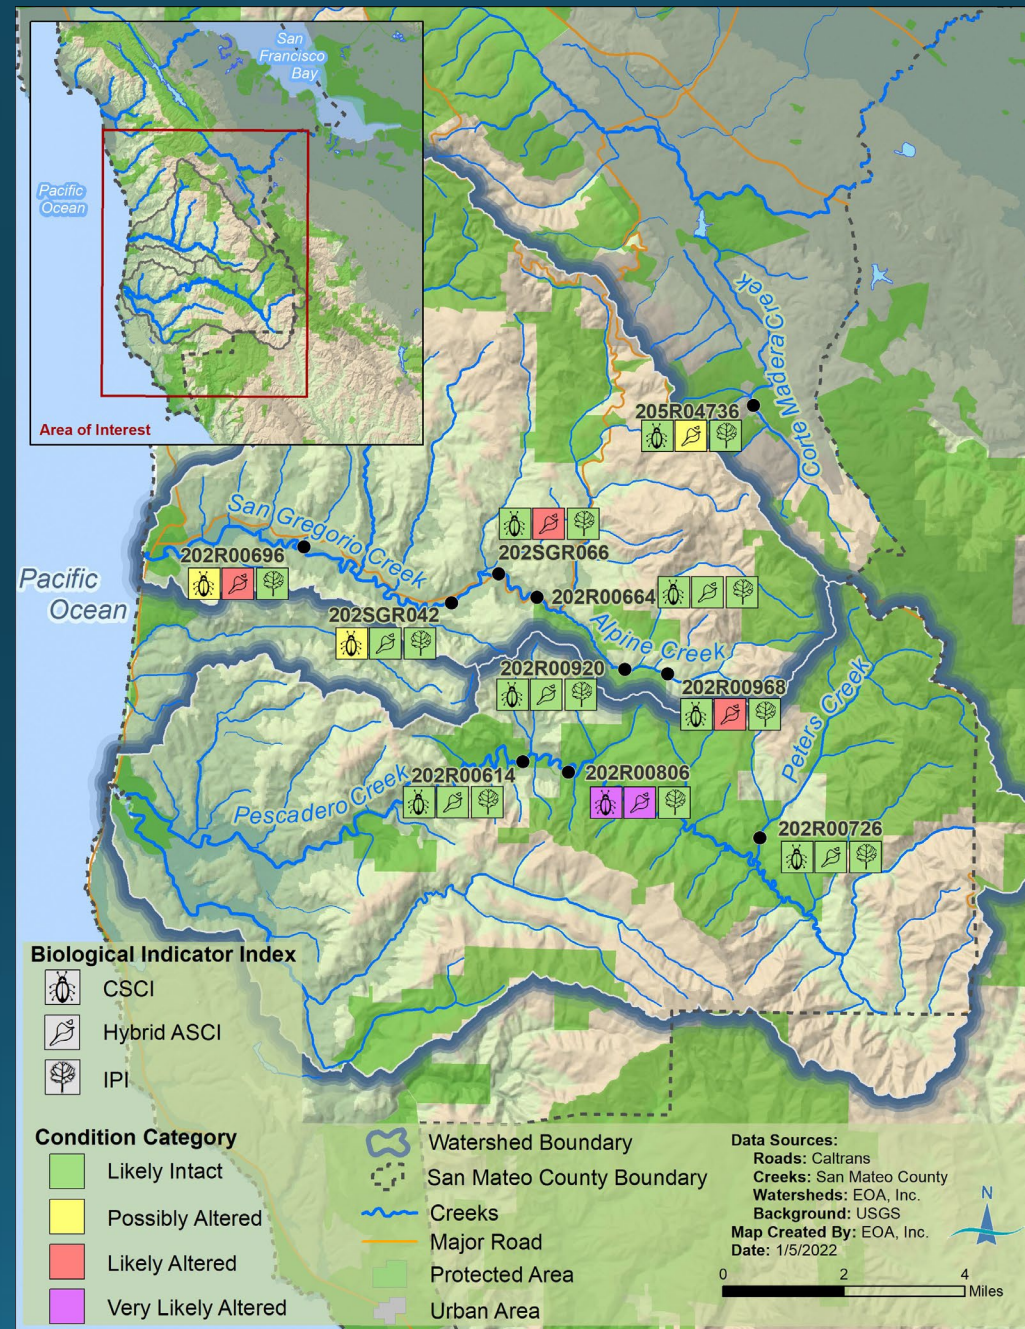
Biological Condition

WY 2021 Sites
