TOWN OF HILLSBOROUGH

Reducing Water Waste During Unidirectional Flushing Operations

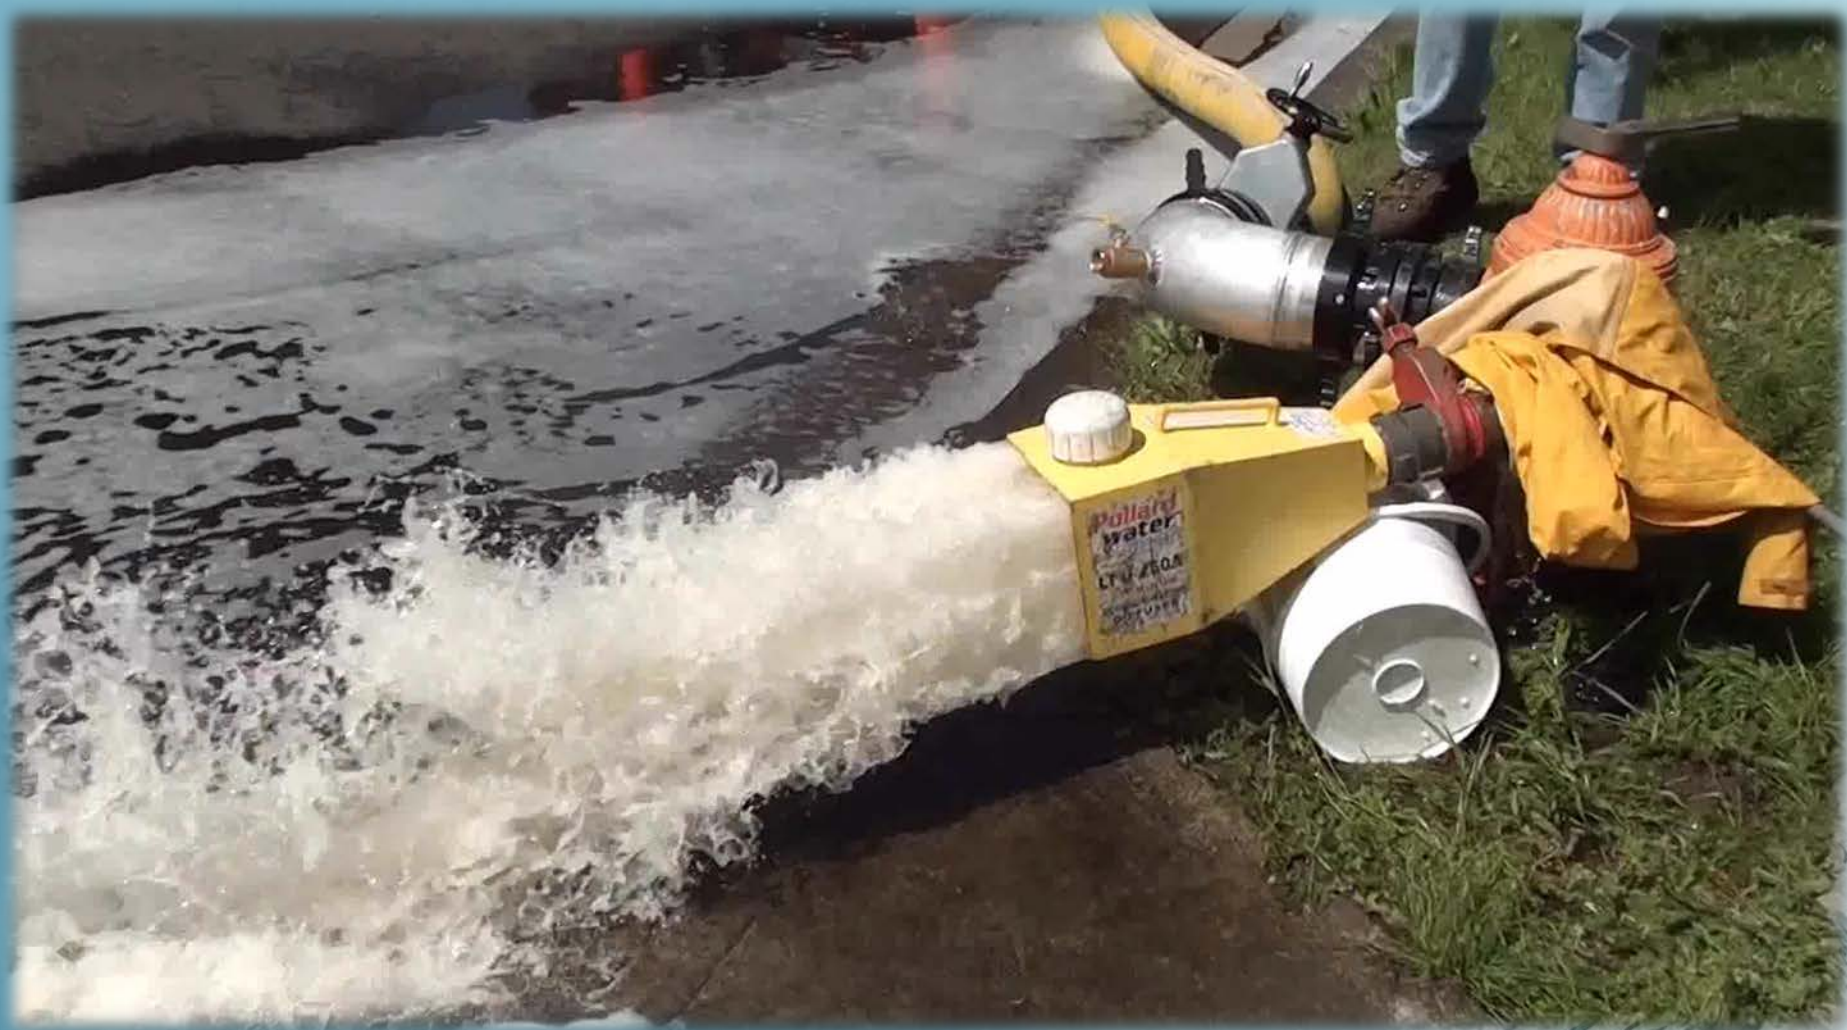
Unidirectional Flushing

The goal of UDF is to:

- Isolate a section of water main.
- Flow water @ 5 feet per second.
- Remove and flush sediment and buildup from water main pipes.

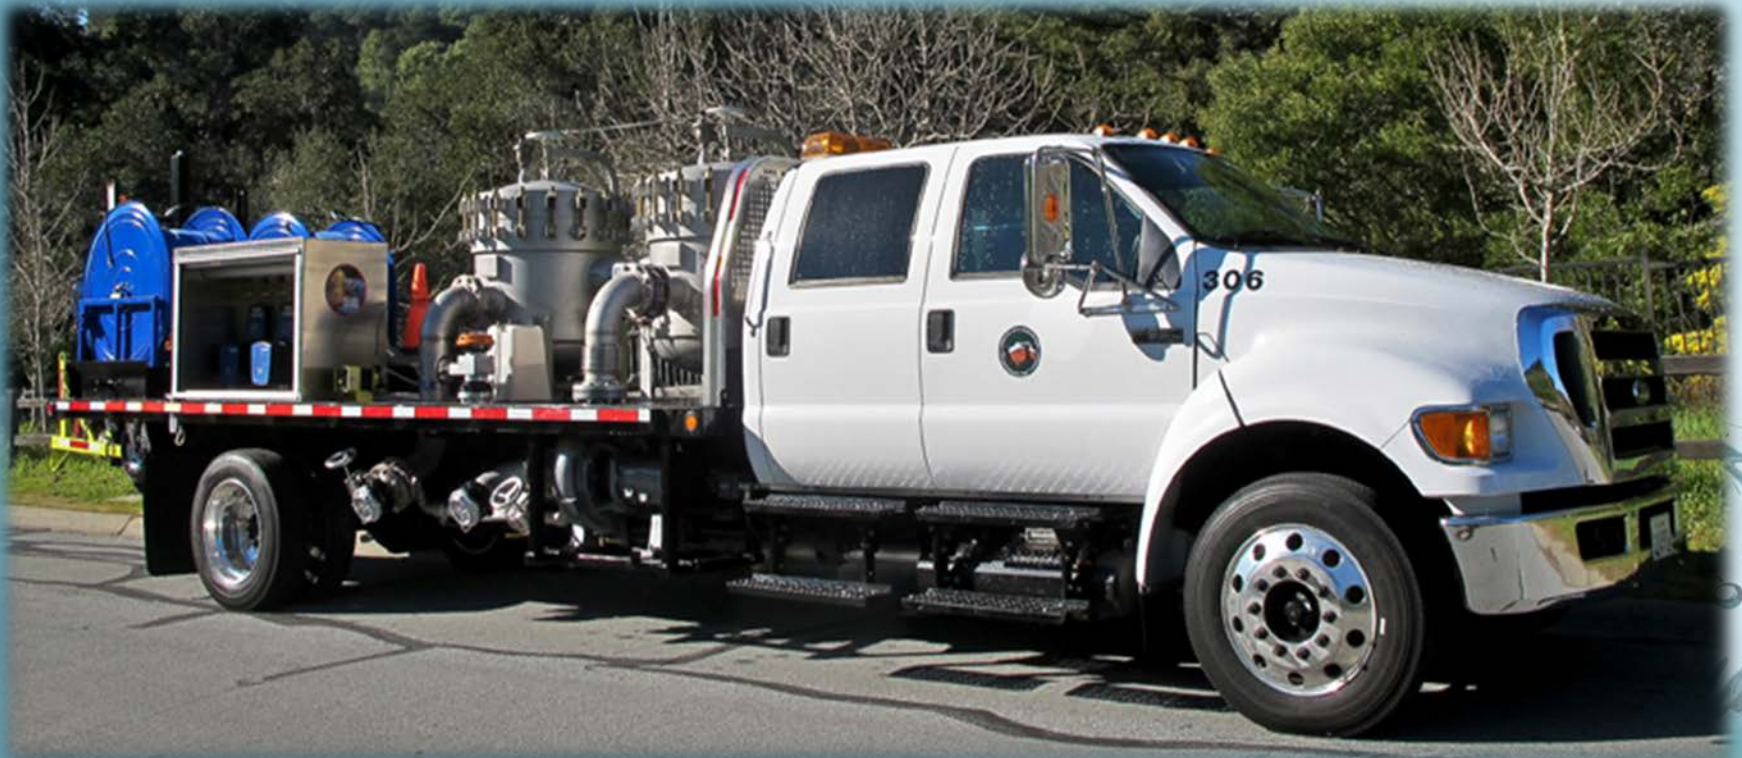
NO-DES

A new water flushing technology that:

- Connects to two water hydrants.
- Creates a reverse hydraulic loop between two water hydrants using on-board pump.
- Filters water to 1 micron absolute.
- Measures water flow and turbidity with on-board instruments.
