Unified Stream Assessment in Seven Watersheds in San Mateo County, California

August 2008

Prepared for the San Mateo Countywide Water Pollution Prevention Program

EOA, Inc. 1410 Jackson St. Oakland, CA 94612

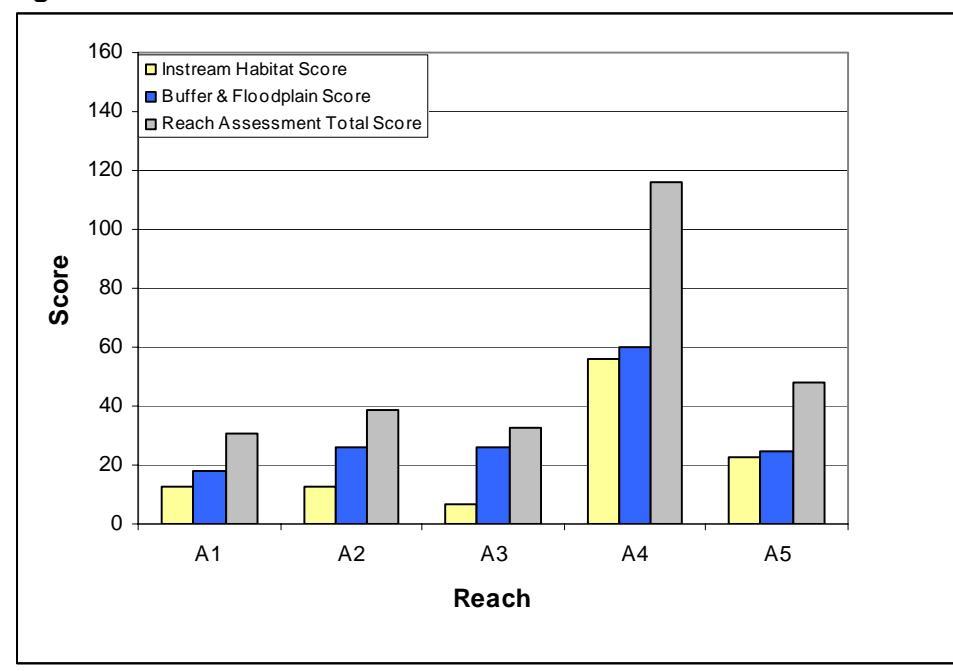
Figure 4. Reach assessment scores in Atherton Creek watershed.

Total reach assessment scores for the mainstem reaches ranged from 31 to 39 out of a possible score of 160. Tributary reaches A4 and A5 had higher scores of 116 and 48, respectively (Table 4 and Figure 4).

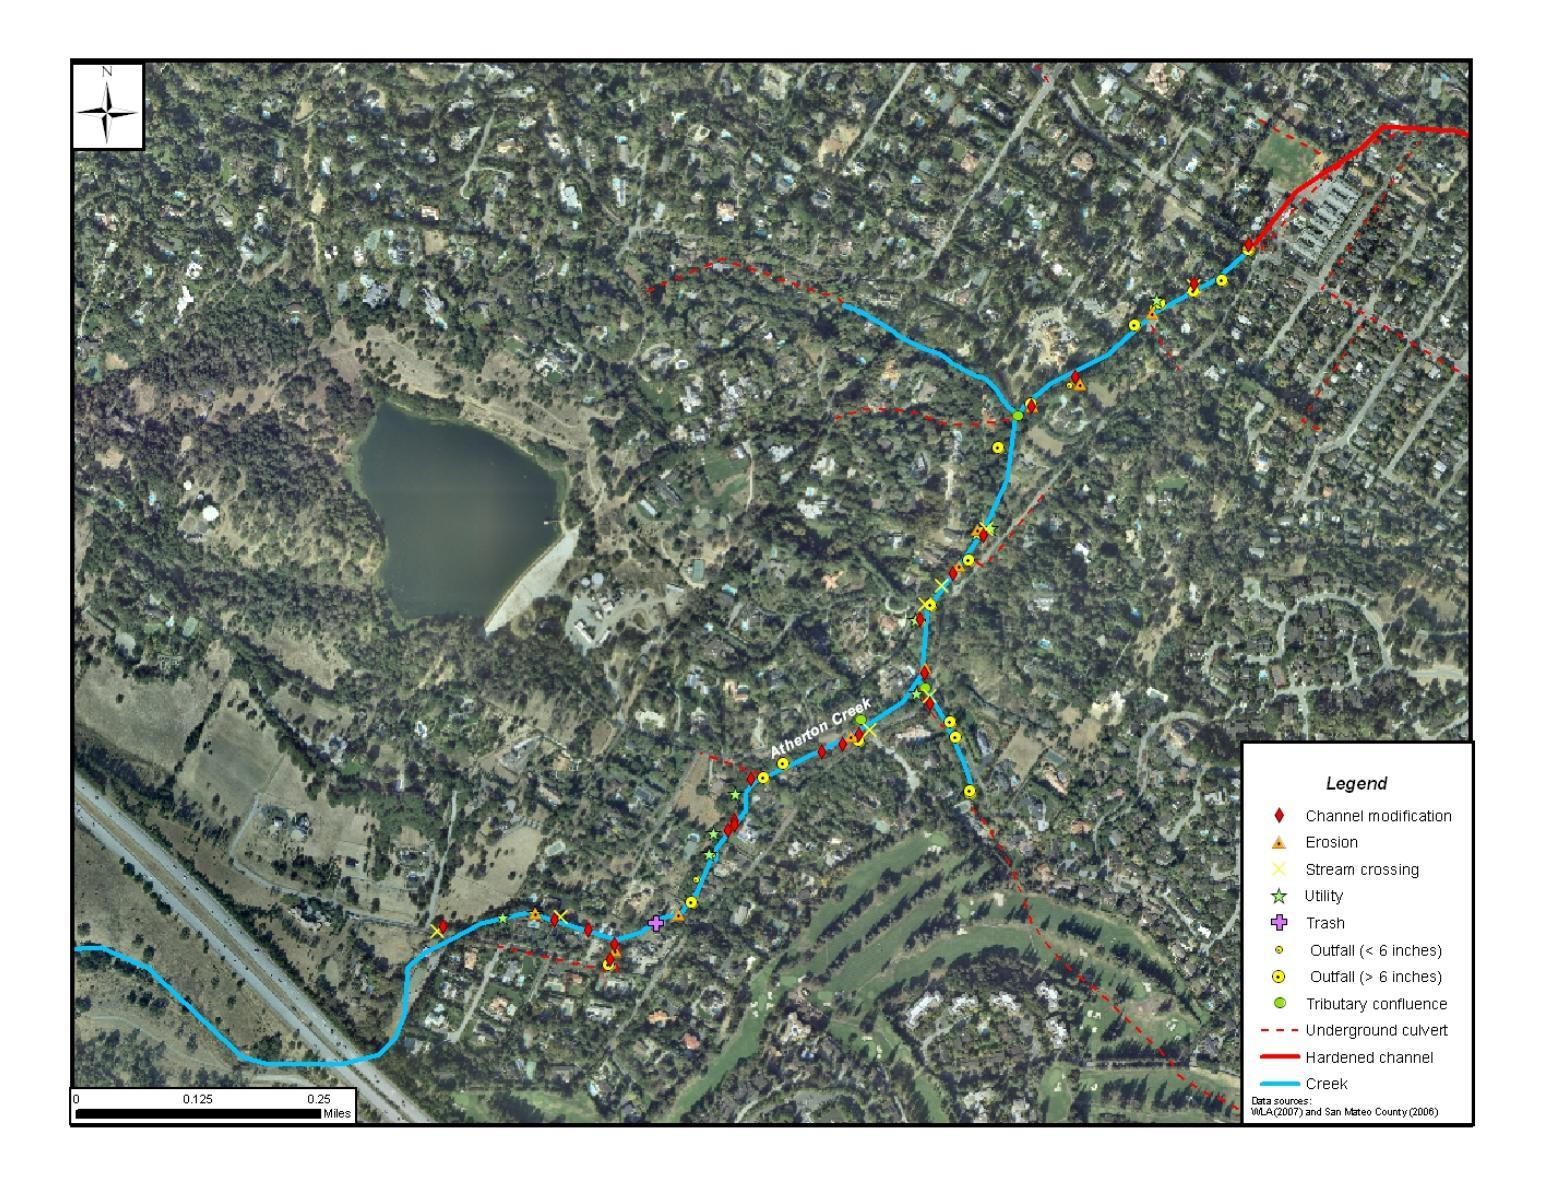
Figure 5. Impacts in the Atherton Creek watershed.

Atherton Creek is highly modified, with about 4,536 feet of armored bed and/or banks, equaling about 57% of the total length assessed. Reach A1 had the greatest proportion of modified channel (79%) primarily due to a continuous length of hardened channel bed from Alameda de las Pulgas to Reservoir Road. Reaches A2, A3 and A5 were also significantly modified, with 41%, 37% and 49% of the total reach length modified, respectively. Bank revetments were typically constructed of sacrete walls (i.e., stacked bags of hardened concrete). A concrete drop structure was documented in each reach except Reach A1. Reach A2 had the largest drop structure; this grade control structure protects a water supply pipeline that crosses the creek immediately above it (Figure 6).

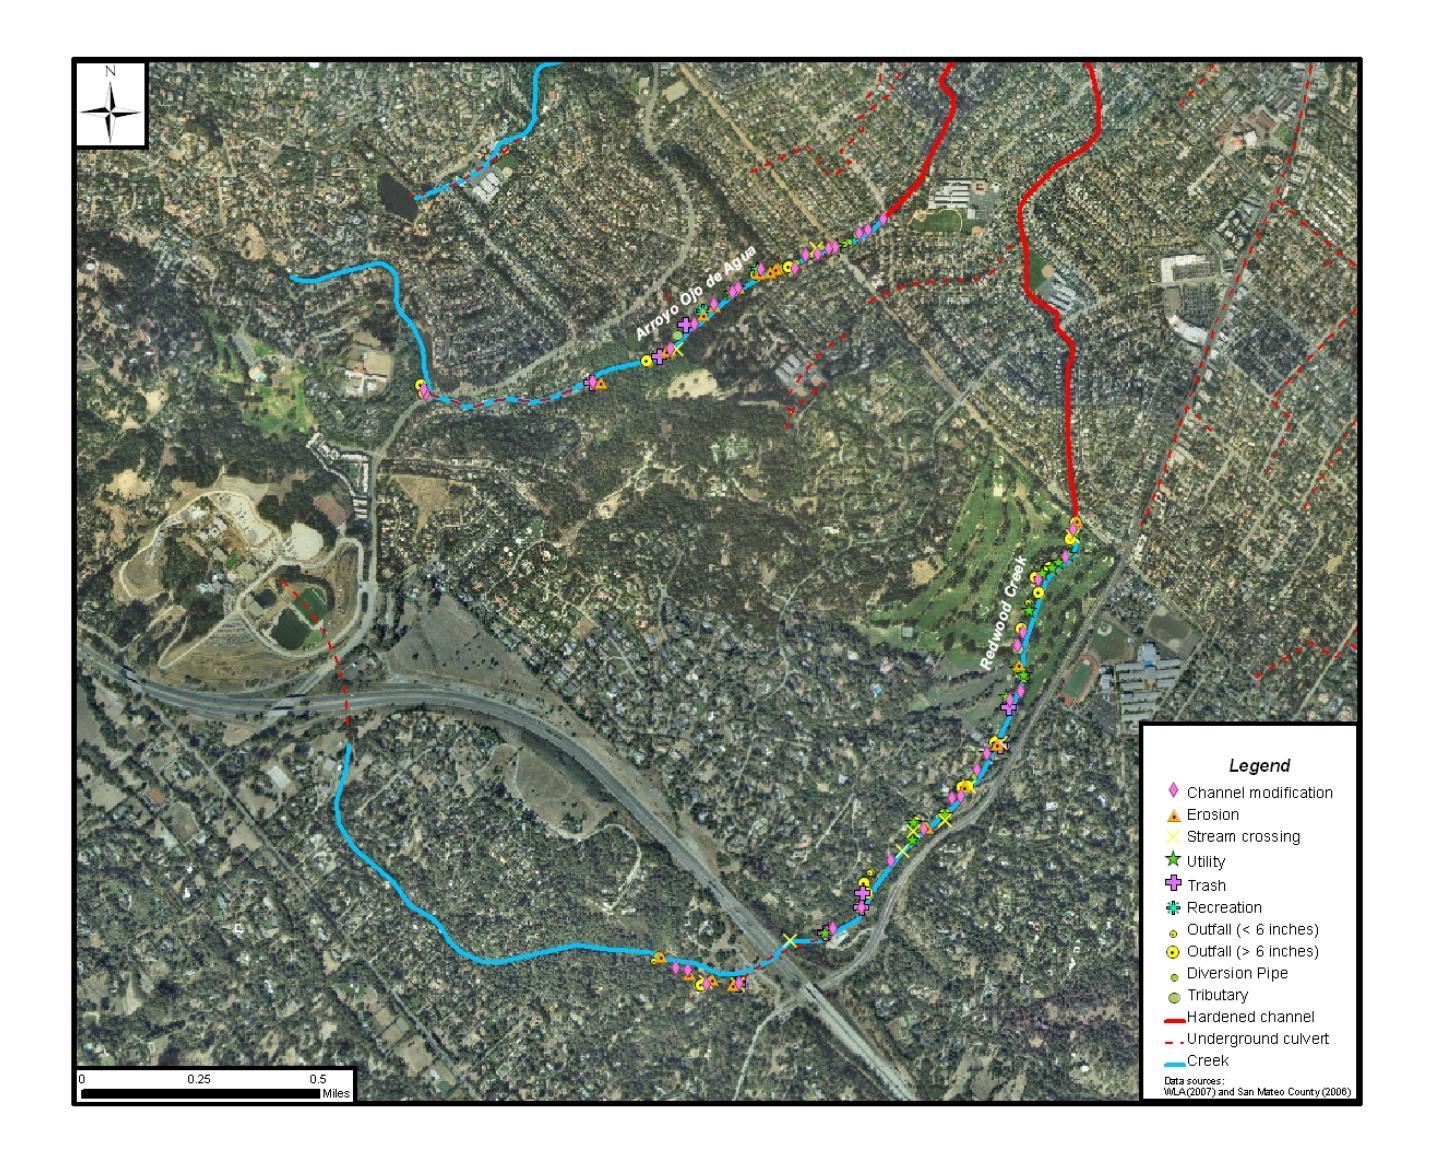
Figure 9. Impacts in the Redwood Creek watershed.

The upper section of Redwood Creek (i.e., above Alameda de las Pulgas) was moderately modified, with about 3,900 feet of armored or culverted channel, equaling about 29% of the total length assessed. Reaches RW3 and OA1 had the greatest proportion of modified channel, 72% and 64%, respectively. Channel modification in Reach RW3 consisted of a long culverted section under Interstate 280 with armored bed and banks downstream of the culvert. Channel armoring in Reach OA1 was primarily sacrete and concrete walls constructed to protect private homes and yards. In addition, there were nine concrete drop structures observed in this watershed.

The most extensive bank erosion occurred in reaches RW1, RW2 and OA2, ranging from 75 – 92% of the total reach length. These reaches were also the least modified. Erosion impacts were predominately associated with bank scour and failure due to highly incised channel with steep and un-vegetated banks. Channel incision was estimated between 6 to 8 feet in depth in Reaches RW1 and RW2. Old landslide scars were observed at two locations in Stulstaft Park (Reach OA2).

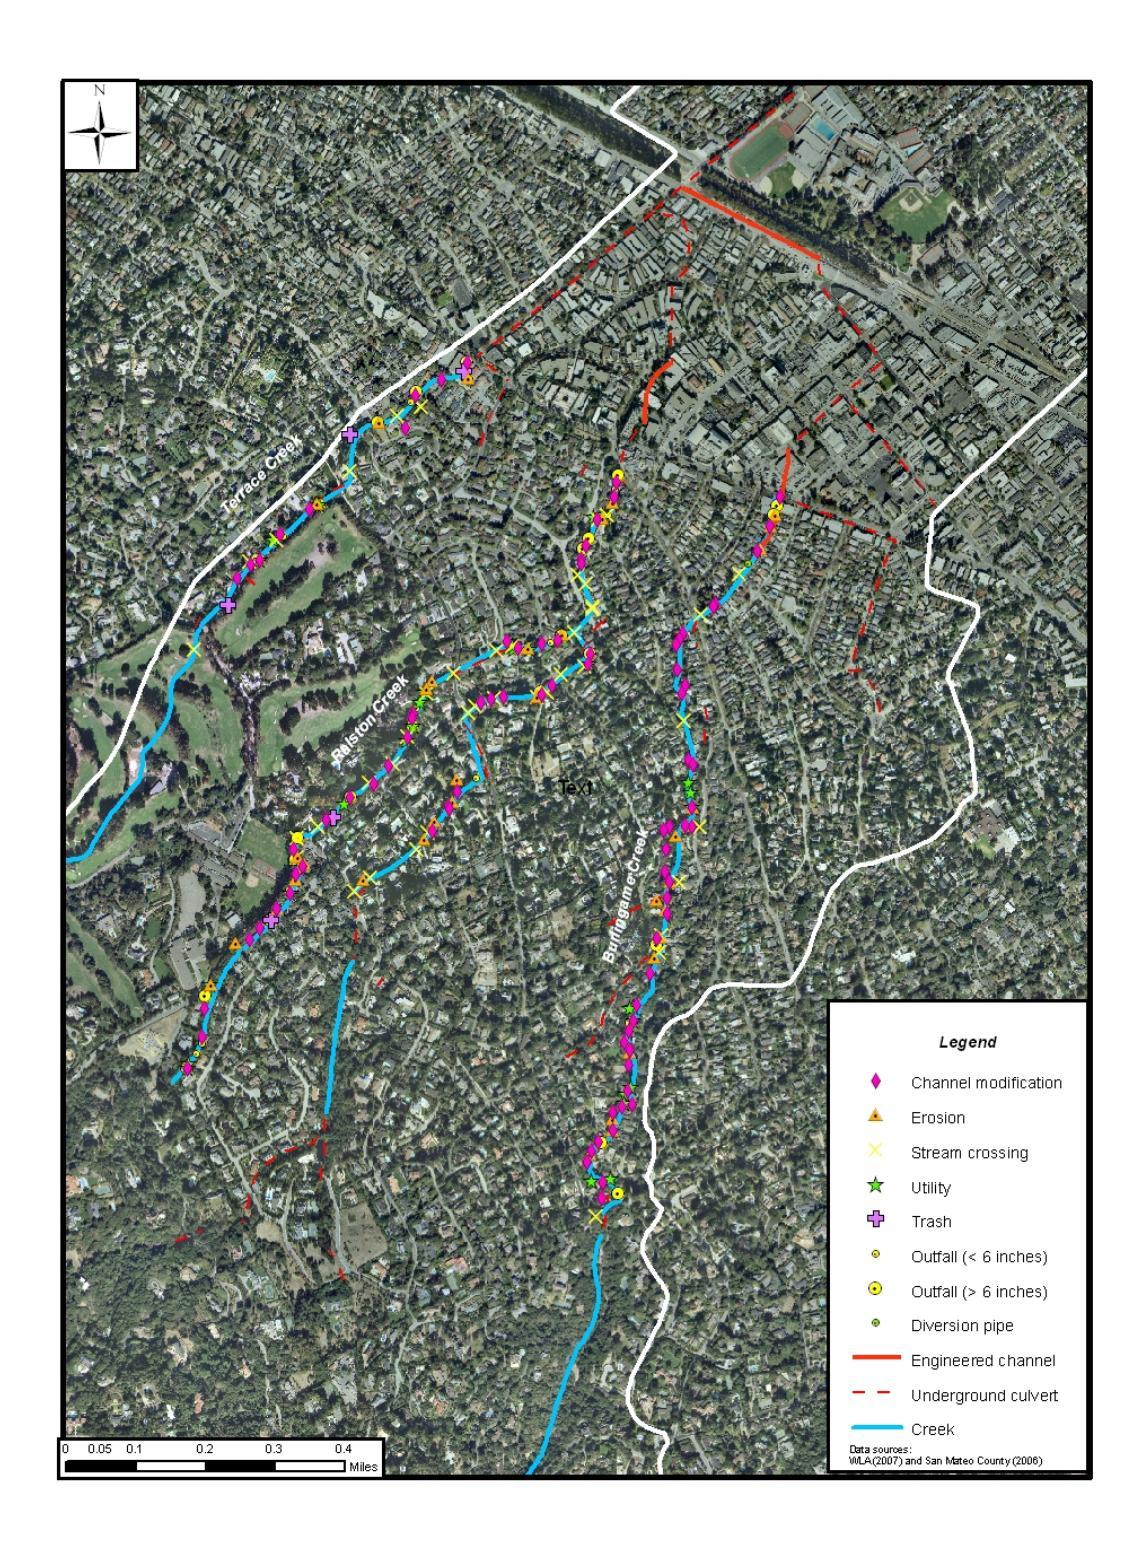
Figure 15. Impacts in the Burlingame Creek watershed.

Channel armoring materials observed throughout this watershed were primarily concrete and rock walls constructed to protect private homes and yards. In addition, there were 23 concrete drop structures observed in this watershed, occurring primarily in Ralston Creek (13) and Burlingame Creek (9).

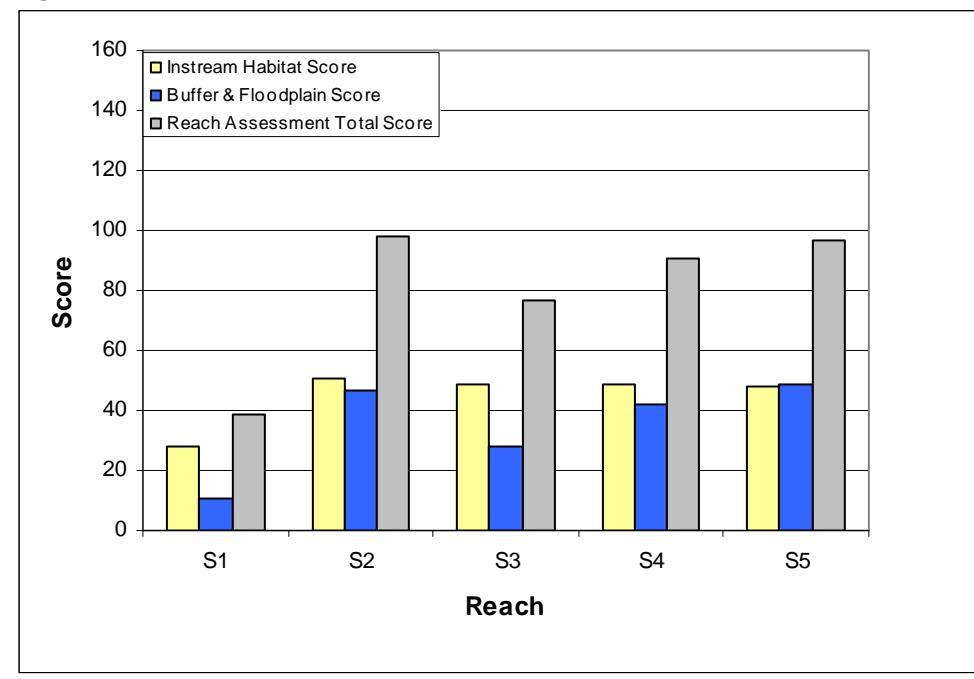
Figure 20. Reach assessment scores in Sanchez Creek watershed.

Total reach assessment scores ranged from 39 to 98 (Table 13 and Figure 20).⁴ Reach S1 had the lowest total score (39) in the watershed and Reach S2 had the highest total score (98). Reach S2 had a relatively low amount of channel modification and relatively high access to the flood plain.

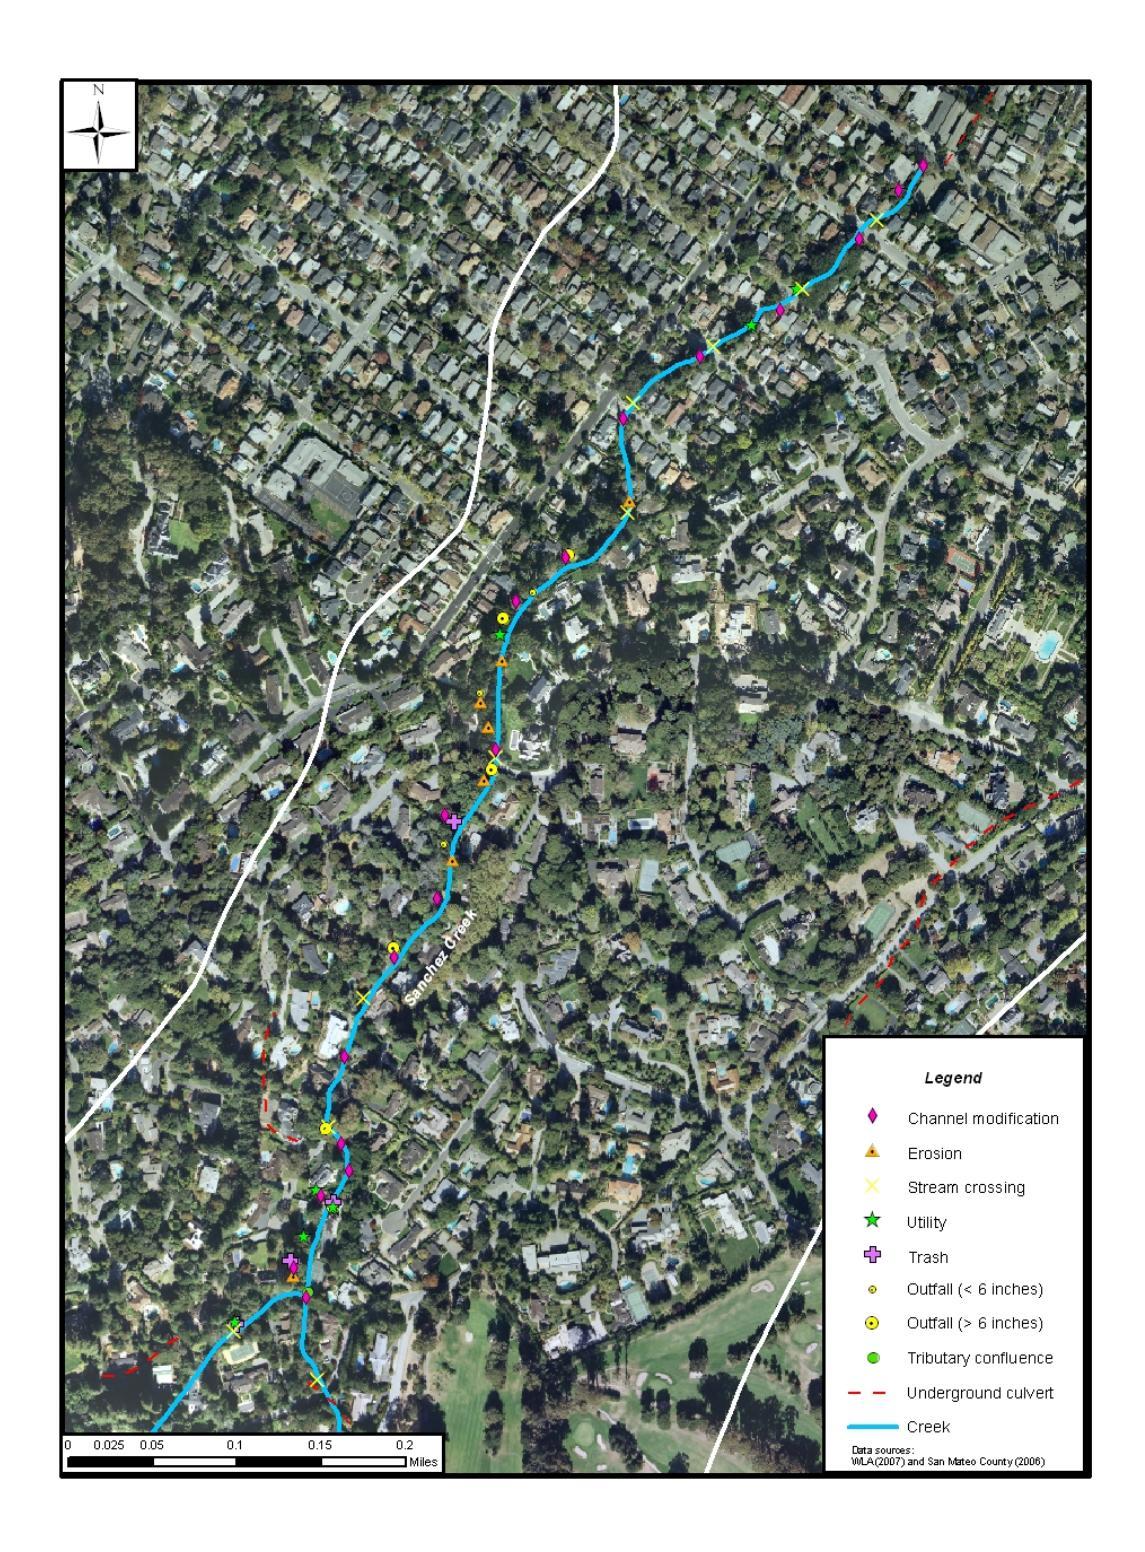
Figure 21. Impacts in the Sanchez Creek watershed.

The study reaches in this watershed were highly modified, with about 4,761 feet of armored or culverted channel, equaling about 73% of the total length assessed. The proportion of modified channel ranged from 44% - 99%. Reaches S1 and S5 were almost entirely modified at 99% and 91%, respectively. Reach S2 had the lowest proportion of modification (44%) in the watershed. About 46% of the total modified length was culverted. A culvert in Reach S1 that conveyed the creek under a large utility pipe appeared to be failing (Figure 22).

The amount of erosion in this watershed was relatively limited (183 feet total), with the highest amount occurring in Reach S2 (136 feet). This reach also had the least amount of channel modification. Erosion impacts were predominately associated with bank scour at failing revetments and meander bends. There were some cases of bank failure at sites with unprotected steep banks (10-15 feet in height).

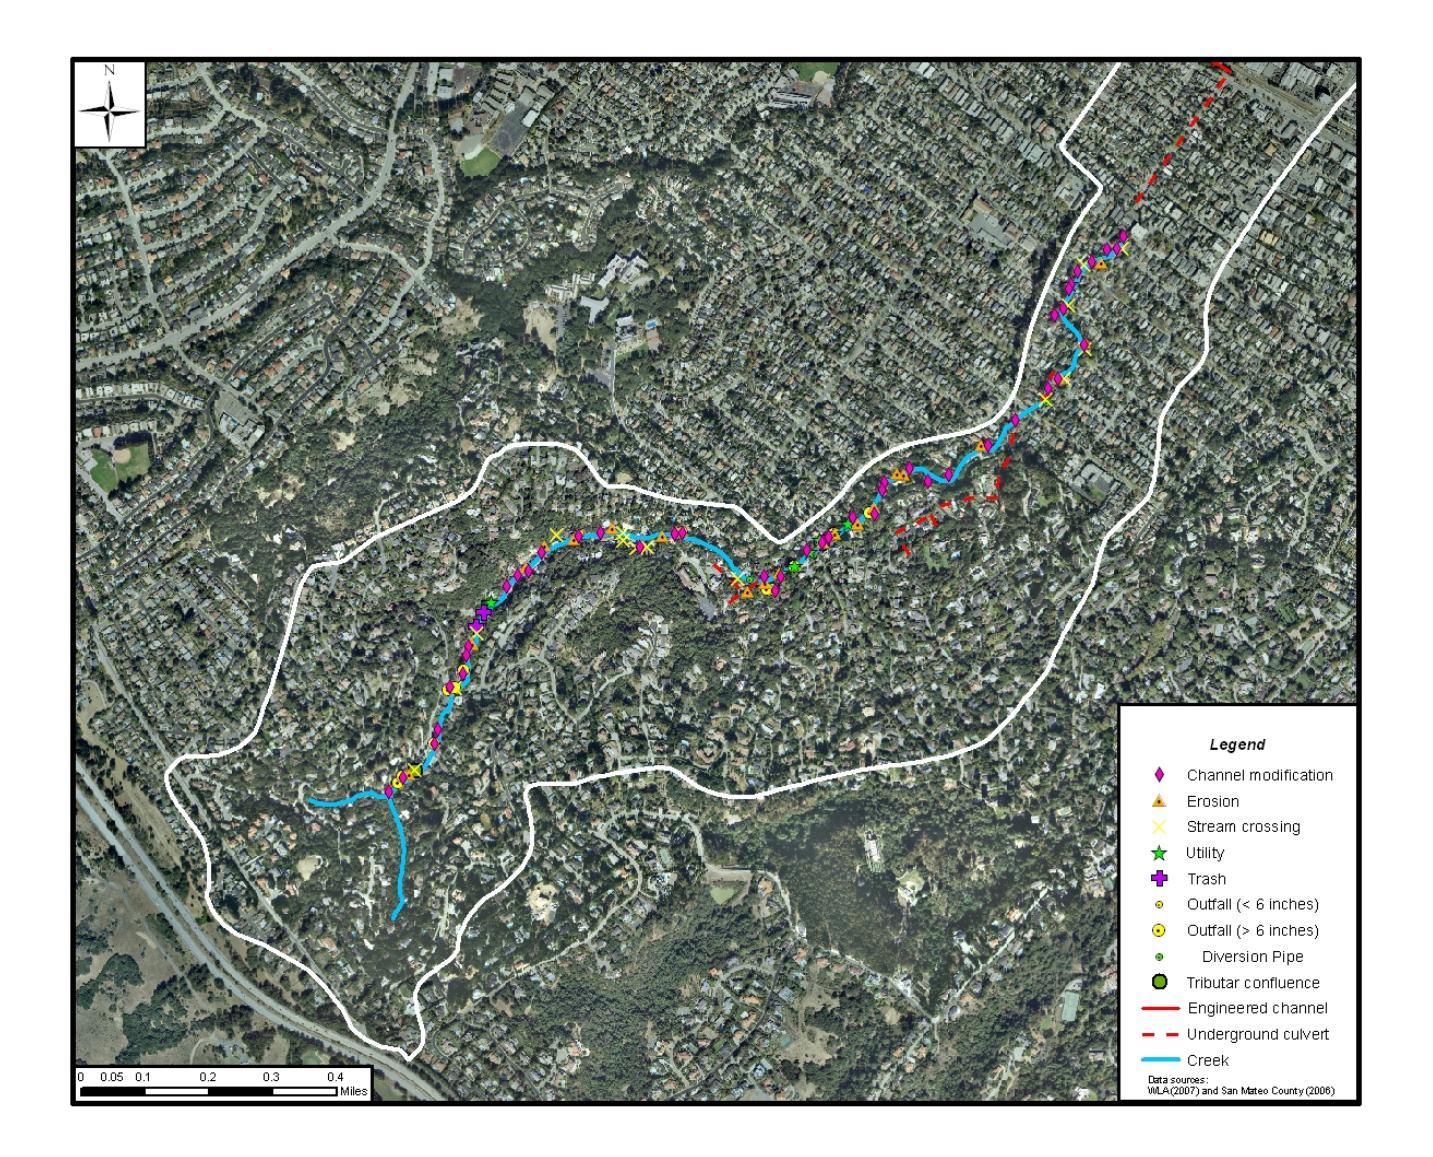
Figure 27. Impacts in the Easton Creek watershed.

predominately consisted of bank scour at failing revetments and meander bends. Surface erosion on a bank from a leaking pipe was observed in Reach E2.

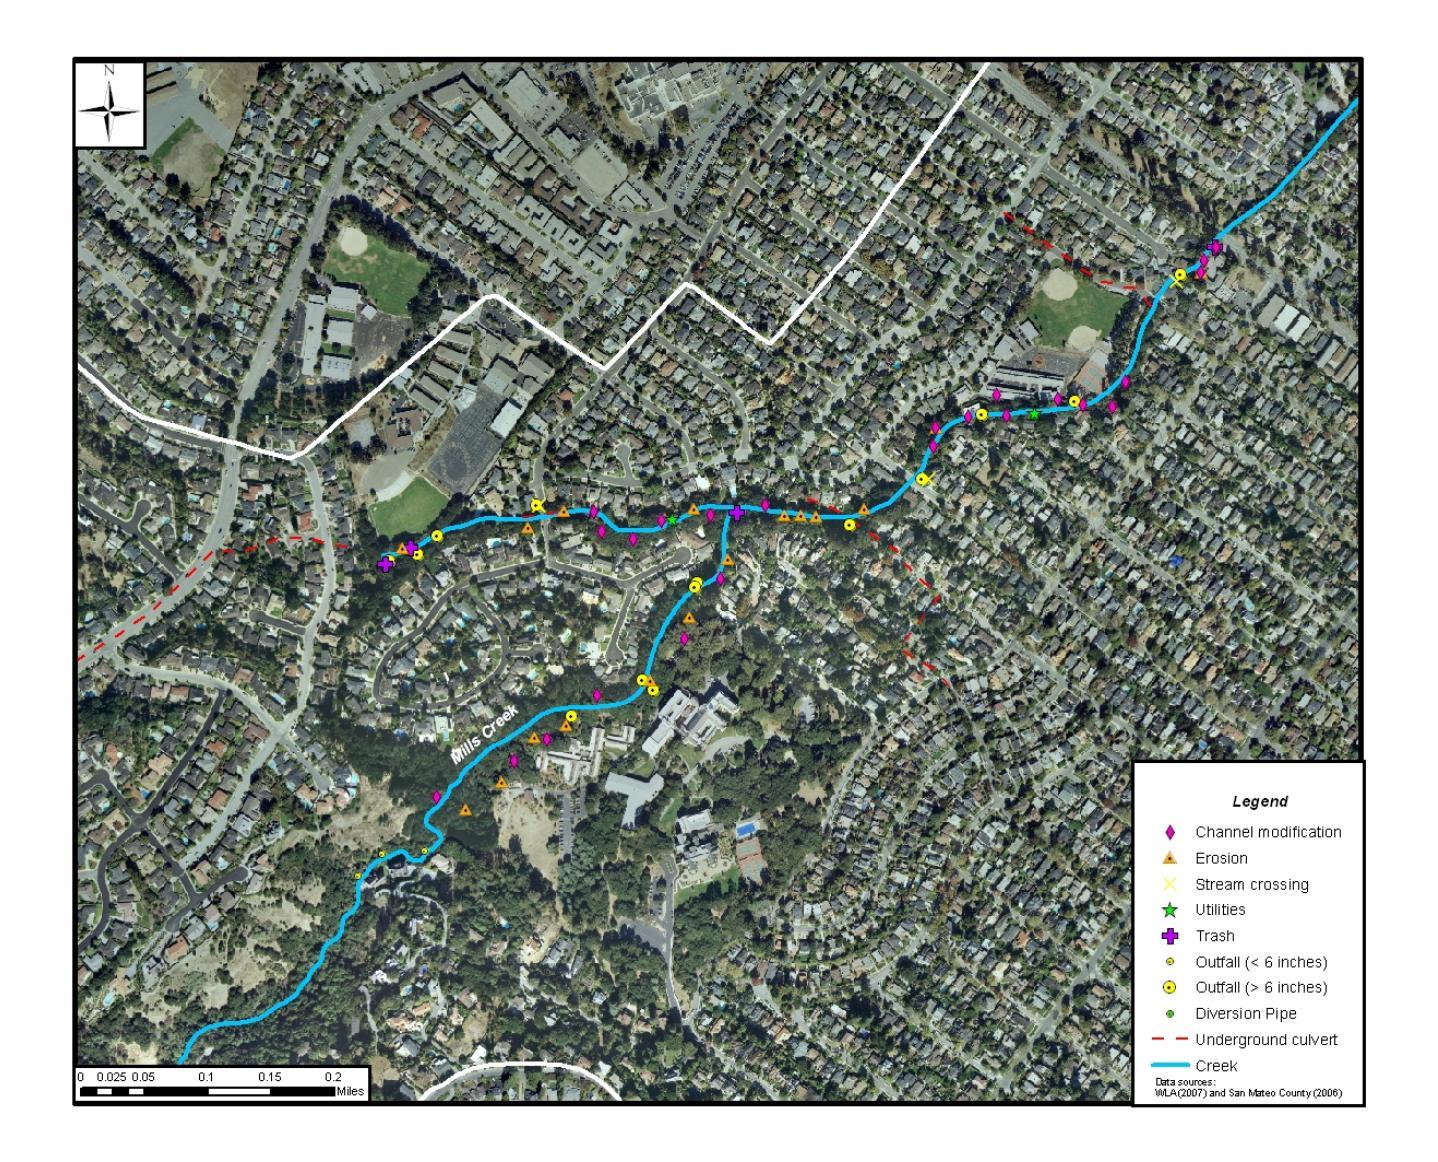
Figure 34. Impacts in the Mills Creek watershed.

The assessment reaches were highly modified, with about 2,700 feet of armored or culverted channel, equaling about 39% of the total length assessed. The proportion of modified channel in the study reaches ranged from 26% - 57%, with Reach M1 having the greatest amount of modified channel. About 25% of the total modified length was culverted sections of creek under roads and homes. The longest culvert (485 feet) was in the lower portion of Reach M1. Channel armoring materials in this watershed typically consisted of concrete or wood walls on the banks and concrete on the channel bed to protect private homes and yards. There were three concrete drop structures in the watershed, ranging from 4 to 10 feet in height.

There was about 2,500 feet of erosion observed in this watershed. Reaches M2 and M3 had the greatest proportion of erosion with 49% and 58% of their channels eroded, respectively. Erosion impacts typically consisted of bank scour at failing revetments, downstream culverts and meander bends. The upper portion of Reach M2 within Mills Canyon Park had widespread erosion due to an incised channel with steep banks (Figure 35).

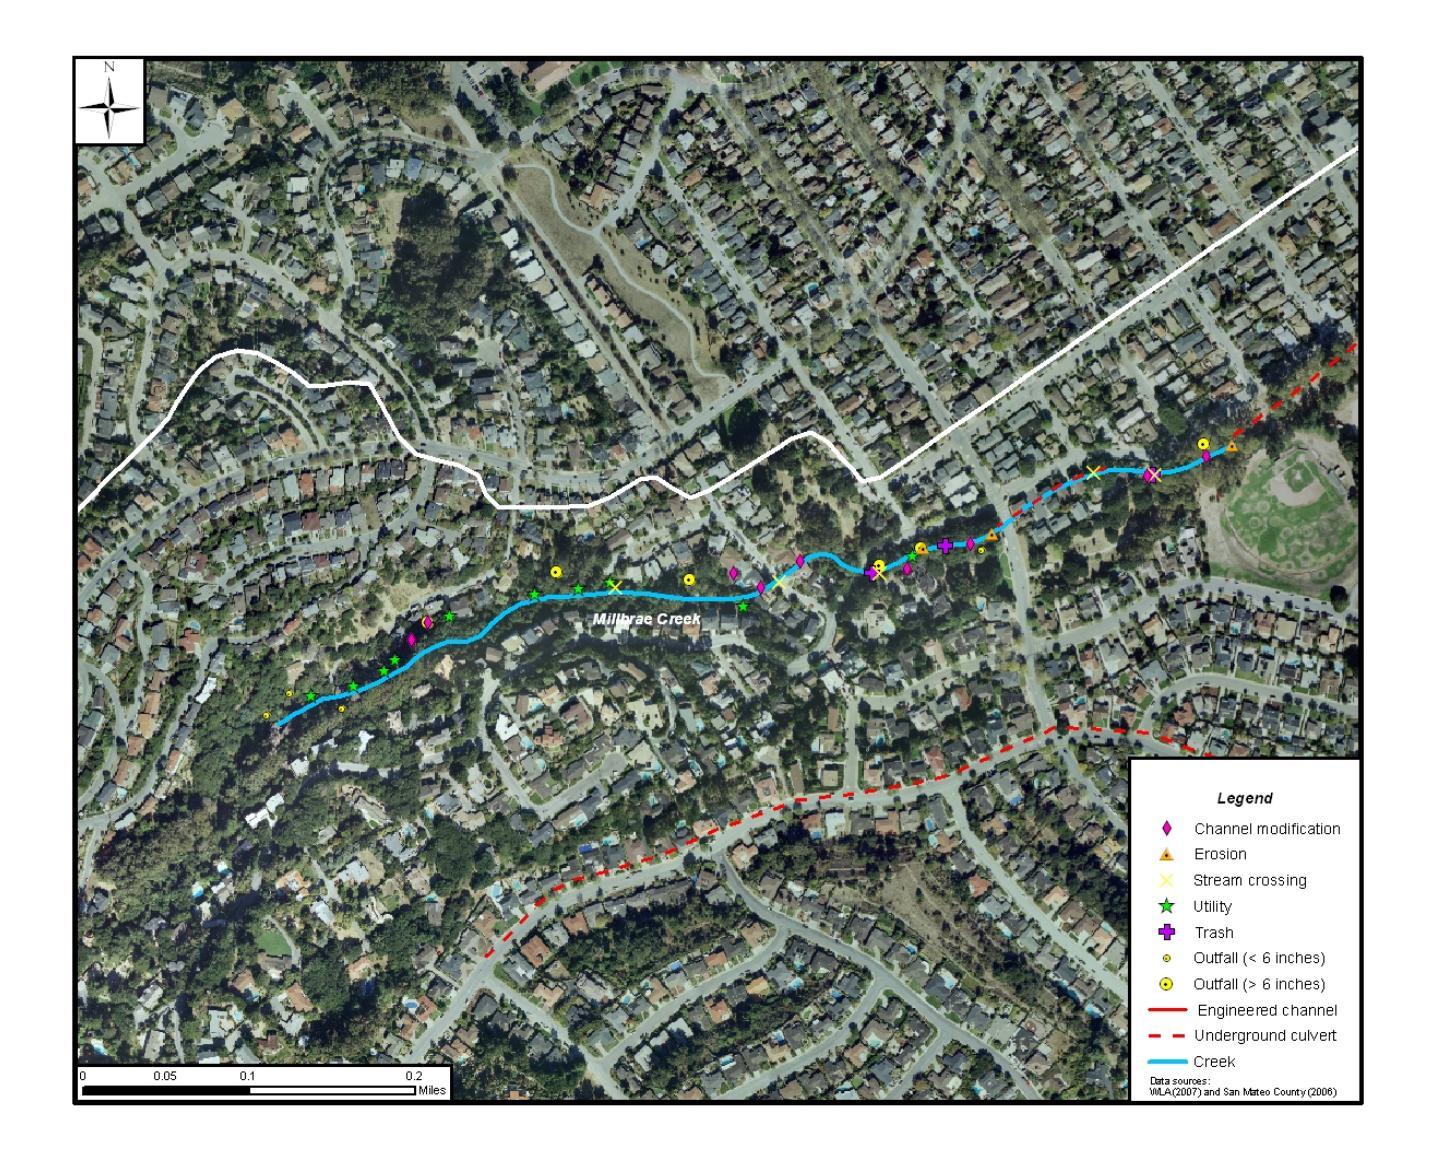
Figure 40. Impacts in the Millbrae Creek watershed.

The assessment reaches were highly modified and had about 1,350 feet of armored or culverted channel, equaling about 38% of the total length assessed. The proportion of modified channel in the study reaches was 70% in Reach M1 and 26% in Reach M2. About 41% of the total modified length in the watershed was culverted sections of creek under roads and homes. Channel armoring materials in this watershed typically consisted of concrete or wood walls on the banks and concrete on the channel bed to protect private homes and yards. Four concrete drop structures were observed in this watershed (Table 23).

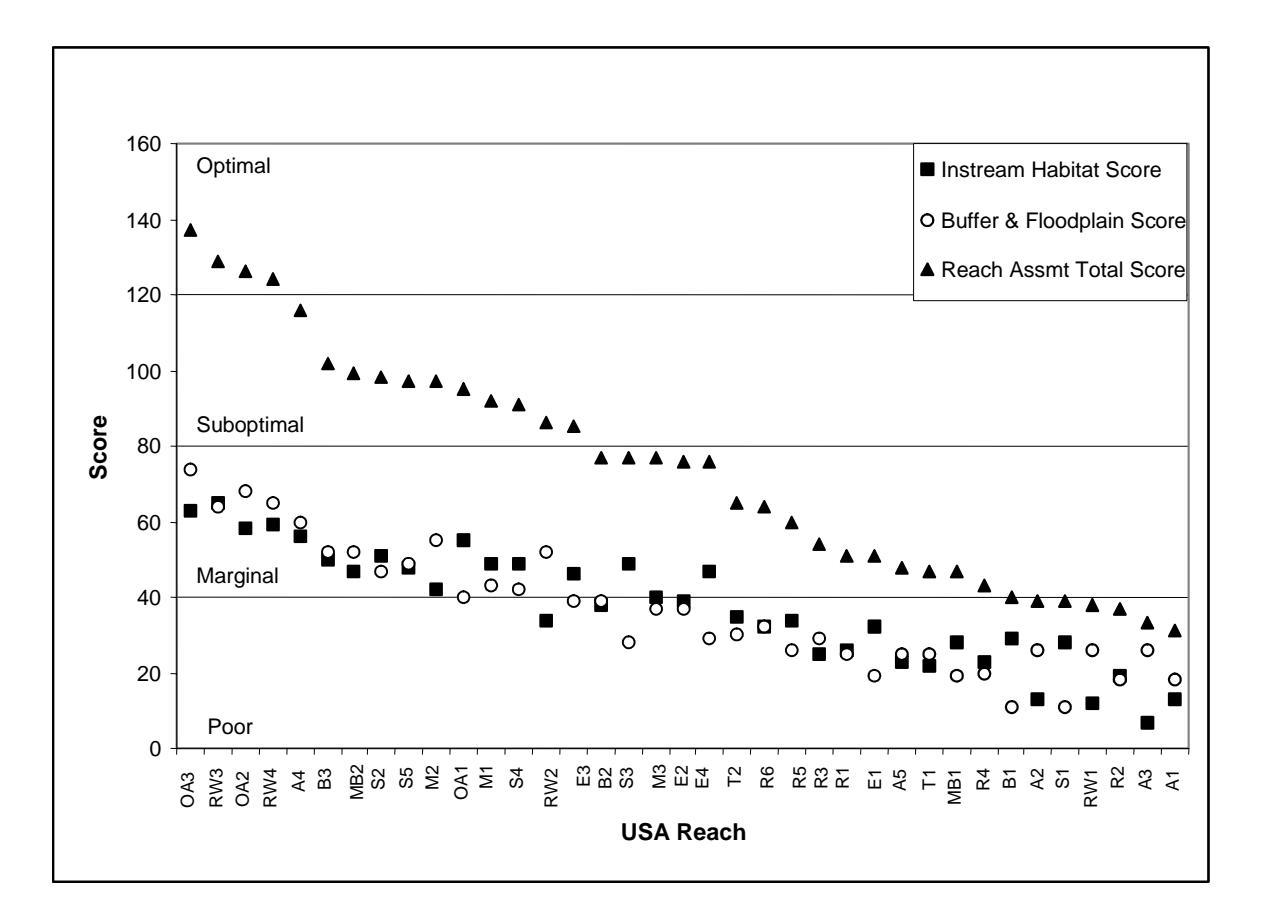
Figure 43. Ranked assessment scores for the 37 study reaches.

The upper two reaches of Redwood Creek and Arroyo Ojo de Agua had the highest total reach condition scores in the study watersheds and were the only reaches in the optimal category (120 – 160 range) (Figure 43). The score for the upper reach of Atherton Creek was just below the threshold for optimal ranking. The Redwood and Atherton Creek watersheds were the largest watersheds in this study and showed a general trend of increasing reach assessment scores with increasing elevation. There were no apparent trends by watershed or elevation for the reach scores in the five smaller study watersheds.

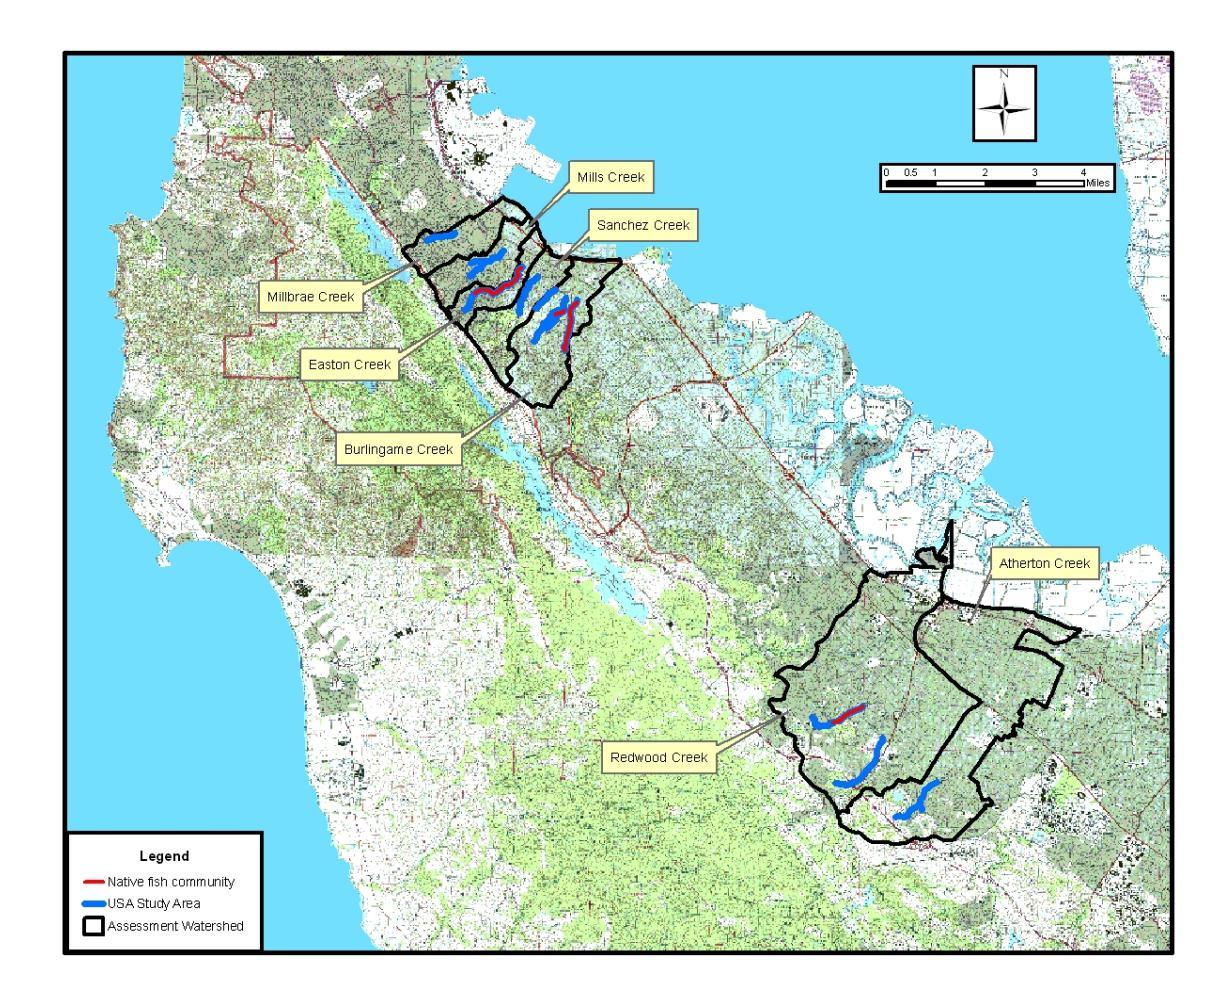
Figure 44. Native fish community distribution in reaches assessed during the USA.
5.0 DISCUSSION

The native fish communities observed during this study are shown in Figure 44. Fish were documented in nine reaches of four creeks: Arroyo Ojo de Agua, Burlingame Creek, Easton Creek and a tributary to Ralston Creek. The fish observed were largely native stickleback, however two to three species of fish were observed in the lowest reach of Arroyo Ojo de Agua. The total reach assessment scores ranged for these reaches ranged from 40 to 126. Stickleback are very tolerant of warm water and low dissolved oxygen, so it is not surprising they were observed in highly impacted reaches with poor habitat and water quality. Fish passage impediments may play an important role in limiting overall range of native fish communities. Anadromous fish (e.g., steelhead) were not observed during this study.
