Unified Stream Assessment in Six Watersheds in San Mateo County, California

August 2007

Prepared for the San Mateo Countywide Water Pollution Prevention Program

EOA, Inc. 1410 Jackson St. Oakland, CA 94612

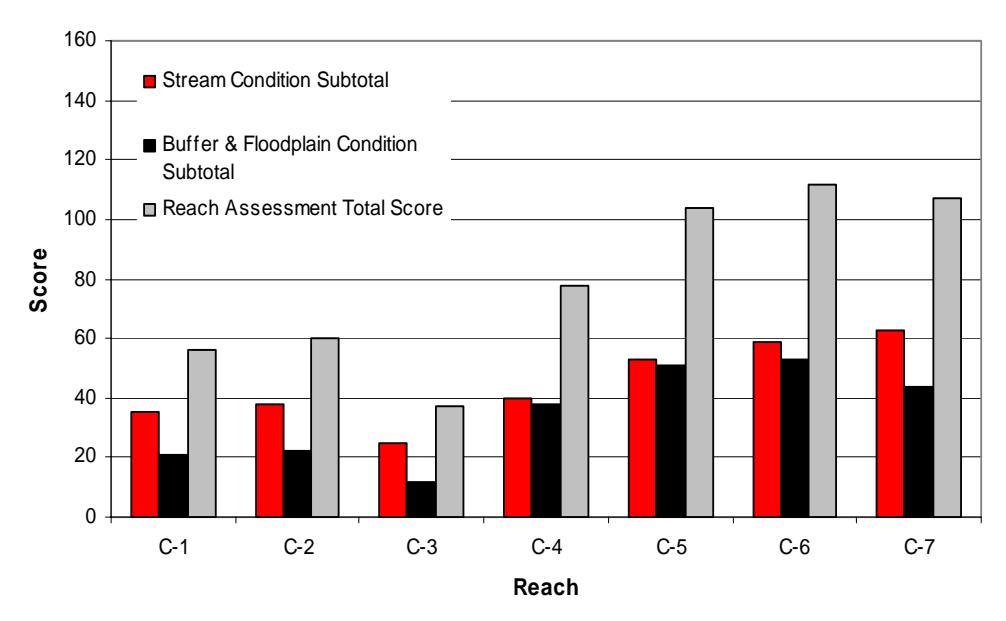
Figure 5. Reach assessment scores in the Cordilleras Creek watershed.

Residential and commercial development around the lower reaches has reduced the buffer zone. Moving upstream, floodplain encroachment decreased, which contributed to an increase in the buffer width and floodplain habitat diversity. Bank slopes were more moderate, particularly in reaches C5 and C6. Scores decreased in C7 due to residential encroachment in the floodplain, particularly on the right bank. In general, total reach assessment scores increased in the upstream direction (Figure 5).

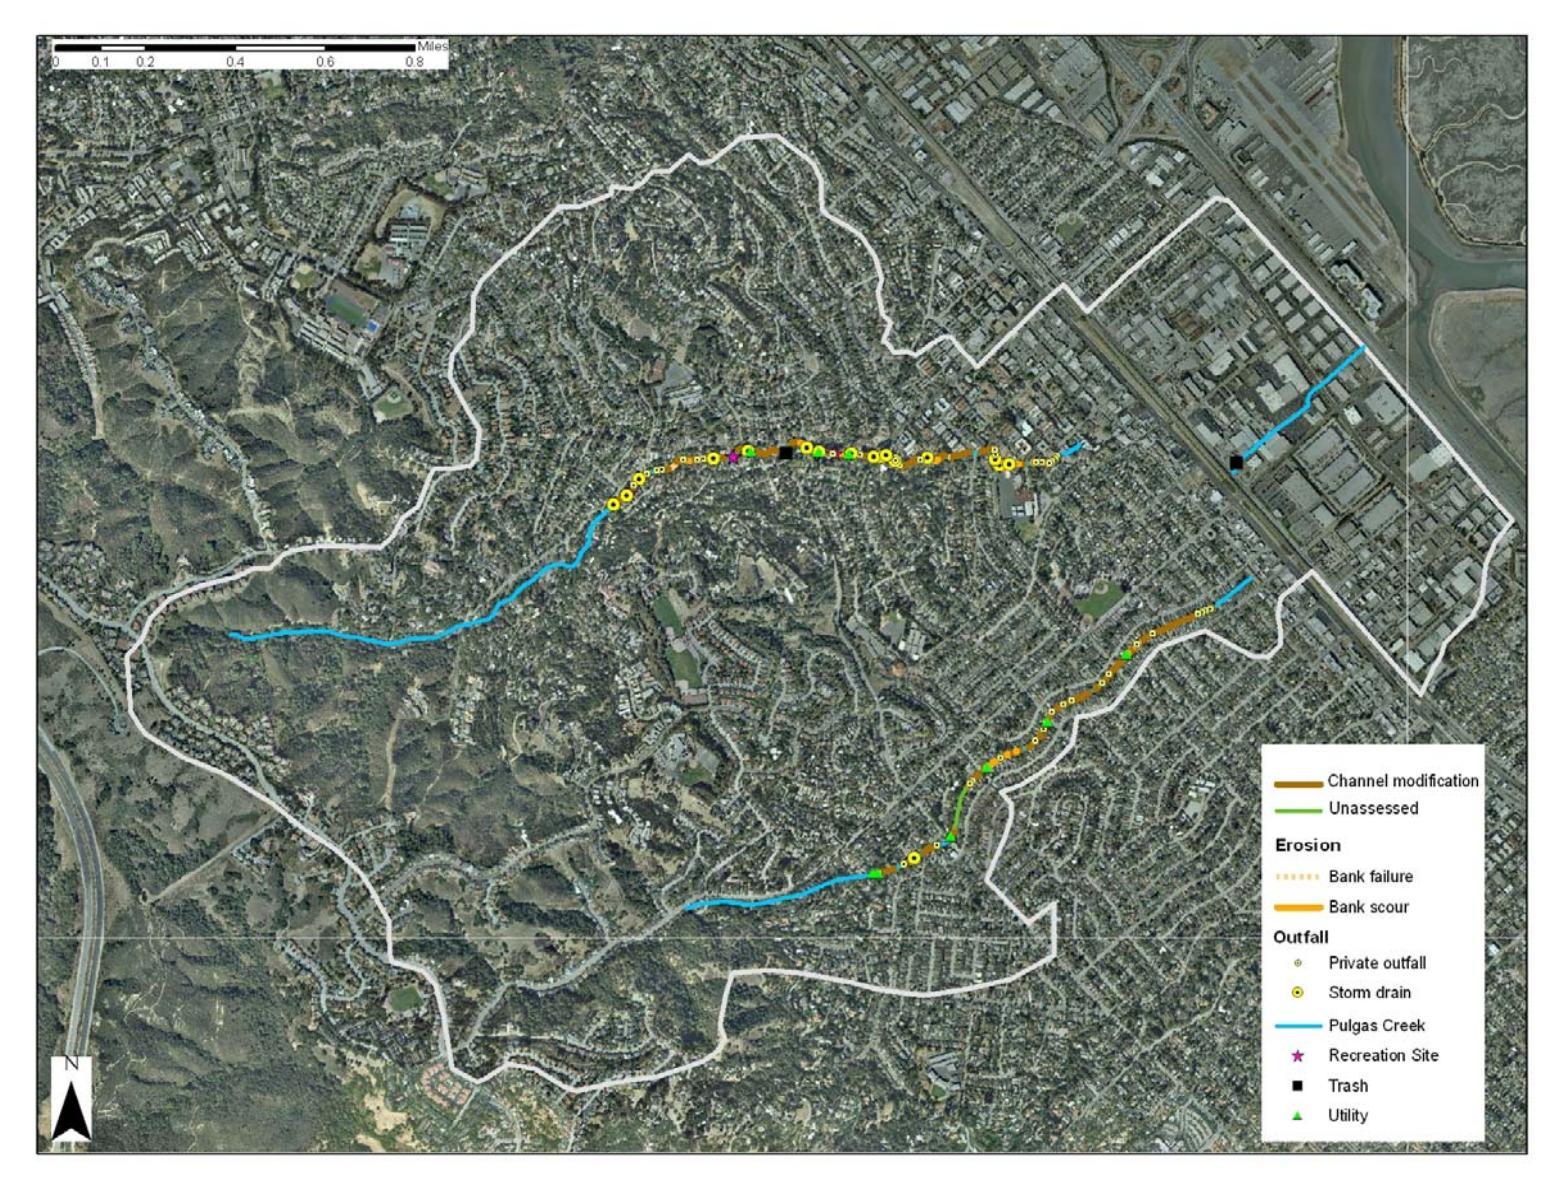
Figure 7. Impact assessments in the Pulgas Creek watershed. Base image: San Mateo County Department of Public Works.

Pulgas Creek was highly modified (Figure 7), with a total of 8,301 feet of modified channel, equaling ~64% of the total length assessed. Reaches P1 and P6 had the highest proportion of channel modification with 87% and 82% modified, respectively (Table 7). All of the channel modifications took the form of bank hardening. Concrete, sackcrete, gunnite, and stone were among the materials commonly used to harden banks sides.

Three trash sites were documented in the watershed (Table 7). Land use surrounding these sites was generally residential. Types of trash observed included plastic bags, Styrofoam, and beverage containers.

Eight utilities were observed in the watershed (Table 7). Most of these were water or electrical utilities that crossed the channel 2 - 5 feet above the creek and none was observed to be contributing to bank instability.

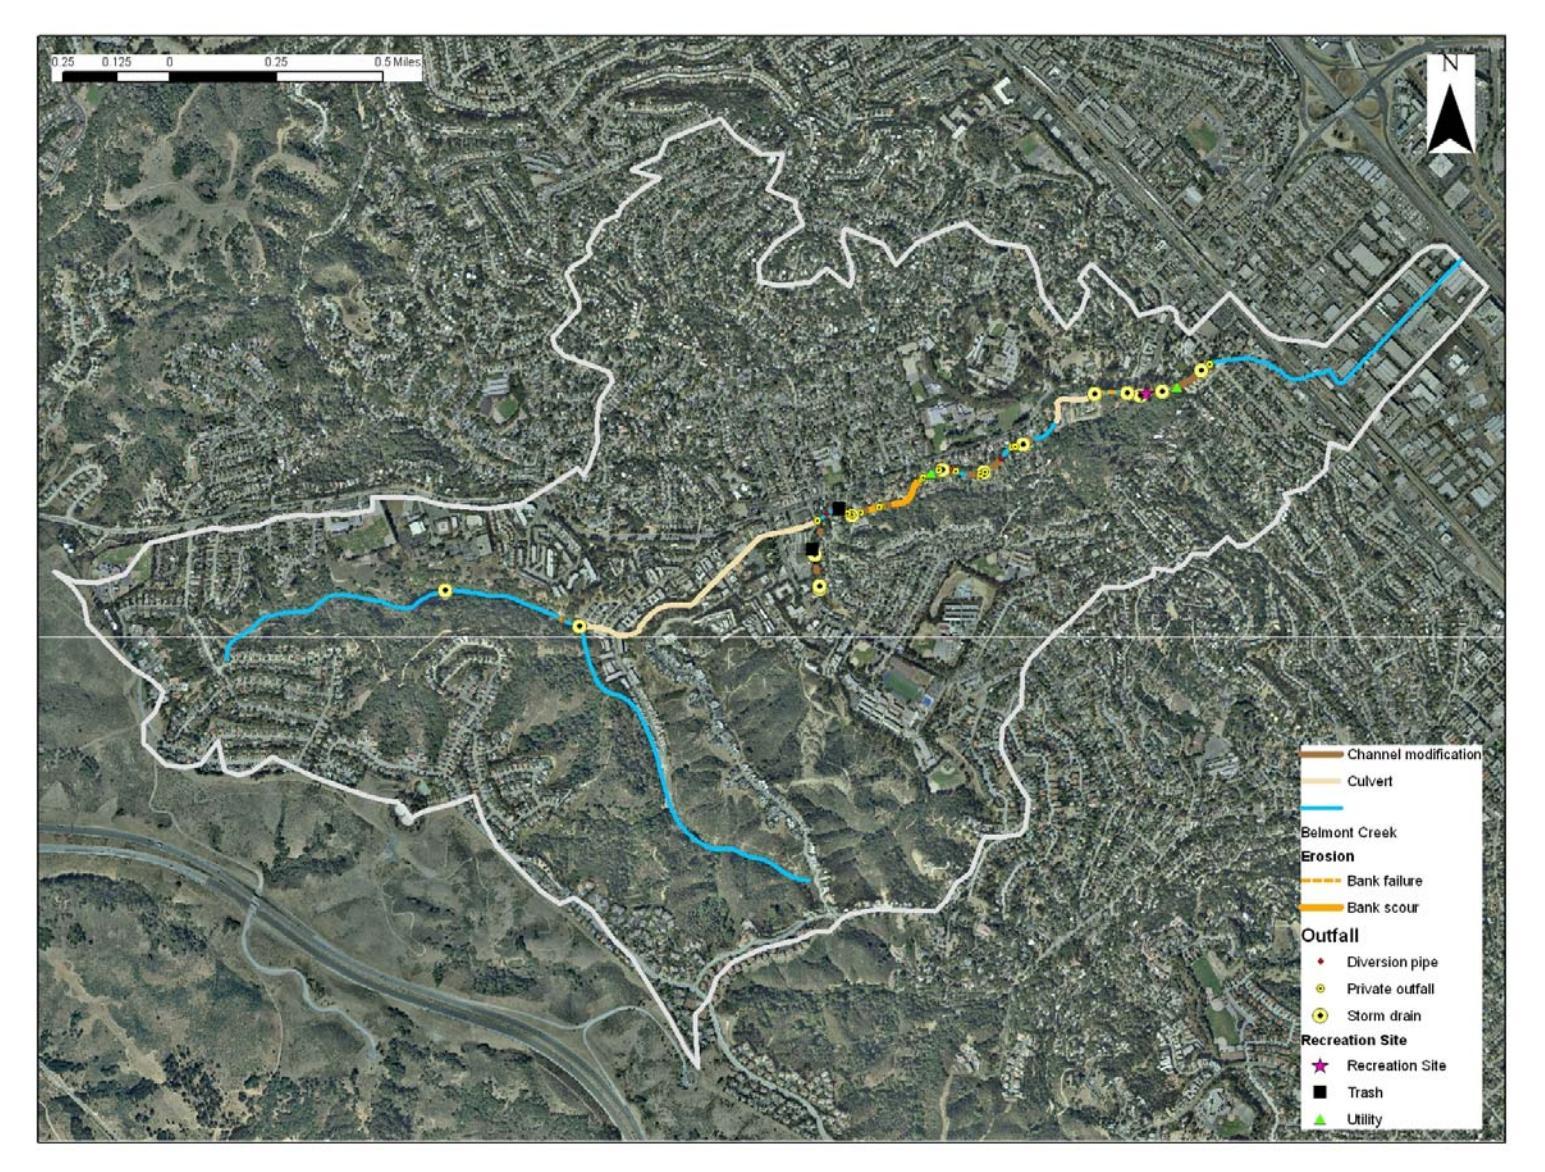
Figure 10. Impact assessments in the Belmont Creek watershed. Base image: San Mateo County Department of Public Works.

Approximately 50% of Belmont Creek has undergone some form of channel modification (Figure 10). The most downstream reaches (B1 and B2) had the highest proportion of their channels modified. The proportion of channel modification decreased in the upstream direction. Most of the modifications included bank hardening, although ~800 feet of B1 and ~3,400 feet of B2 were culverted.

The majority of creek crossings in Belmont Creek were road crossings (Table 10). Each road crossings had a hard bottom and therefore acts as a grade control within the creek channel. At the upstream end of the creek, there was one large earthen dam at the outflow of Water Dog Lake. Two of the road crossings documented in Belmont Creek (in reaches B1 and B2) could potentially act as a migration barrier to some fish species.

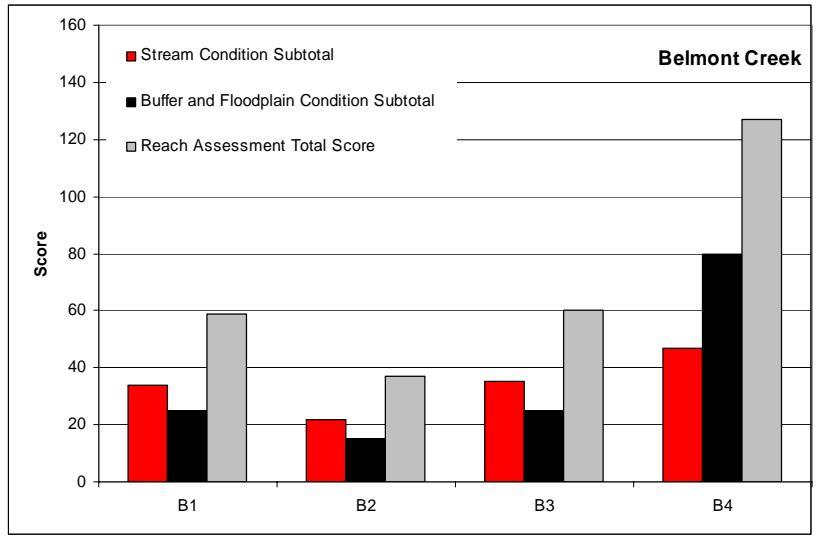
Figure 11. Reach assessment scores in the Belmont Creek watershed.

In reaches B1 – B3, instream and floodplain condition scores were generally in the poor or marginal range (Figure 11). In B1, half of the reach was hardened; banks that were

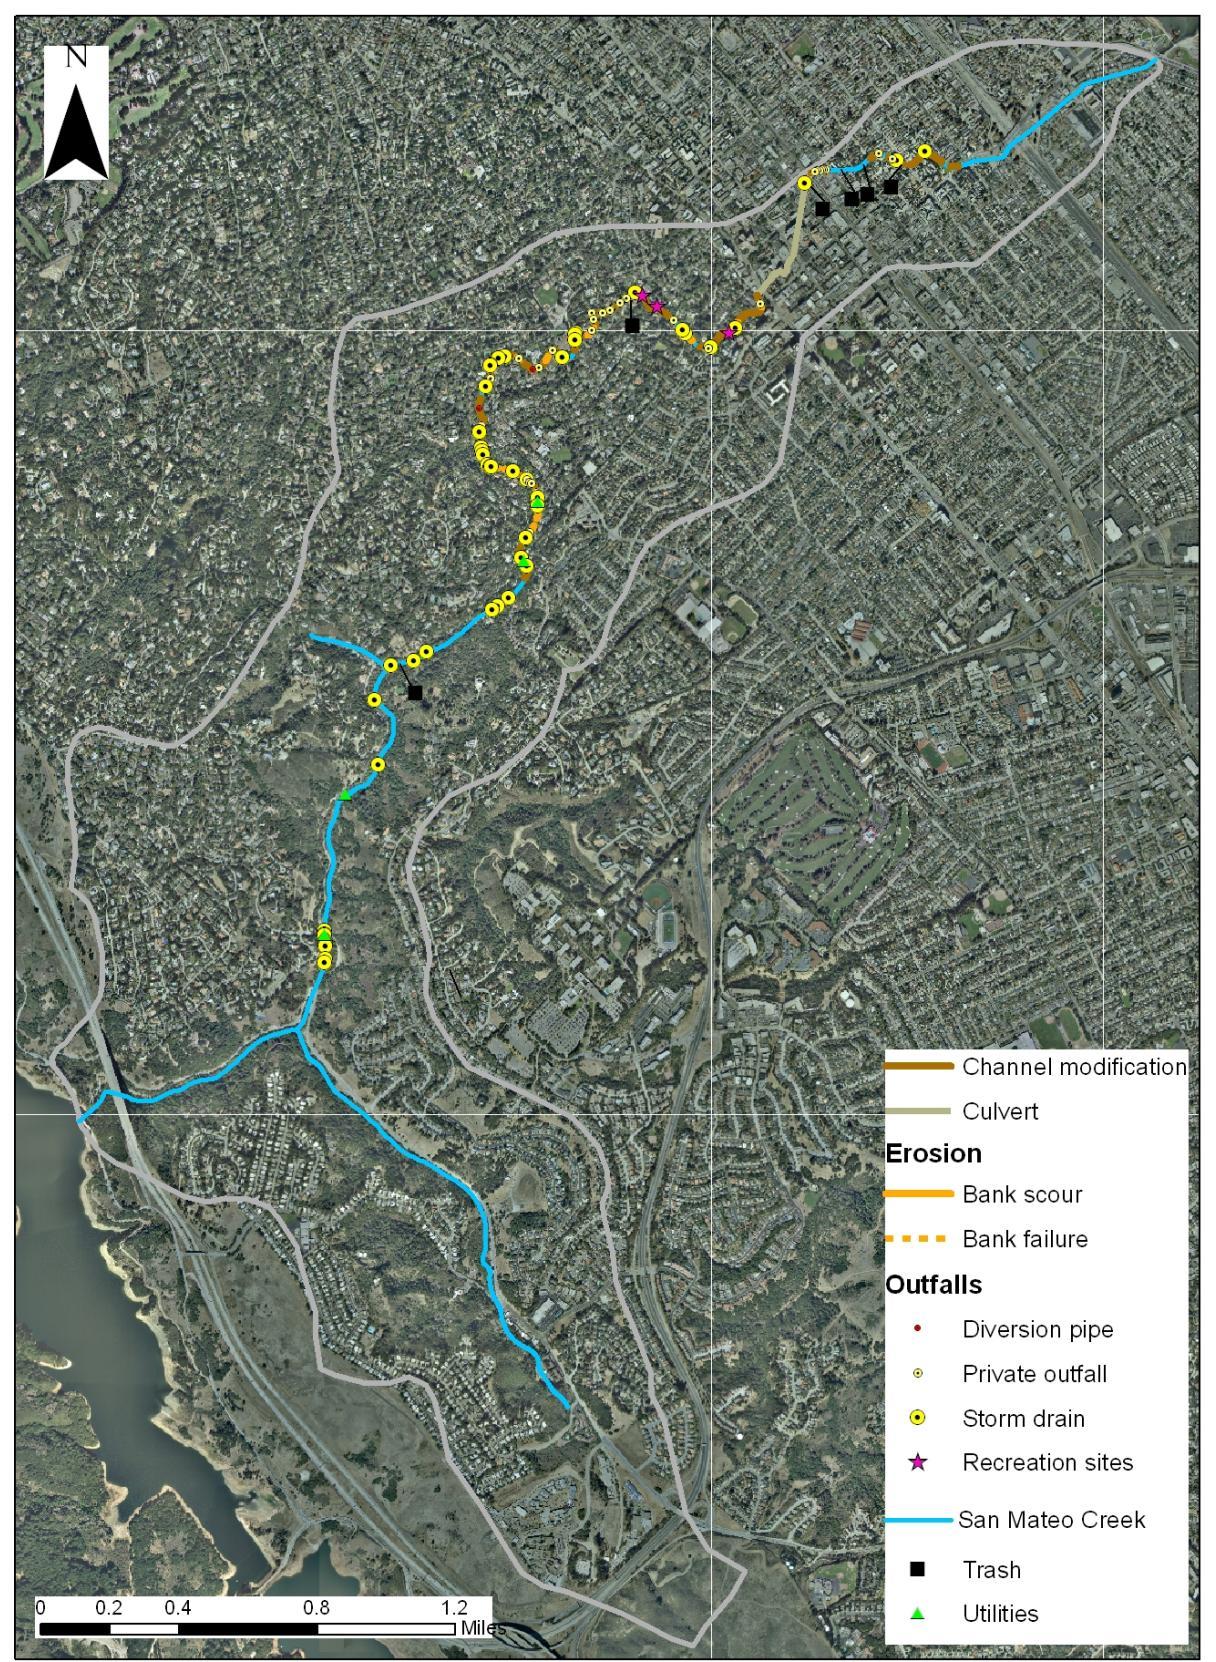
Figure 16. Impact assessments in the lower San Mateo Creek watershed. Base image: San Mateo County Department of Public Works.

Table 16 and Figure16 summarize the results of the impact assessments. Approximately 40% (9,080 ft) of the linear creek length assessed in the San Mateo Creek watershed was modified channel. While some reaches had very little channel modification, many were extensively altered, particularly in the lower and middle reaches. For example, 92% of reach SM2 had some form of channel modification. Approximately 2,000 feet of this reach (between El Camino Real and the Caltrain station) is culverted.

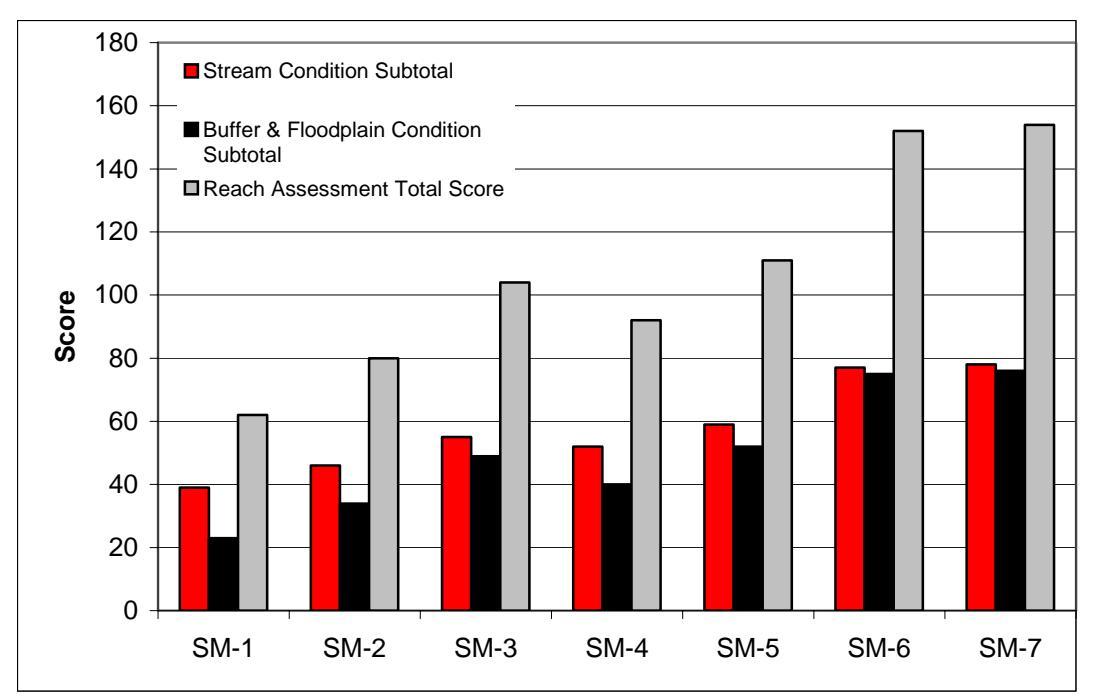
Figure 18. Reach assessment scores in the lower San Mateo Creek watershed.

Creek condition, buffer and floodplain condition, and overall reach condition scores generally increased with increasing elevation (Figure 18). This pattern also held true for each of the subcomponents of creek condition (instream habitat, vegetative protection, and bank erosion) and buffer condition (vegetated buffer width, floodplain vegetation, floodplain habitat, and floodplain encroachment) (Table 17). Most of the scores for the subcomponents fell into the marginal (6 – 10) or suboptimal (11 – 15) range, except in the most upstream reaches, SM6 and SM7, which scored in the optimal range (16 -20). Total reach assessment scores ranged from 62 (SM1) to 154 (SM7). Conditions were approximately the same for the left bank and right bank (Table 17). Instream habitat condition scores were consistently slightly higher than the scores for buffer and floodplain conditions, particularly in lower reaches where creek channelization was prevalent (Figure 18).

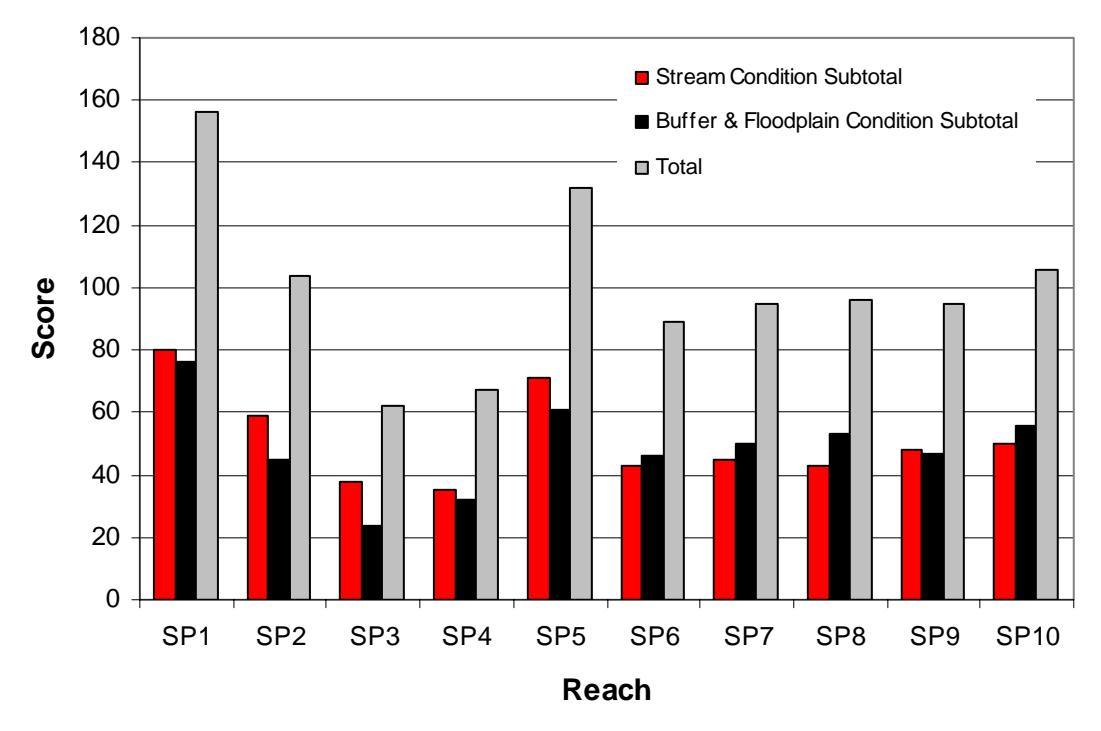
Figure 21. Reach assessment scores in the San Pedro Creek watershed.

Unlike the other study watersheds, reach scores did not increase in the upstream direction in the San Pedro Creek watershed (Figure 21). This is mostly due to creek restoration work that has been performed in this watershed. In the restored reaches (primarily SP1 and SP5), reach scores were relatively high (Table 20). SP1, which was restored approximately two years ago, now has a naturally meandering channel, dense riparian vegetation, and a large diverse floodplain that is well connected to the creek channel. Instream habitat is stable and diverse, with large woody debris snags. These factors help optimize habitat for aquatic organisms. The lower part of SP2 was also at the beginning stages of a restoration project: riparian vegetation (willow spikes) had recently been planted, and soil on the left bank was secured with straw. The left bank in this section had a large floodplain that was connected to the creek. Further upstream conditions in SP2 worsened somewhat with a long stretch of the reach hardened with sackcrete. In reaches SP3 and SP4, scores reflect an increase in bank hardening, erosion, and floodplain encroachment. The channel in these reaches was entrenched and tall banks were common. Failing or undercut bank revetments were also common in these reaches.
