## County of San Mateo Green Infrastructure Planning

Middlefield Road Parking Lot

Julie Casagrande August 18, 2021

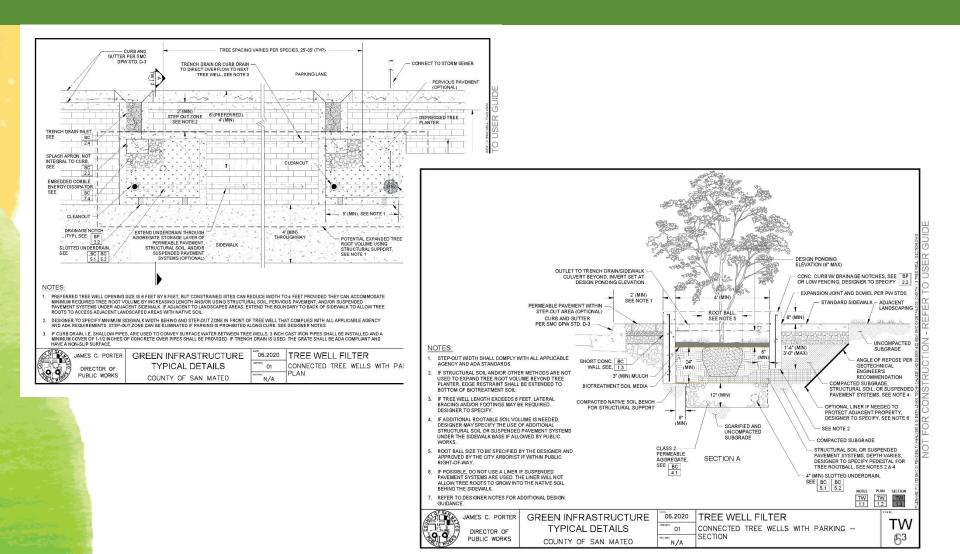
## Typical Details

- Modified typical details from SMCWPPP GI Design Guide (SFPUC) to meet County standards
- Developed new typical details:
  - Bioretention basin for street with valley gutters
  - Connected tree well filters along street parking zone
  - Bioretention edge treatments: metal fencing, wood fencing, seat wall, timber foot bridge, rock-stabilized slope, and compacted soil bench
  - Bioretention inlet with trash capture (curb cut with trash screen in 18" wide trench drain)
  - Bioretention planter barrier for Class 4 bikeway

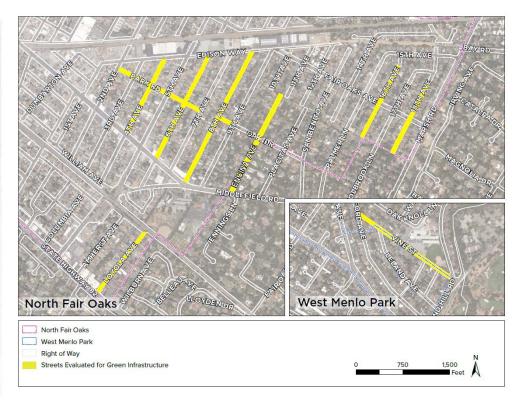
Combined Priority (Drainage, PCI, & Survey)	Street	Prioritization Category			
1	Edison Way (5 <sup>th</sup> Avenue to end) as one project.				
2	Edison Way – 1 <sup>st</sup> to 5 <sup>th</sup> Avenues				
3	11th Avenue				
4	12 <sup>th</sup> Avenue	Drainage			
5	2 <sup>nd</sup> Avenue				
6	Fair Oaks Avenue				
7	9 <sup>th</sup> Avenue				
8	Oak Drive				
9					
10	7th Avenue - Fair Oaks Ave to Spring St				
11	3 <sup>rd</sup> Avenue				
12	14 <sup>th</sup> Avenue				
13	15 <sup>th</sup> Avenue, a.k.a. Palmer Lane				
14	Amherst Avenue	DCI 41 42 55			
15	10 <sup>th</sup> Avenue	PCI 41 to 55			
16	San Benito Avenue				
17	7th Avenue B. J. B. Lin Edison Way				
18	Avenue – Middlefield Rd to Park				
10	Loyola Avenue				
40	Encina Avenue				
21	16 <sup>th</sup> Avenue				
22	8 <sup>th</sup> Avenue				
23	Park Road	PCI 55 & Above			
24	18 <sup>th</sup> Avenue				
25	4 <sup>th</sup> Avenue				
26	6 <sup>th</sup> Avenue

Logand					Beige = Streets r	north/east of railroad of the analysis.	d tracks that				Green = Potential GI feasi recommended.	bility - further analysis	Yellow = Limited GI feasibility - further analysis not recommended.
Legend					may not be part	or are unuryas.					AS AVAILABATA DESTATA		
NORTH FAIR OAKS Street From	To	Sidewalk, curb and gutter?	Paved Sidewalk?	Paved Shoulder?	Unpaved Shoulder?	Overhead Powerlines?	Street Trees	School?	Storm drain Inlets on street?	ROW width (ft)	Road Standards	Notes	Initial GI Feasibility Assessment
Fourth Avenue William Ave	Edison Way	Most	Yes - some are not paved on 400 and 500 block	No	No - some on 400 and 500 block	Yes - on one side		f Yes - Everest High School on 400 block	No	60	A-3 Urban Residential Collector or Minor Commercial	Generally a high level of imperviousness of the streetscape including parcel frontages	PP in parking lane on 300 block might be good because there are few trees. Might be able to install tree well filters or bioretention near intersections where there is a storm drain line (at Middlefield or Edison). Curb extensions a Middlefield intersection could overlap existing red curb to minimize parking loss. Could potentially combine with PP in parking lanes to treat all ROW runoff. Potential opportunity to large stormwater planter and pedestrian improvements in front of Everest High School where there is already red curl and poor landscaping if we could run 50 pipe through school parking lot to connect to 50 main in 5th Ave.

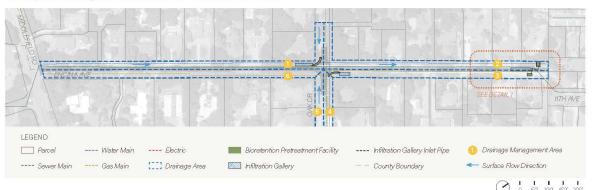
#### Conceptual Site Layout Plan: Encina Avenue, North Fair Oaks

This concept proposes to incorporate stormwater infiltration galleries along Encina Avenue within the County boundary. The proposed green infrastructure will consist of a bioretention area to capture surface runoff and provide pretreatment prior to draining to This project will manage runoff from approximately 1.6 infiltration galleries located under the roadway. The acres of roadway along Encina Ave.

DMA	Managed Area*	Proposed GI	GI Footprint	
1	04740 02	Bioretention Pretreatment^	217 ft²	
1,	31,740 ft²	Infiltration Gallery	595 ft²	
2	28,320 ft <sup>2</sup>	Bioretention Pretreatment^	207 ft <sup>2</sup>	
3	21,620 ft <sup>2</sup>	Bioretention Pretreatment^	149 ft²	
2 & 3		Infiltration Gallery	760 ft²	
v.	00.550.03	Bioretention Pretreatment^	163 ft²	
4	22,550 ft²	Infiltration Gallery	444 ft²	
5	21,670 ft²	No GI proposed within Athert	on city limits	
6	27,040 ft²	No GI proposed within Atherton city li

Encina Avenue is a two-block stretch of road, within infiltration galleries have been sized to drawdown the unincorporated County of San Mateo and City of design volume with 48 hours to meet C.3 requirements. Atherton limits. Both blocks will undergo roadway improvements to restore and repave the 18-foot consists of a 72-90" deep gallery with open-graded Middlefield Road will include 6-inch wide flush curbs top Proprietary systems consisting of chambers or other while the northern block near the roadway dead end will include 2-foot wide concrete valley autters to manage surface runoff.

- » Infiltration Potential. Infiltration tests performed in the North Fair Oaks neighborhood with the borehole method yielded corrected infiltration rates of 0.6 inches per hour on the southern half of Encina Ave, and approximately 0.75 inches per hour on the northern half. The bioretention and infiltration gallery facilities should be sized and designed to ensure drawdown within 48 hours.

- » High Flow Bypass. Encina Ave does not have a storm drain, therefore the bioretention facilities must be designed to passively bypass larger flows that exceed the capacity of the infiltration galleries. This can be achieved with curb cut outlets to the street at the overflow elevation.

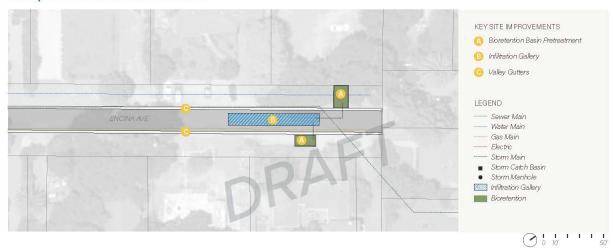
### Concept Detail 1: Encina Avenue End Block

The infiltration gallery sizing assumes that this facility travel path. Additionally, the southern block nearest to aggregate and a perforated distribution pipe along the structural elements may be used to increase the storage volume per footprint. The bioretention facilities only provide pretreatment (i.e. sediment and debris capture) and thus have not been sized to treat the entire drainage management area per C.3 requirements. Alternative pretreatment facilities, including proprietary systems, should be evaluated in the future design phase.

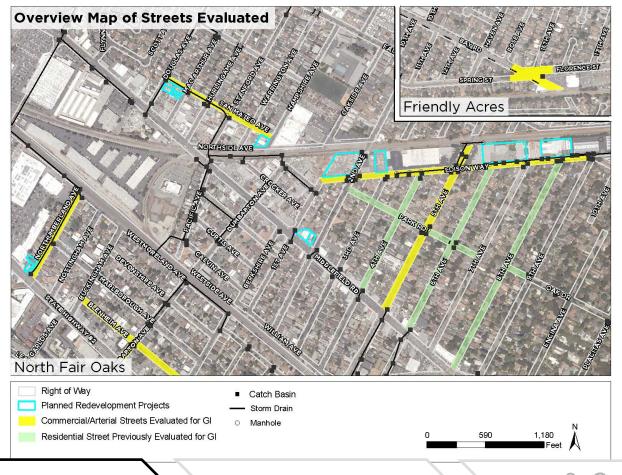
## Desktop Analysis – Redevelopment/ Frontage

Cou	nty of s	San Mate	o Gree	n Infra	structure	Scree	ning Analysi	s for Com	mercial Streets	
NORTH FAIR	OAKS					iicy Oi c	out Widte	0 0100		stractar c	50100	Green = High Potential GI t analysis recommended.		Green = Moderate Potential GI feasibility - further analysis recommended.	Yellow = Limited GI feasibility - further analysis not recommended.
Street	From		Sidewalk, curb and gutter?	Paved Shoulder?	Bike Lanes?	Onstreet Parking?	Overhead Powerlines?	Street Trees	School?	Stormdrain Inlets on street?	ROWwidth (-ft)	Road Standards	Redevelopment	Notes	Initial G I Feasibility Assessment
Edison Way	1st Ave		Curb and gutter on both sides; continuous paved sidewalk on north side, mix of paved and gravel for sidewalk area on	Yes	No	Yes	Partially along north side	No	No	Yes, two at 2nd Ave intersection	50-60	A-3 Urban Residential Collector or Minor Commercial	North side of street	Sanitary's ewer and Water Main on south side of Edison in street	Not much space for Pervious Pawement (PP) because roadways only 20-ft wide with 6-ft paining lanse. Esting bulbout a southwest corner of 2nd and Edson intersection good location for bioretention if no utility interference. Potential 5-CE (SCE) at northwest corner of 2nd and Edison. However, small drainage are as ince Edison is so flot. Opportunity for tree wells along sidewalk in front of new development on north side.

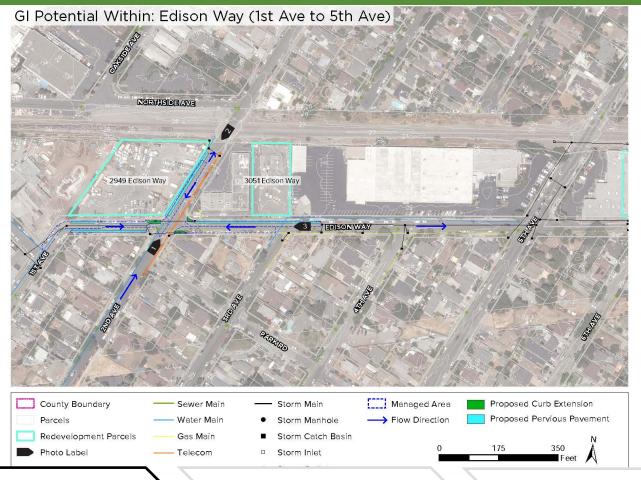
## Desktop Analysis – Redevelopment/Frontage

A .				frastructure Feasibility						
Planned Project		Two parcels (2949 Edison Way and 3051 Edison Way) are slated for development. Both								
Description	projects will provide a minimum 8-foot sidewalk.									
Road Type	A-3 Urban Residential Collector/Minor Commercial. 55-foot right-of-way,									
Gi Opportunities Evaluated		Stormwater Curb Extension (Parking Zone)     Pervious Pavement (Parking Zone)								
Gi Plan Prioritization	High									
Site Conditions	Soll	unknown								
	Groundwater	10-20 feet								
Drainage	• 1st through 5t	Edison Way drains towards 2nd and 5th Ave with a high point at 3rd Ave.     Ist through 5th Ave drain north     Catch basins at the intersections with 2nd through 5th Ave collect runoff from Edison								
Utility Conflicts		on south side of Ed								
	Water main or	er main 7-feet from north side of Ediso on south side of Ed	n in sidewa							
Gi Evaluated	Stormwater Curb Extension  The Intersection of 2nd Ave and Edison Way has opportunities fextensions on the northwest, northeast, and southeast corners utilities can be avoided. Existing catch basins at each corner can a connection for underdrains and overflows. Special DPW approvious needed to allow for curb extensions less than 3-feet away from water main on the northwest corner. Sanitary sewer located 6-feath the south curb of Edison prohibits curb extensions on the sout side of Edison Way.

Pervious Pervious pavement appears feasible in the parking lane of Edison V on the north side of the street with setbacks from water mains. A main east of 2nd Ave prevents feasibility for pervious pavement on south side of Edison Way.									
3i Performance	Total street are	managed		0.58 acres						
	Pervious Pavern	ent		6,200 square feet						
	Bioretention	Total Plante		775 square feet						
		Sizing Ratio		4.0 %						
	Parking Loss			4 spaces at Edison and 2nd Intersection						
Design Criteria	Pervious Pavement Width 8 feet (Incl. gutter and flush curb) Curb Extension Width 5-9 feet (9 ft where planter strip proposed)									
GI Feasibility	extensions and Where sidewall provide wider be can be installed	can provide improve widening is plann ioretention areas the	ed pedestred, stormatenced, stormatenced at encroaces of the property of the p	rsection can incorporate stormwater curb rian safety with reduced crossing distances, water curb extensions can be designed to h into the planting strip. Pervious pavement oposed developments to provide additional

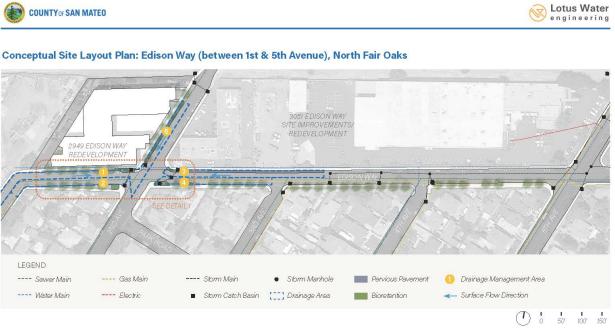
### **Green Infrastructure Sizing**

DMA	Managed Area*	Proposed GI	GI Footprint
1	6,964 ft²	Bioretention Bulbout	440 ft²
2	5,230 ft²	Bioretention Planter	215 ft²
^	ATE 02	Pervious Pavement	2,865 ft²
3	6,751 ft²	Bioretention Bulbout	186 ft²
4	4,925 ft²	Bioretention Bulbout	333 ft²
5	5,160 ft²	Pervious Pavement	1,083 ft²

Edison Way has several parcels that are redeveloping between 1st Ave and 9th Ave, including 2949 Edison Way which is proposing to build a 7-story residential development. This project envisions streetscape and with the redevelopment. Proposed improvements infiltrate stormwater runoff from the roadway and pavement and stormwater curb extensions to collect and infiltrate stormwater runoff from the roadway and

Pervious pavement is proposed on both sides of the This project will manage runoff from approximately 0.7 street between 1st and 3rd Ave which will delineate street acres of impervious roadway and sidewalk area. parking and manage runoff from the adjacent roadway. The proposed pervious pavement will minimize runoff generated from impervious areas by capturing and infiltrating stormwater runoff.
